2017 BRIDGE INVENTORY

BRIDGE NO.: 0076 **HIGHWAY:** New York Avenue, N.E.
OVER: Anacostia River

INSPECTION START DATE: 12/11/2017 **INSPECTION END DATE:** 01/11/2018
INSPECTION CYCLE: 24 mo. **INSPECTION TYPE:** Routine

2017 District of Columbia Bridge Inspections Summary Report

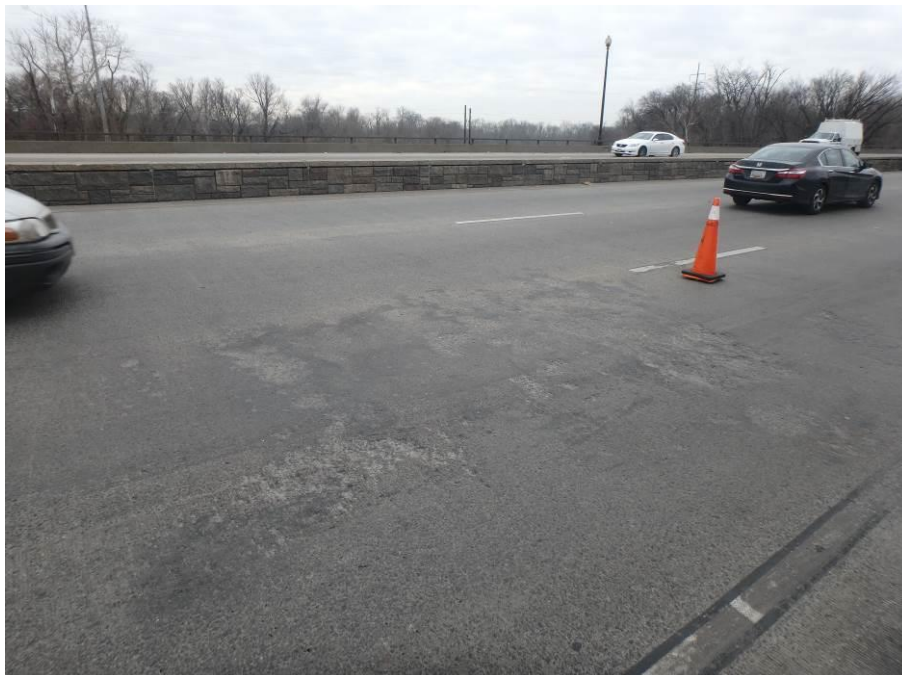
<p>12 300 302 330 331 520</p>	<p>Deck:</p> <p>The concrete wearing surface is in good condition (see Photograph No. 13). There is light scaling in the traffic lane wheel paths and a 3'-4" long x 4'-2" wide area of minor shallow spalling in the South shoulder of Span 2 in the Eastbound lanes. The Westbound lanes exhibit a 4'-6" x 4'-6" area of shallow spalling in the right shoulder over the West Abutment Span and a 12'-0" long x 6'-0" wide area of shallow spalling in the right lane of Span 2 (see Photograph No. 14). There is a 10" long x 7" wide x 1 1/2" deep pothole in the left Eastbound lane of the West Abutment Span and an 18" wide x 6" long x up to 1/2" deep spall in the wearing surface in the right Westbound lane adjacent to the West Abutment joint. The left Eastbound lane of the East Abutment Span exhibits a 12" x 12" repair. There are longitudinal hairline cracks in the wearing surface over the two cellular abutments (see Photograph No. 15). These cracks should be monitored as they may allow for possible leakage on and between the concrete box beams in the abutments. There is water ponding on the North shoulder of Span 1. The roadway markings are in satisfactory condition with missing sections in the Eastbound lanes of Span 1. Seventeen (17) roadway reflectors are broken or missing in the Eastbound lanes and fourteen (14) are broken or missing in the Westbound lanes (see Photograph No. 16).</p>

Photograph No. 14 – 12'-0" Long x 6'-0" Wide Area of Shallow Spalling in the Right Westbound Lane of Span 2

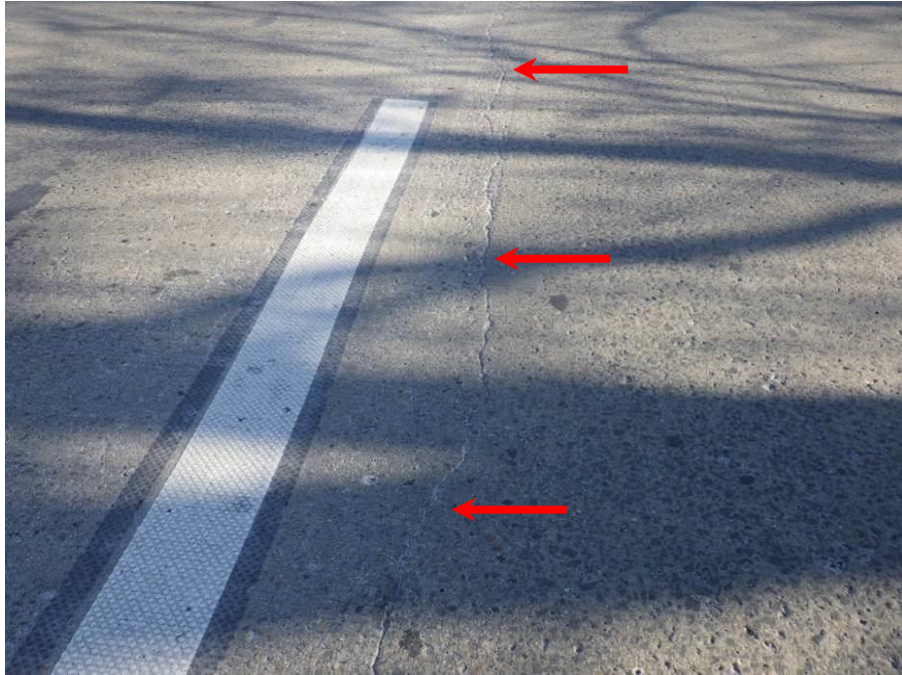
Photograph No. 15 – Typical Longitudinal Hairline Crack over Cellular Abutments, Eastbound Lanes of East Cellular Abutment Shown (Arrows)

BRIDGE ELEMENT	RECOMMENDED ACTION		PC
Concrete Wearing Surface (12)	Monitor the cracks in the wearing surface over the cellular abutments.

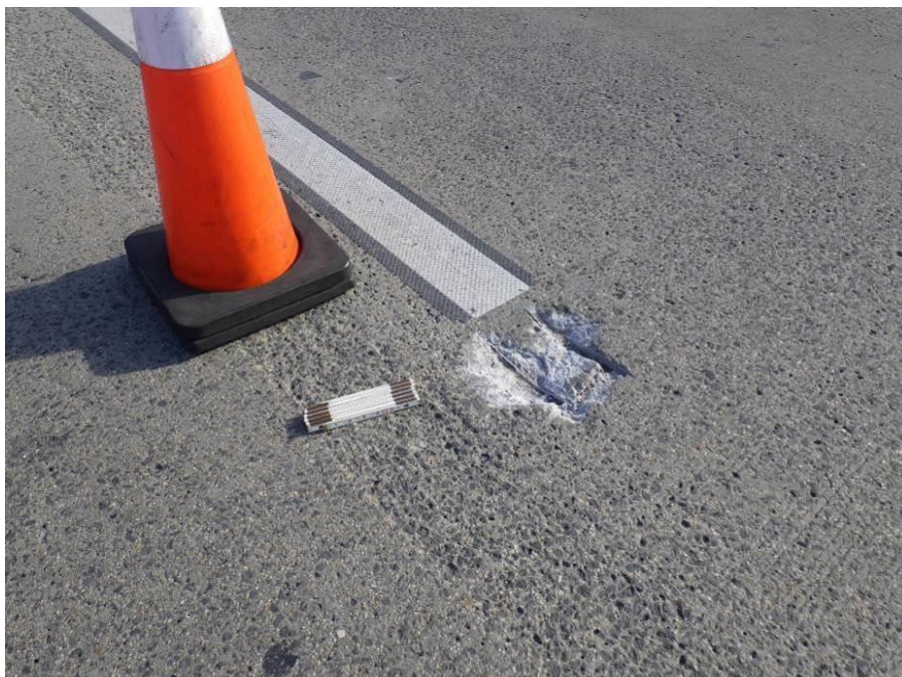
Photograph No. 16 – Missing Roadway Reflector between the Left and Center Eastbound Lanes

4
Miscellaneous	Replace broken or missing roadway reflectors (31 EA) and bridge railing reflectors.

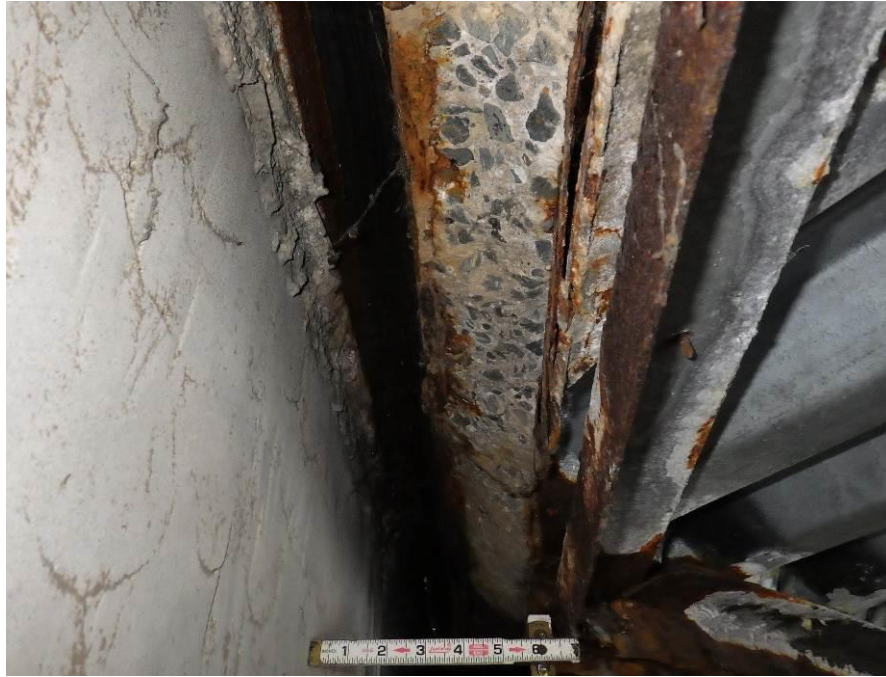
Photograph No. 17 – 26'-0" Long x 3" Wide x 6" Deep Spall in the Soffit at the West Abutment adjacent to the S.I.P. Forms, Looking North

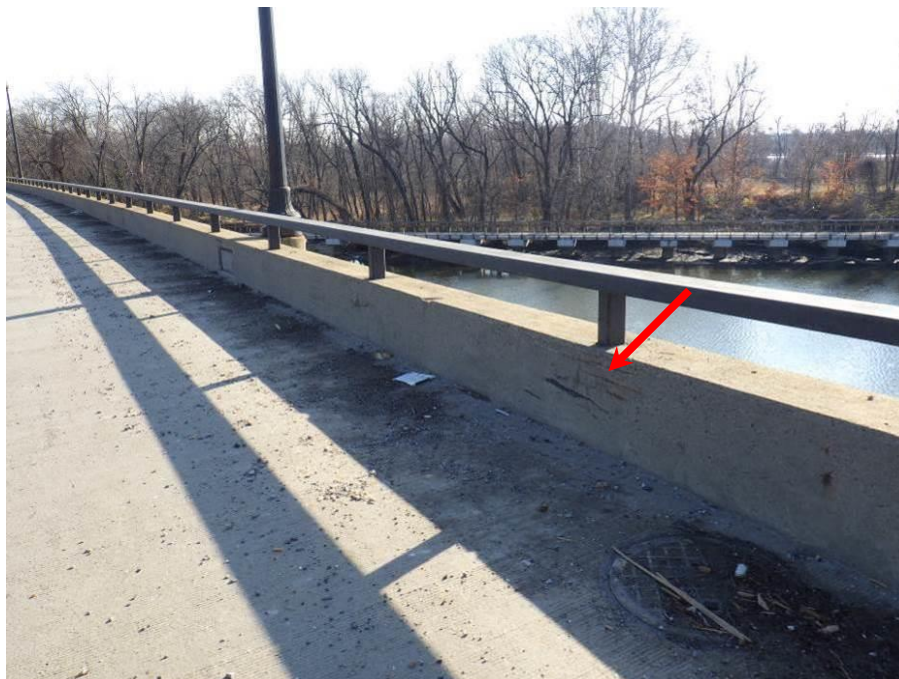
Photograph No. 18 – Typical Reinforced Concrete Parapet with Metal Railing Mounted on Top. Note Minor Scrape Marks (Arrow)

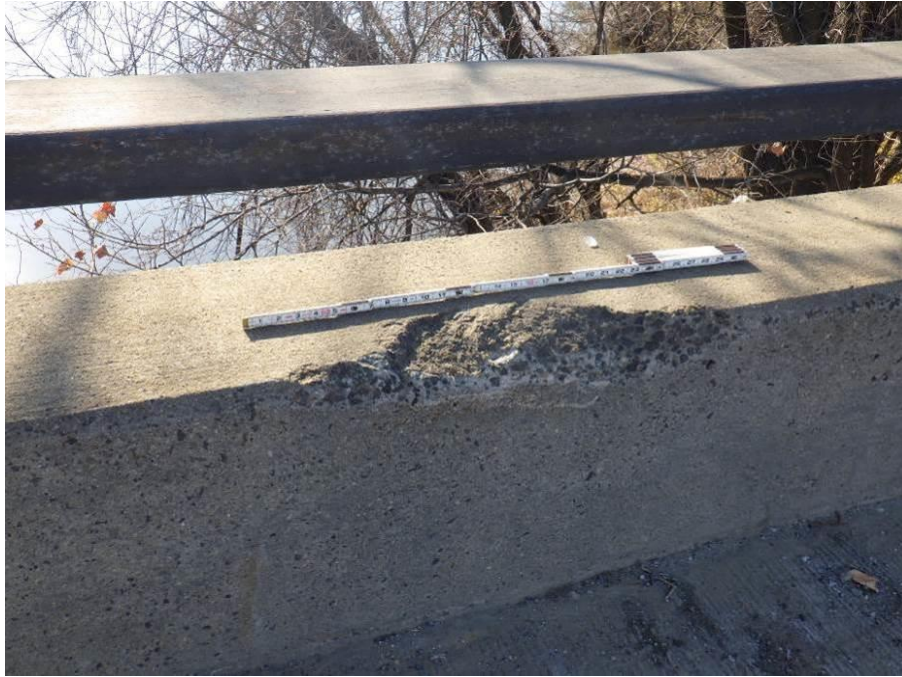
Photograph No. 19 – 2'-4" Long x 3" x 3" Spall in Upper North Corner of South Parapet

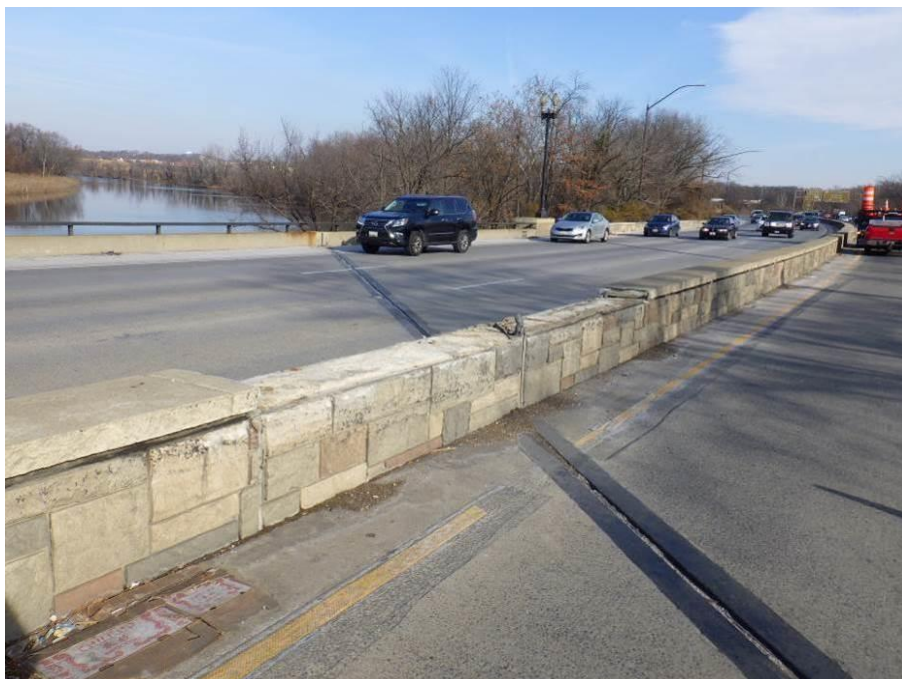
Photograph No. 20 – 19'-0" Long Section of Missing Median Barrier Capstone at the East End of the Bridge

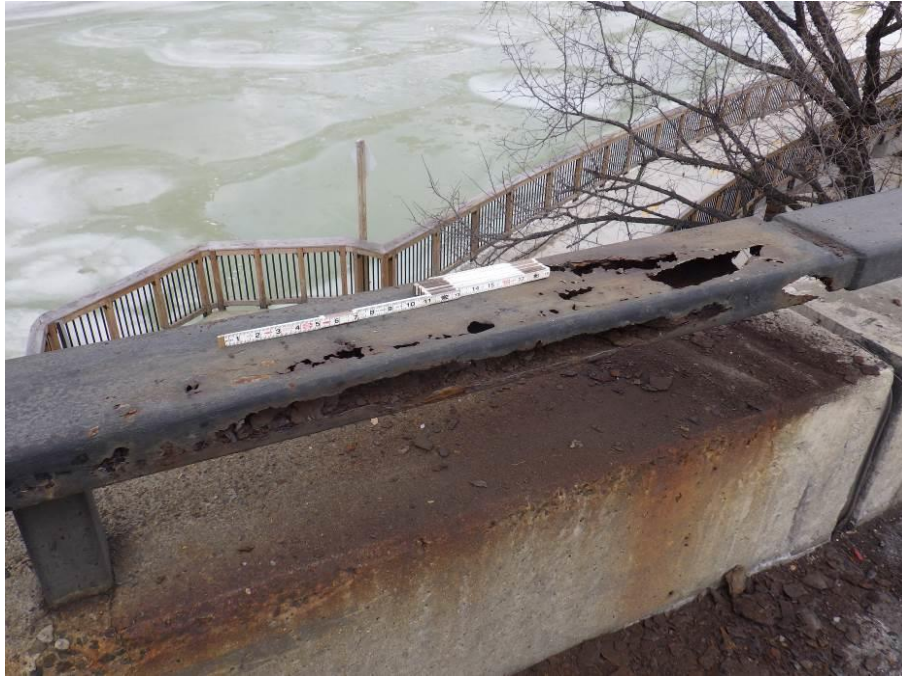
Photograph No. 21 – Areas of 100% Section Loss (Holes) in the East End of the North Bridge Railing

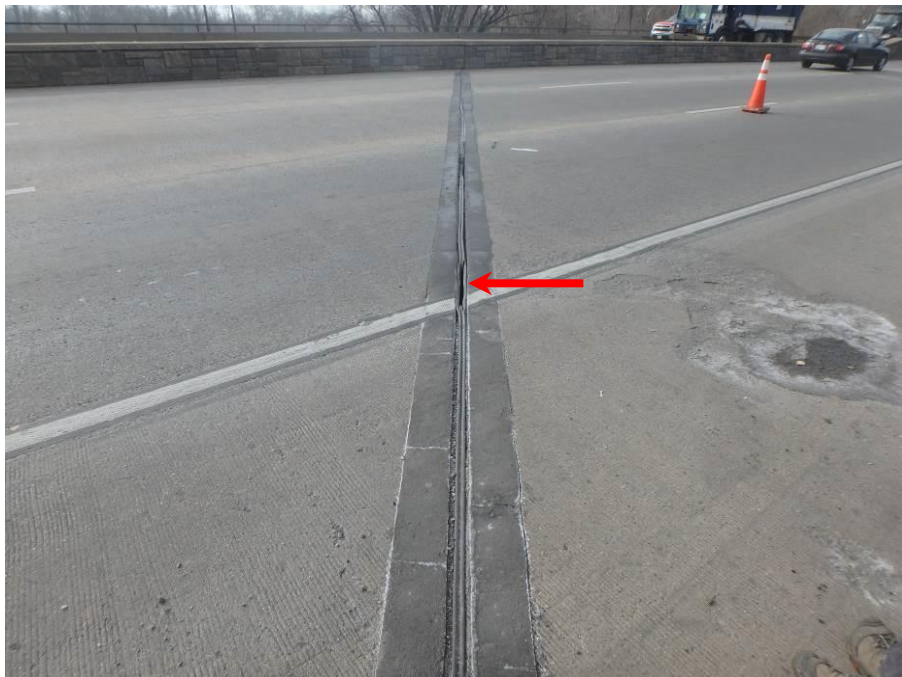
Photograph No. 22 – Compression Joint over Northern Portion of West Abutment, Looking South. Note 2'-6" Long Tear in Joint Material in Right Westbound Lane (Arrow)

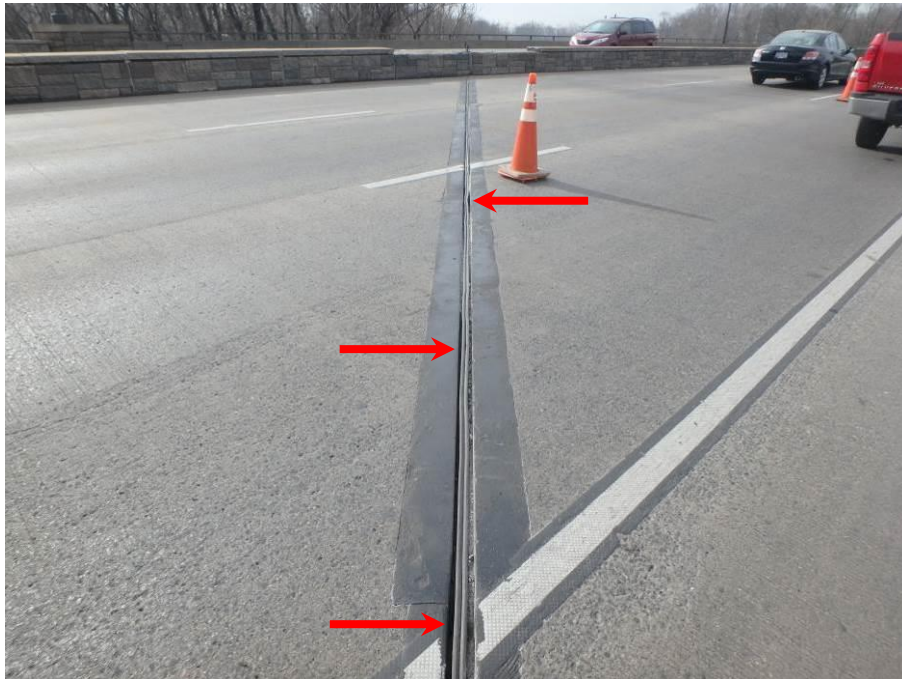
Photograph No. 24 – Compression Joint over Northern Portion of East Abutment, Looking South. Note Debonded Sections of Joint Material (Arrows)

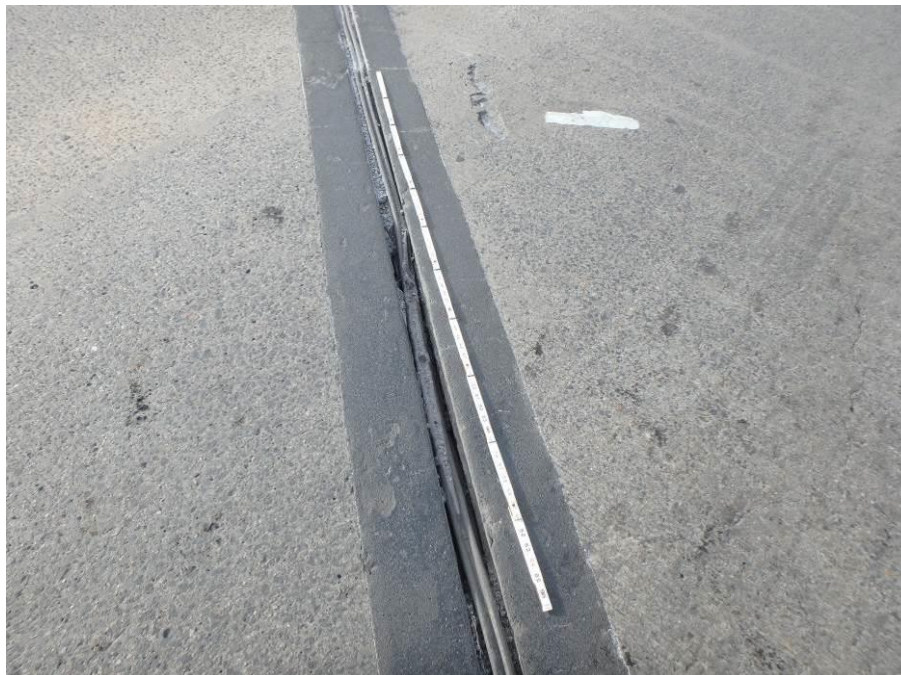
Photograph No. 26 – Compression Joint over Northern Portion of West Abutment, Damaged and Depressed Joint Material in the Right Westbound Lane

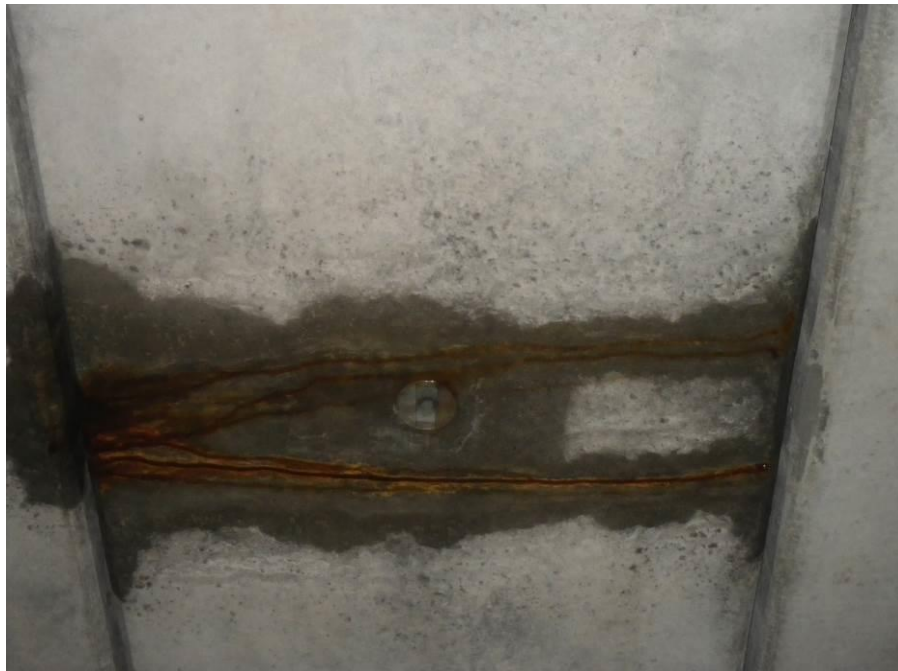
Photograph No. 30 – Evidence of Moisture Leaking between
Box Girders 12 and 13 in West Abutment Span

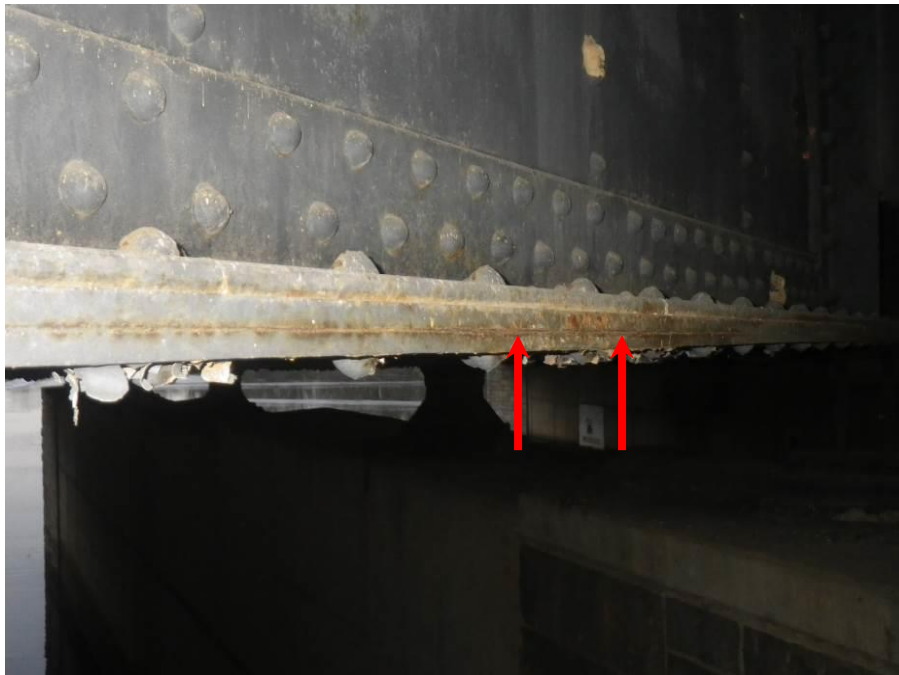
Photograph No. 34 – Girder 7, Span 1, Pier 1, South Face, 1/8" Thick Crevice Corrosion between Bottom Flange Cover Plates (Arrows)

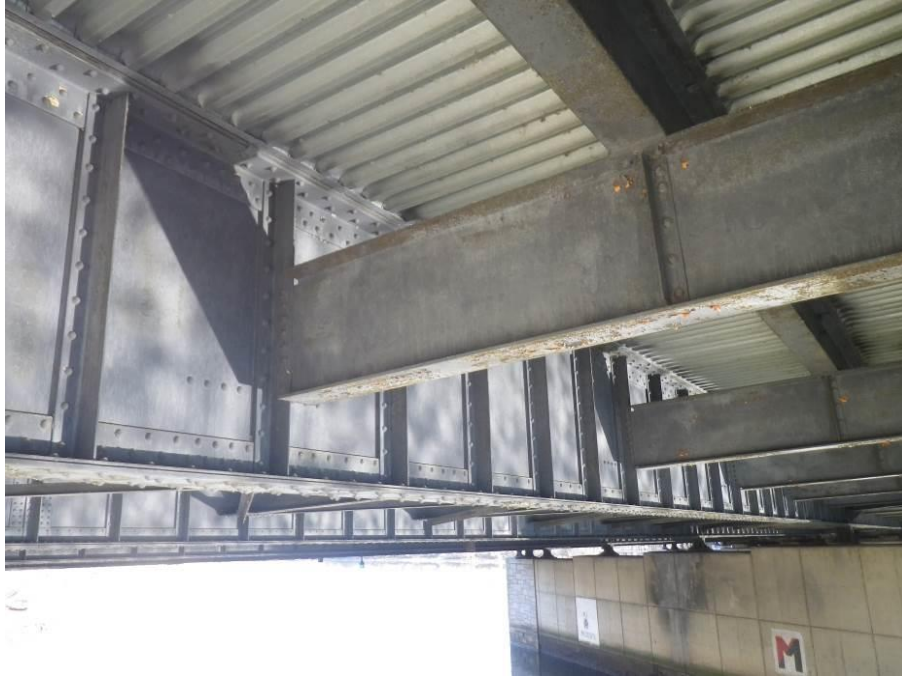
Photograph No. 35 – Typical Floorbeam Connections in Good Condition with Minor Paint Deterioration, Girder 6 in Span 2 Shown, Looking Northeast

4
Steel Stringer, Painted (113) Steel Floorbeam, Painted (152)	Spot clean and paint areas with deteriorated paint on the stringers (approximately 2,004 SF) and floorbeams (approximately 2,660 SF).

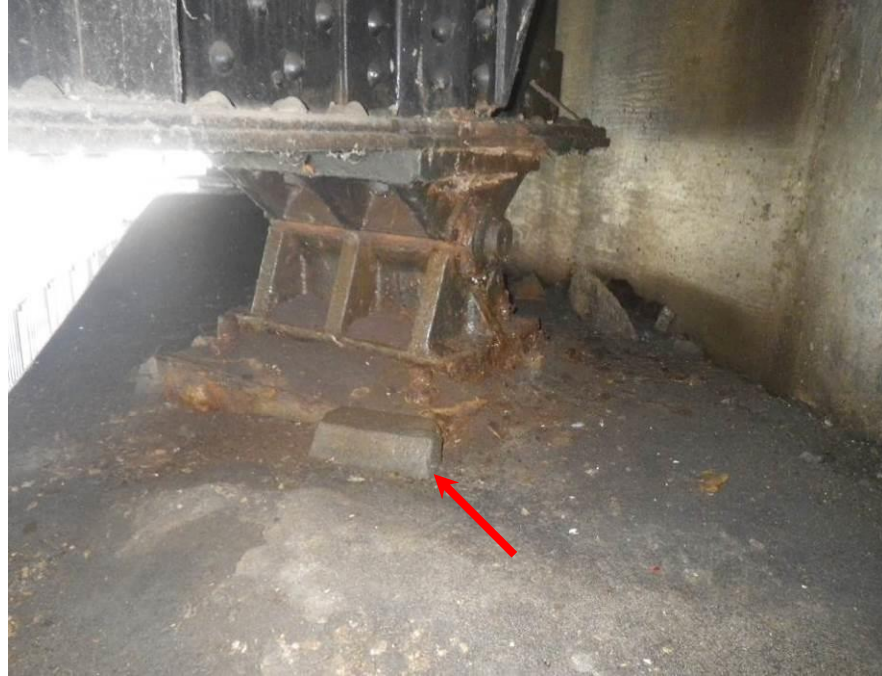
Photograph No. 37 – Typical Rocker Bearing with Minor Paint Deterioration and Surface Corrosion at Base, East Abutment Bearing 3 Shown. Note Spalled Concrete Pedestal Plate Encasement (Arrow)

BRIDGE ELEMENT	RECOMMENDED ACTION		PC
Movable Bearing (31) Fixed Bearing (313)	Remove remaining cracked and spalled encasement concrete from around the bearing masonry plates at the East Abutment.

3
	Clean and paint the corroded exposed expansion and fixed bearing metalwork (34 EA); remove any crevice corrosion below the rockers (14 EA) and lubricate the movable bearing pins (32 EA).

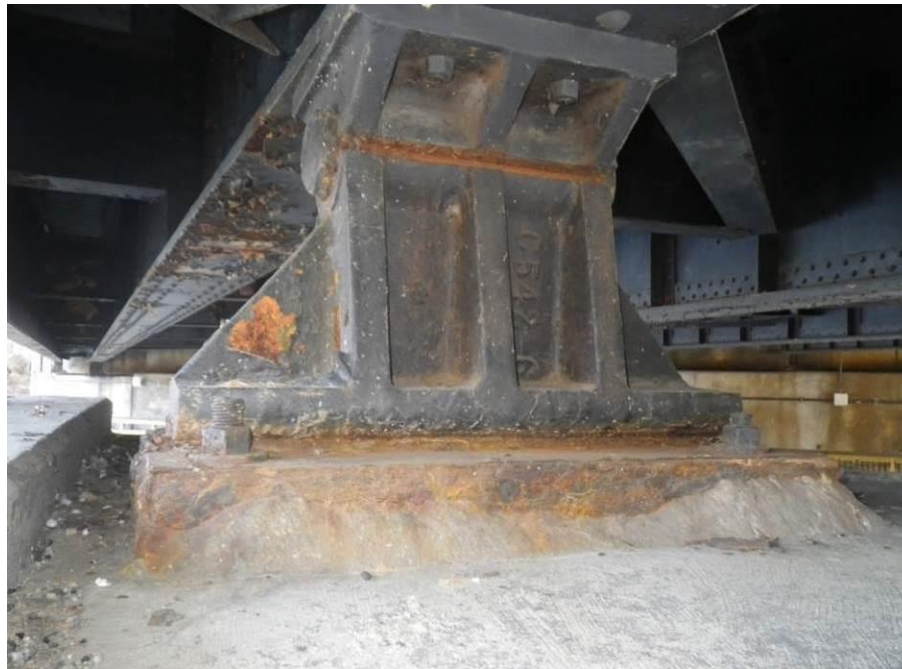
Photograph No. 38 – Moderate Crevice Corrosion between Rocker Bearing and Masonry Plate, Bearing 2, West Face at Pier 3 Shown

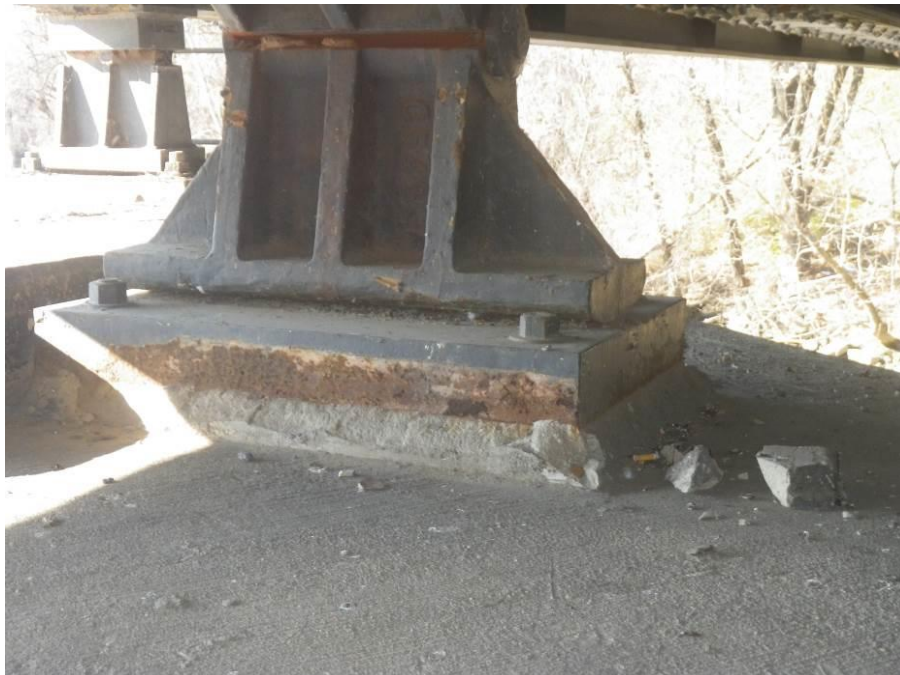
Photograph No. 40 – Spalled Bearing Pedestal Encasement for Girder 7 at Pier 1, Looking Southwest

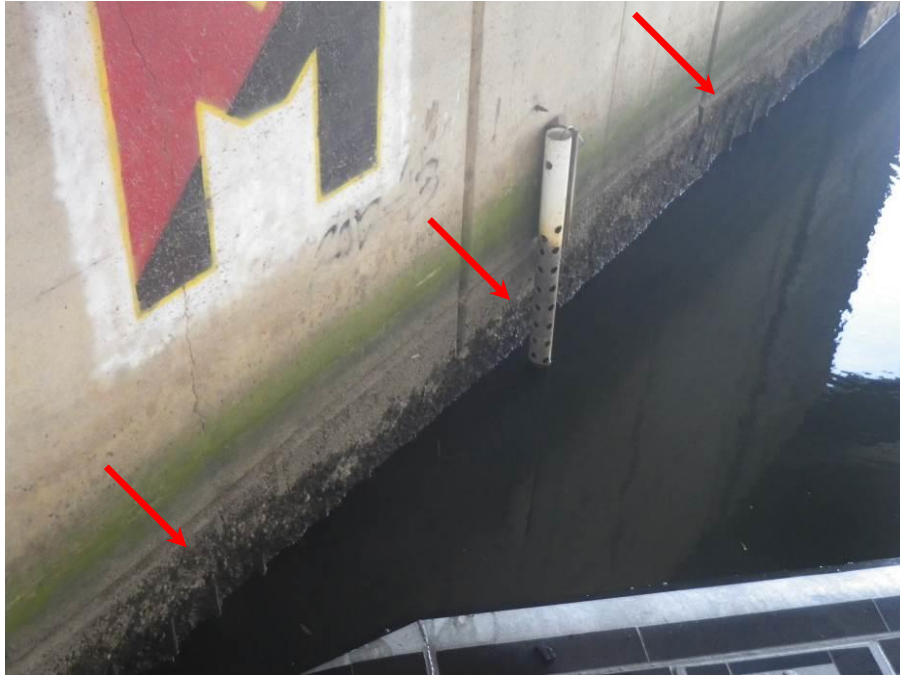
NBI Item No.	Name	Rating	Descriptions
58	Deck	7	
59	Superstructure	7	
60	Substructure	6	Severe scaling below waterline, and moderate spalls and delaminations in abutment stems
61	Channel	7	
62	Culverts	N

Photograph No. 47 – Typical Severe Scaling with Exposed Reinforcing Steel below Waterline at West Face of Pier 2, Visible Due to Low Tide (Arrows)

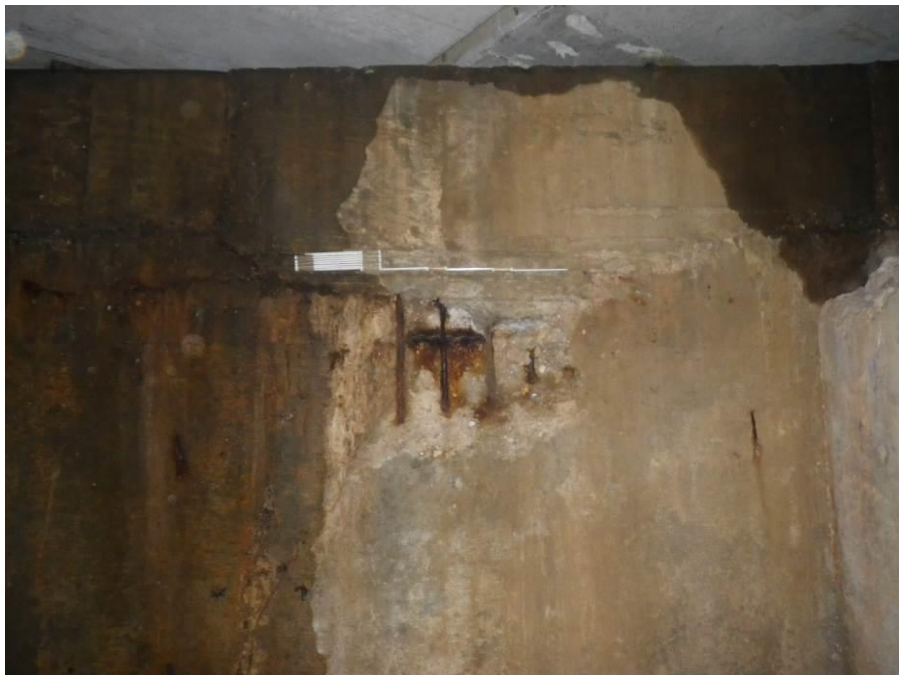
Photograph No. 48 – 22" x 17" x 2 1/8" Deep Spall with Up to 75% Section Loss of Exposed Corroded Reinforcing Steel in West Abutment Grade Beam between Box Beams 5 and 6, Looking West

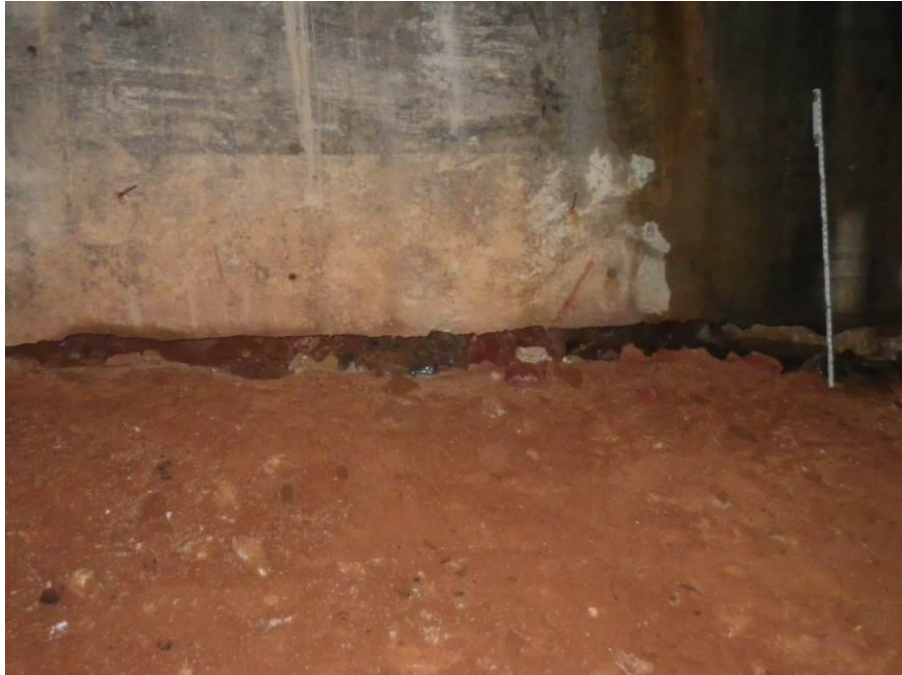
Photograph No. 49 – Settlement of West Abutment Span Fill Material along Base of West Abutment Grade Beam Allowing Various Sizes of Voids

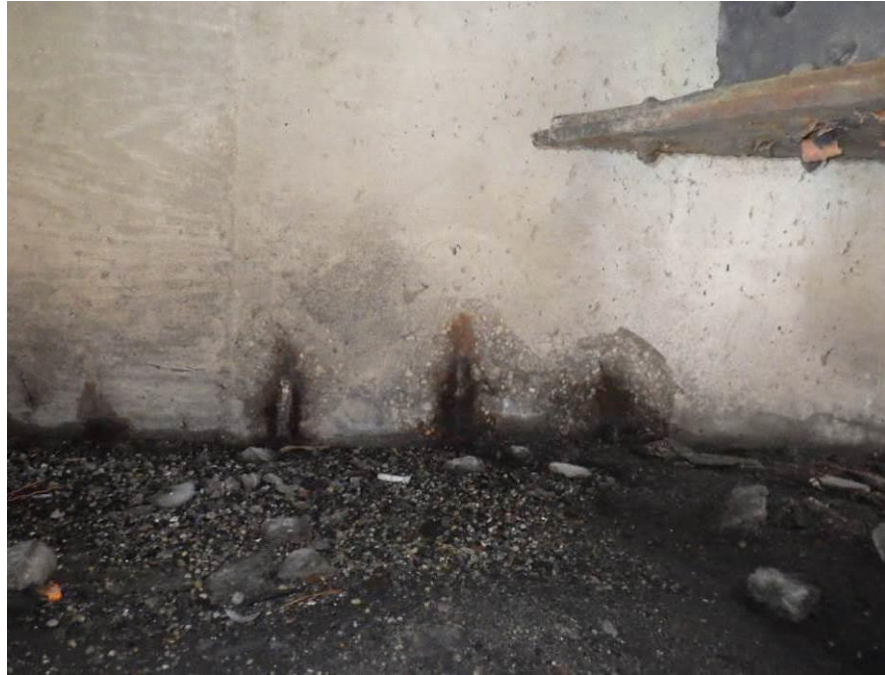
Photograph No. 51 – Three Up to 11" Diameter Spalls with Exposed Corroded Reinforcing Steel in the West Abutment Backwall between Girders 2 and 3

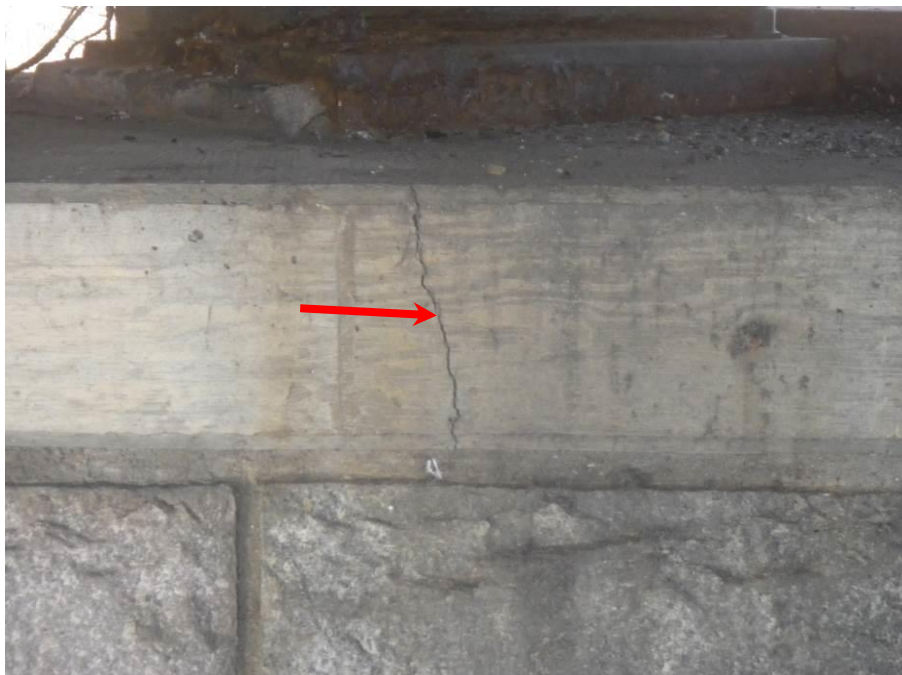
Photograph No. 52 – 1/8" Wide Crack in the East Face of the Pier 1 Cap at Girder 2 (Arrow)

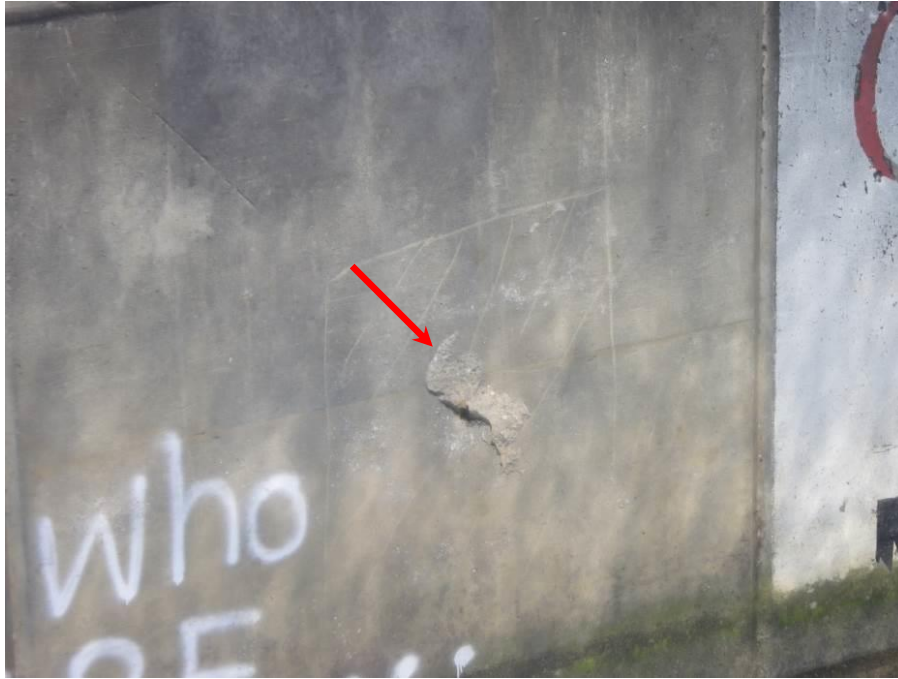
Photograph No. 53 – 13” Long x 16” High x Up to 1 3/4” Deep Spall inside of a 3’-0” Long x 4’-4” High Unsound Area in the East Face of Pier 1 below Girder 5

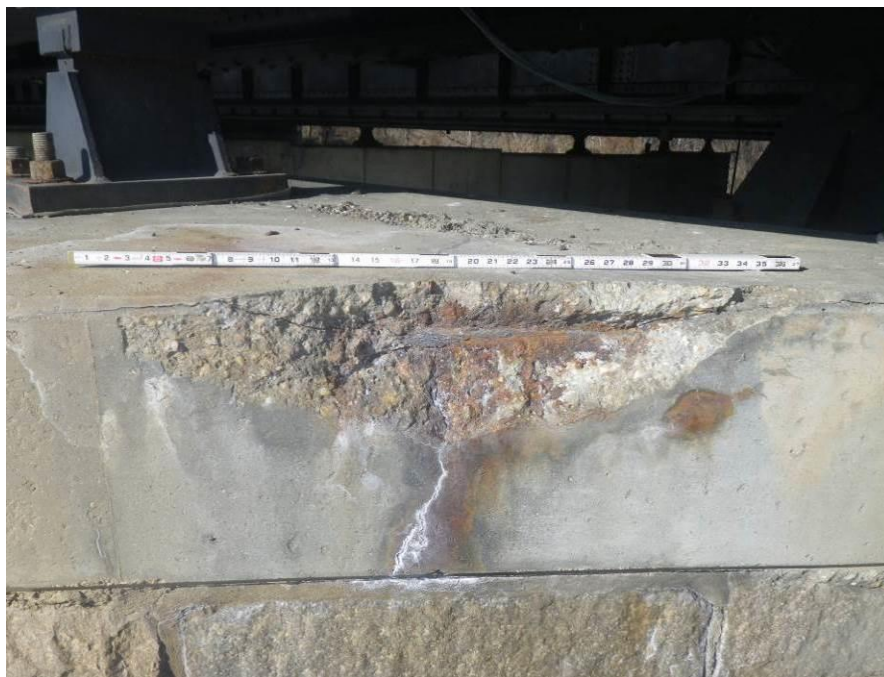
Photograph No. 54 – 2’-8” Wide x 6 1/2” High x Up to 3” Deep Spall with Exposed Corroded Reinforcing Steel and Efflorescence in East Face of Pier 2

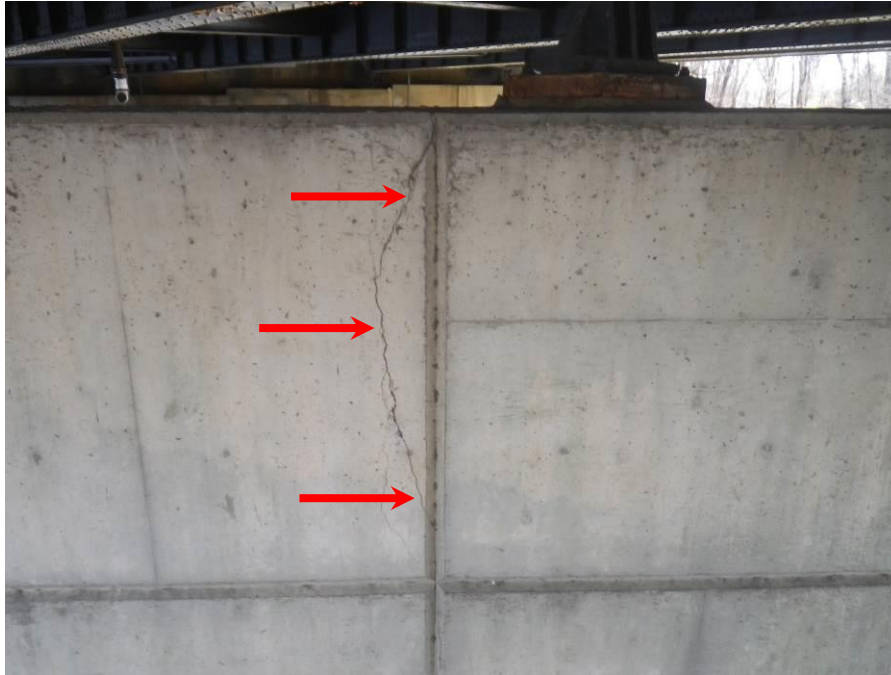
Photograph No. 55 – Upper Portion of Typical Full-Height Vertical Hairline Crack in Pier Wall, West Face of Pier 3 at Girder 4 Shown (Arrows)

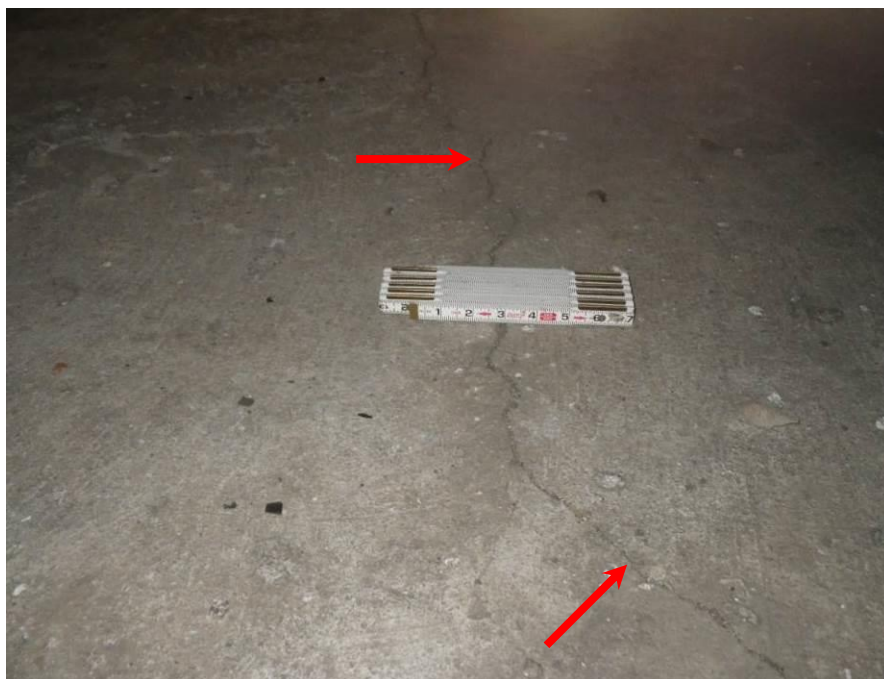
Photograph No. 56 – Hairline to 1/8" Wide Crack Extending across Pier Cap from Vertical Crack in Stem (Arrows), Pier 3 between Girders 3 and 4 Shown

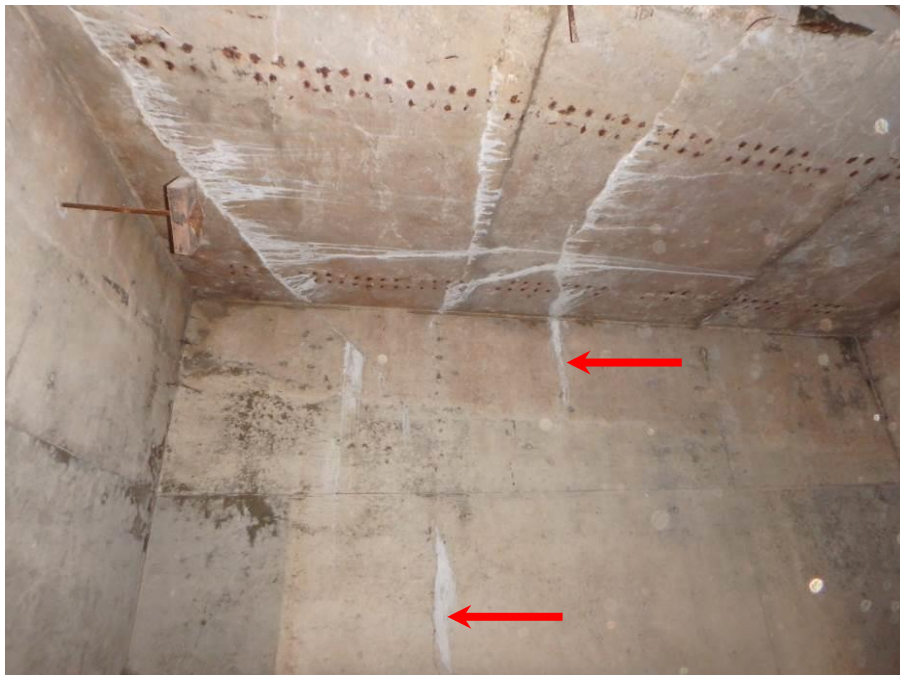
Photograph No. 58 – Typical Full-height Vertical Hairline Cracks with Efflorescence in the East Face of the East Abutment Stem, between Beams 13 and 14 Shown, Looking West (Arrows)

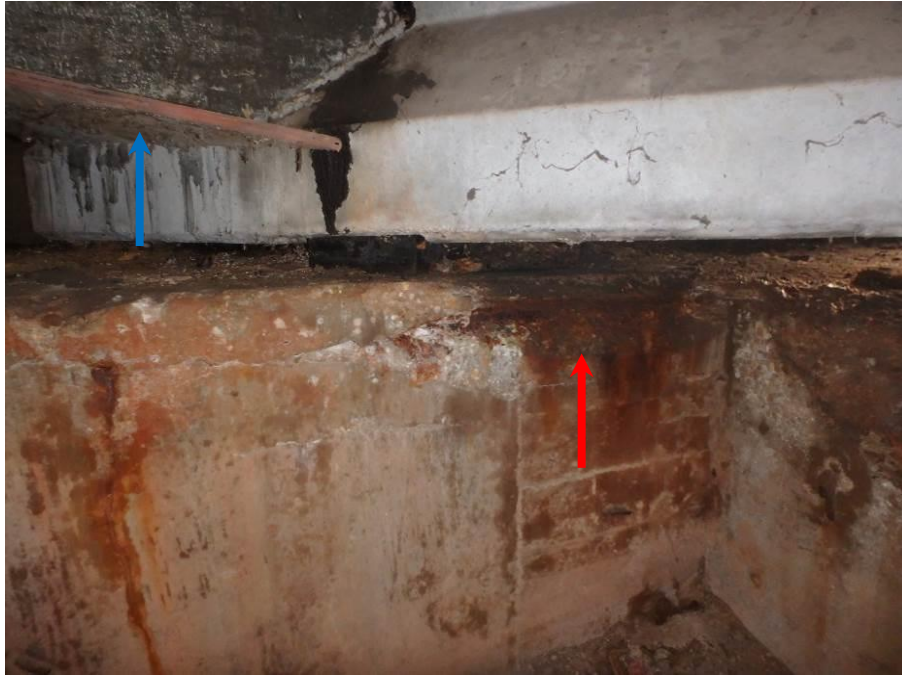
Photograph No. 59 – South End of the East Abutment Grade Beam, 24” Long x 5” High x 2” Deep Spall with Exposed Corroded Reinforcing Steel (Red Arrow). Note Remaining Plywood Formwork (Blue Arrow), Looking Southeast

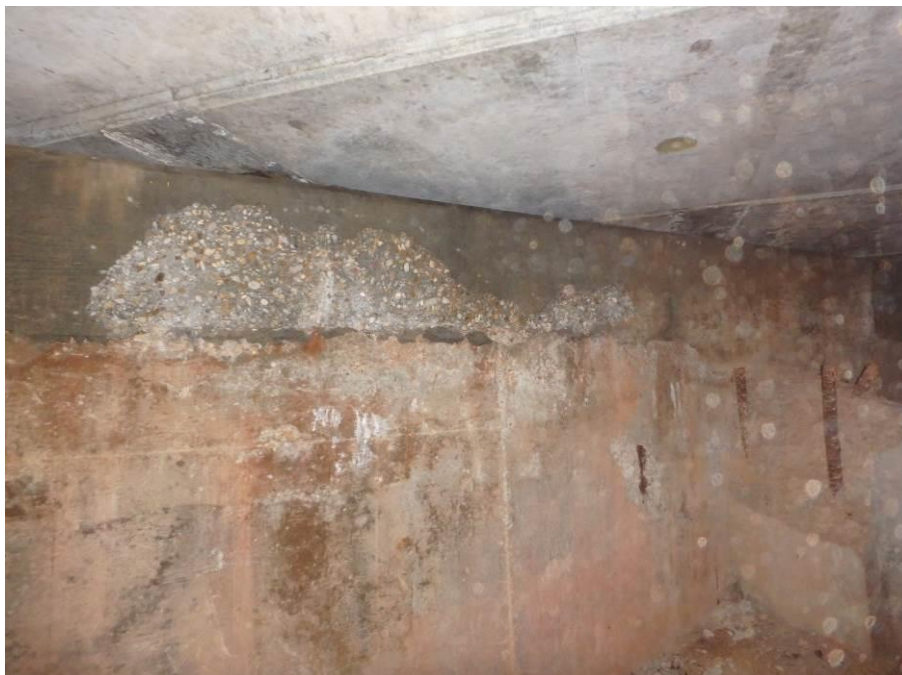
Photograph No. 60 – Spalls and Unsound Concrete in the East Abutment Grade Beam below Box Beam 12, Looking Southeast

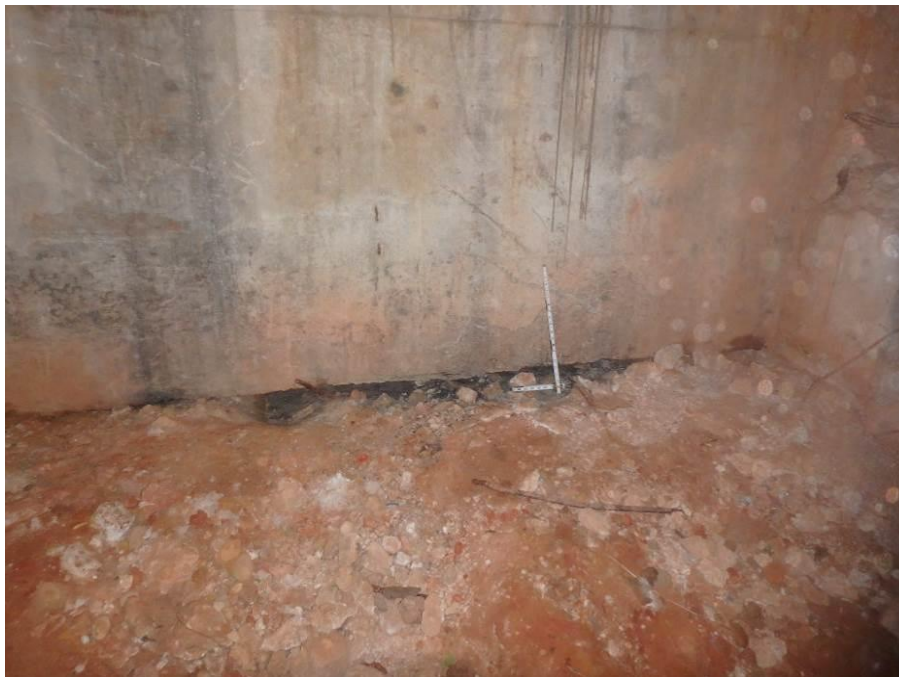
Photograph No. 61 – 6'-0" Long x 2'-8" Deep Area of Minor Erosion below the Grade Beam below Box Beam 4, Looking East

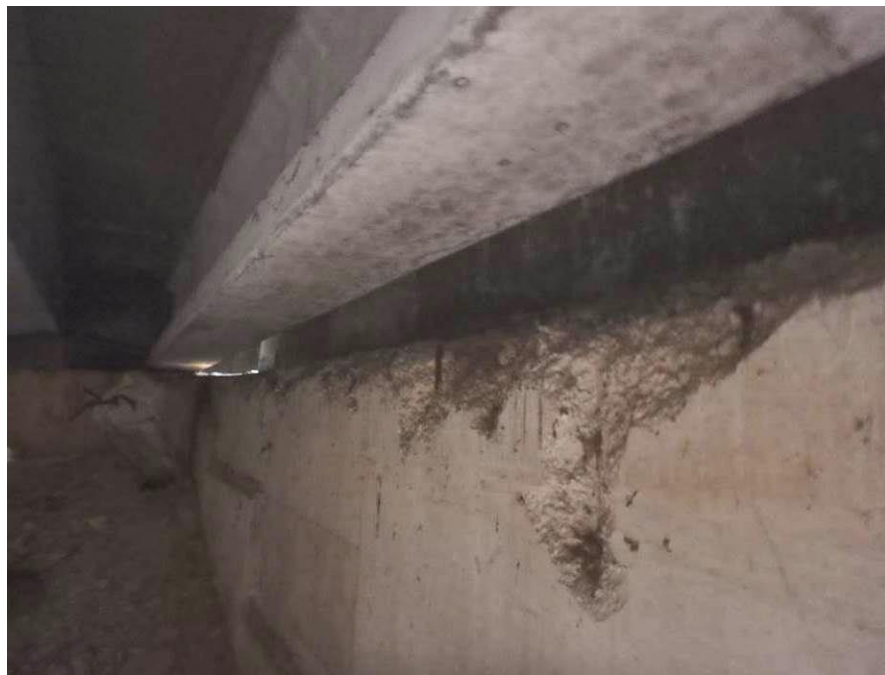
Photograph No. 64 – Spalling along the Top Interior Side of the South Curtain Wall in the East Abutment Span

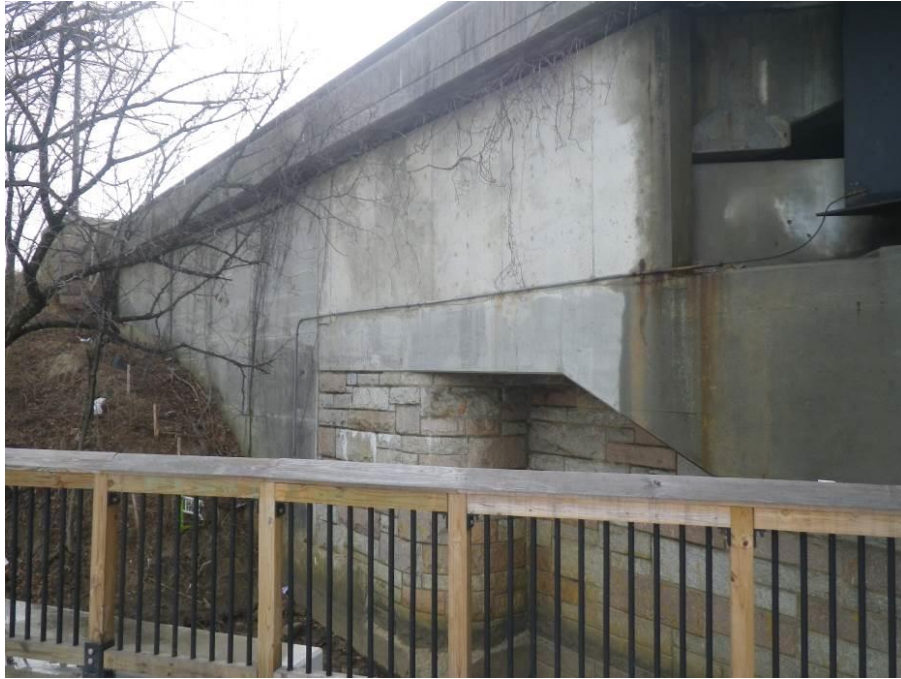
Photograph No. 65 – Northeast Curtain Wall, Minor Vegetation Growth adjacent to Exterior of Curtain Wall

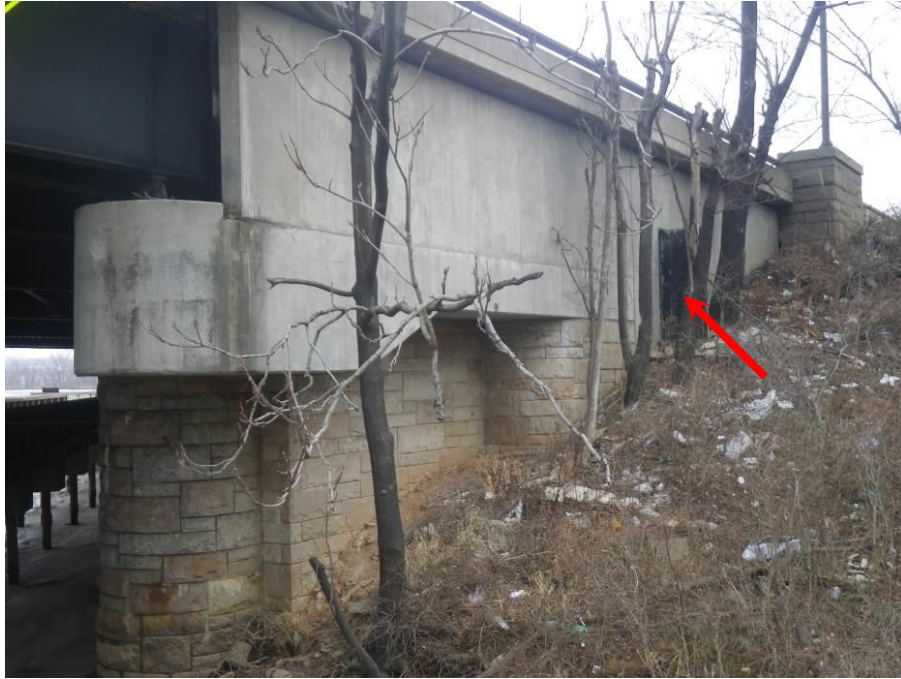
Photograph No. 67 – Southeast Curtain Wall. Note Vegetation Growth adjacent to Exterior of Curtain Wall and Access Door to East Abutment Span (Arrow)

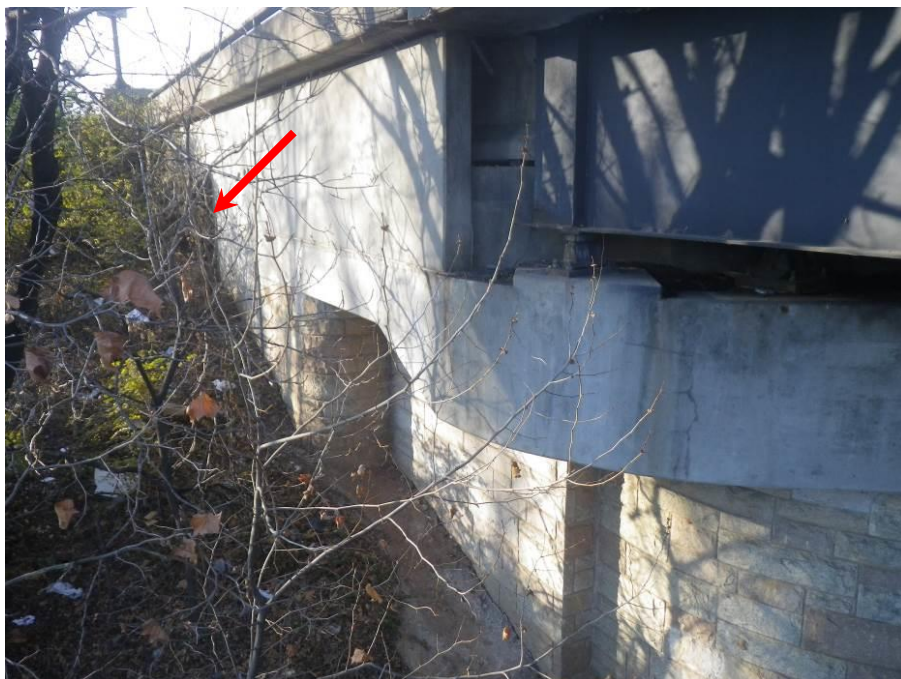
Photograph No. 68 – Southwest Curtain Wall. Note Vegetation Growth adjacent to Exterior of Curtain Wall and Access Door to West Abutment Span (Arrow)
