2017 BRIDGE INVENTORY

BRIDGE NO.: 0076 **HIGHWAY:** New York Avenue, N.E.
OVER: Anacostia River

INSPECTION START DATE: 12/11/2017 **INSPECTION END DATE:** 01/11/2018
INSPECTION CYCLE: 24 mo. **INSPECTION TYPE:** Routine

2017 District of Columbia Bridge Inspections Summary Report

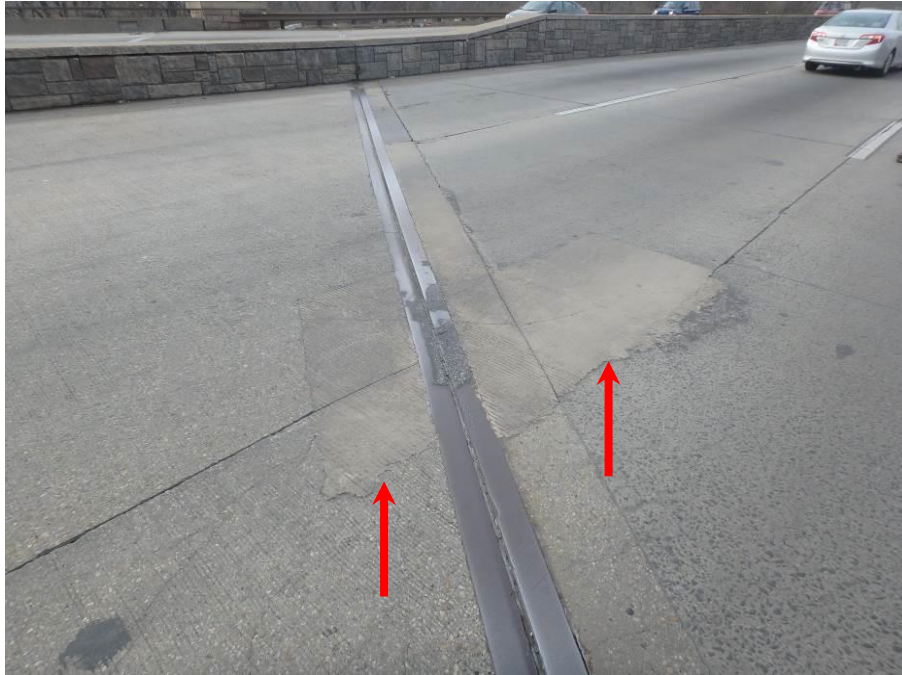
Photograph No. 69 – New Concrete Patch in the Center Westbound Lane of the West Approach Slab and West Approach Roadway (Arrows)

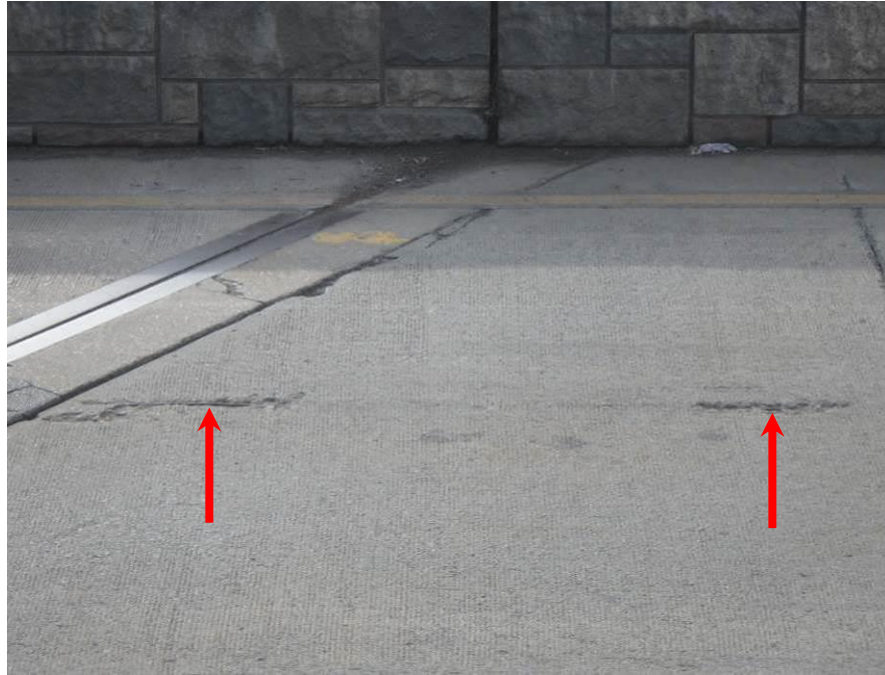
Photograph No. 71 – Two Shallow Spalls in the Left Westbound Lane of the West Approach that Contain Visible Reinforcing Steel (Arrows)

2
Approach Roadway	Repair the two spalls that exhibit exposed reinforcing steel in the West Approach roadway in the left Westbound lane (< 1 CF). On the East Approach roadway, repair the failed repairs in the right Westbound lane (< 1 CF).

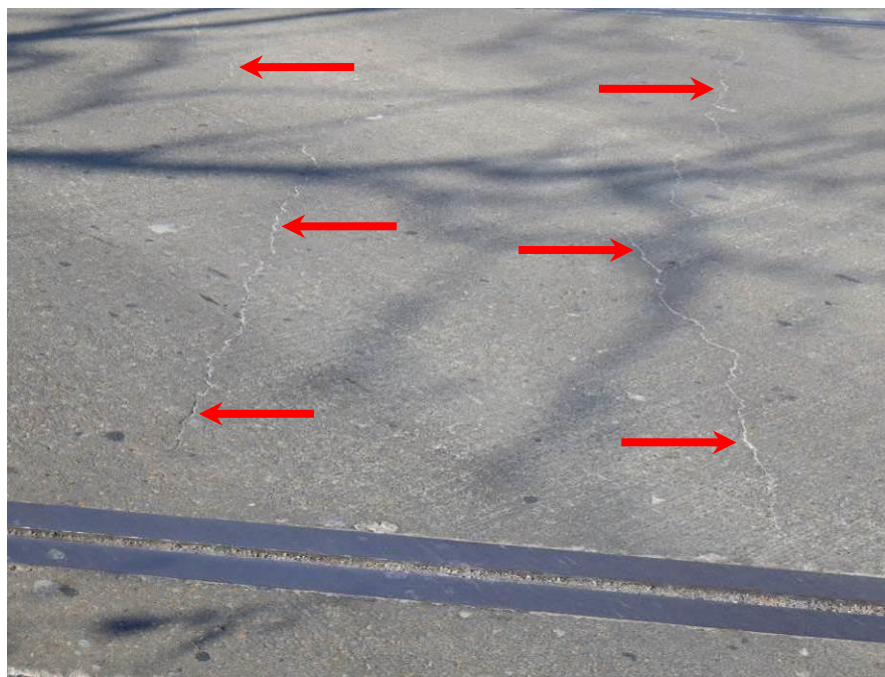
Photograph No. 72 – Typical 1/8" Wide Cracks in the East Approach Slab, Eastbound Lanes Shown, Looking Northwest (Arrows)

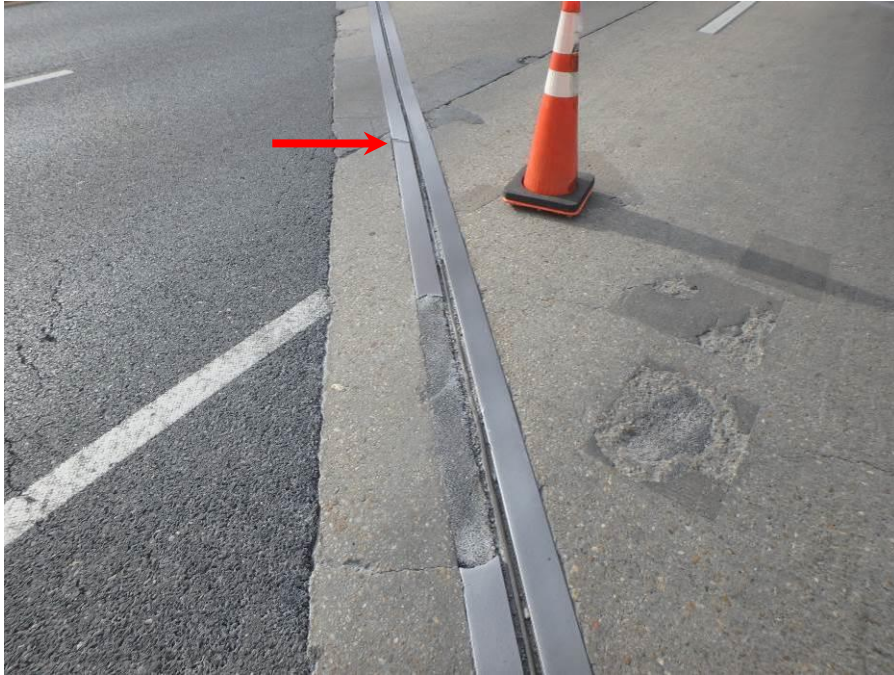
<p align="center">321</p>	<p>Approaches:</p> <p>The approach slabs are in satisfactory condition.</p> <p>There are numerous hairline cracks in the West Approach slab Westbound traffic lanes. The asphaltic patches noted in the previous report in the center Westbound lane of the West Approach slab and in the center lane in each direction of the West Approach roadway have been replaced with concrete patches (see Photograph Nos. 69 and 70).</p> <p>In the left Westbound lane of the West Approach roadway, there are two shallow spalls with exposed reinforcing steel (see Photograph No. 71).</p> <p>The East Approach slab has several hairline cracks, typically perpendicular to the expansion joints, and two 1/8" wide cracks in the Eastbound lanes (see Photograph No. 72). The previously noted 12" diameter shallow span in the Eastbound traffic lanes was not observed during this inspection; however, a 12" x 12" repair was noted in the wearing surface of the East Abutment Span left Eastbound lane. There are some minor potholes/depressions in the approach overlay adjacent to the East Approach joint in the center Eastbound lane. There are two 15" x 15" failed repairs in the right Westbound lane. One approximately 2'-6" long x 15" wide repair and one small spall approximately 2" deep are present in the approach slab in the center Westbound lane.</p> <p>There are several cracks in the East Approach roadway asphaltic pavement and a few cracks and minor spalls in the joint concrete header.</p> <p>The strip seal joints at the far ends of the approach slabs are in satisfactory condition with minor debris in random areas and moderate debris build-up in the shoulders. The West Approach joint exhibits a 5' long tear in the left Eastbound lane. At the East Approach joint, the previously missing section of asphaltic material in place of missing joint armor has been replaced, and an adjacent section of joint armor is broken in the center Westbound lane (see Photograph No. 73).</p>

Photograph No. 73 – Asphaltic Material in Place of a Section of Metal Joint Armor for the East Approach Joint in the Right Westbound Lane, Looking Southwest. Note adjacent Broken Section of Joint Armor (Arrow)

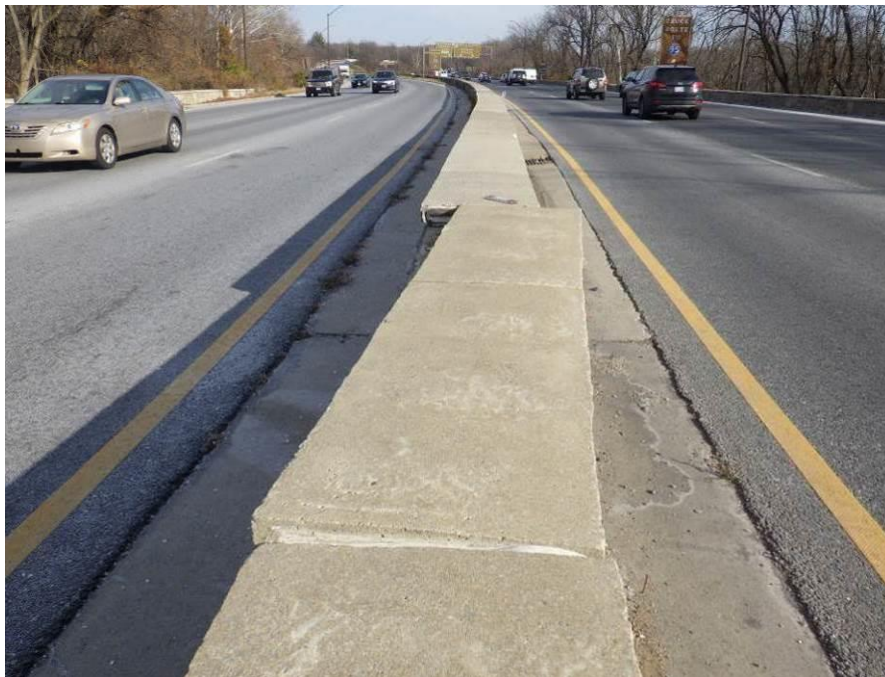
Photograph No. 76 – 10' Long Section of the East Approach Median Capstone Loose and Displaced Up to 9" to the South, Looking East

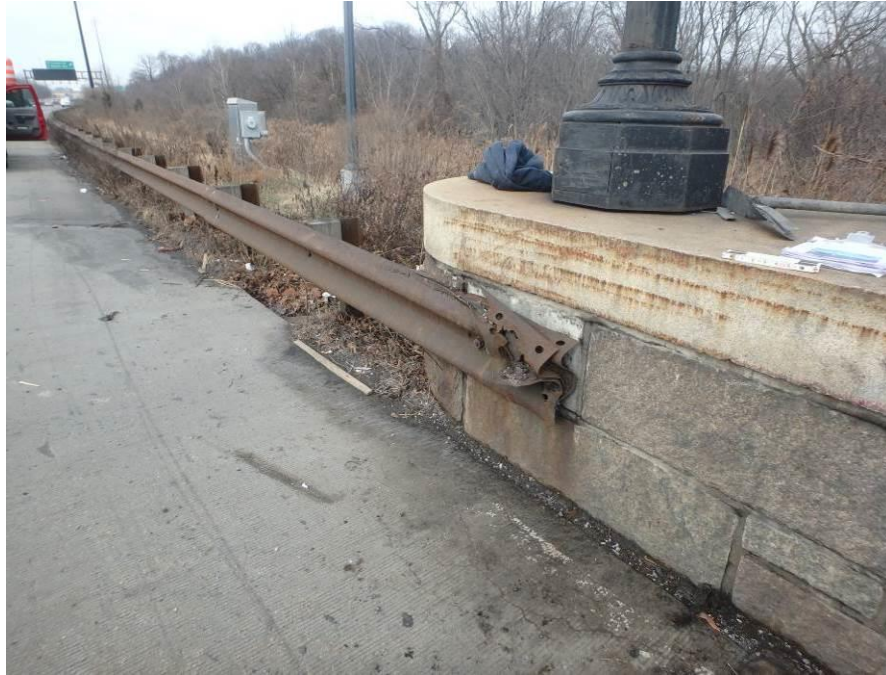
Photograph No. 77 – Non-Standard Attachment of Northwest Guide Rail to Bridge Railing. Note Impact Damage

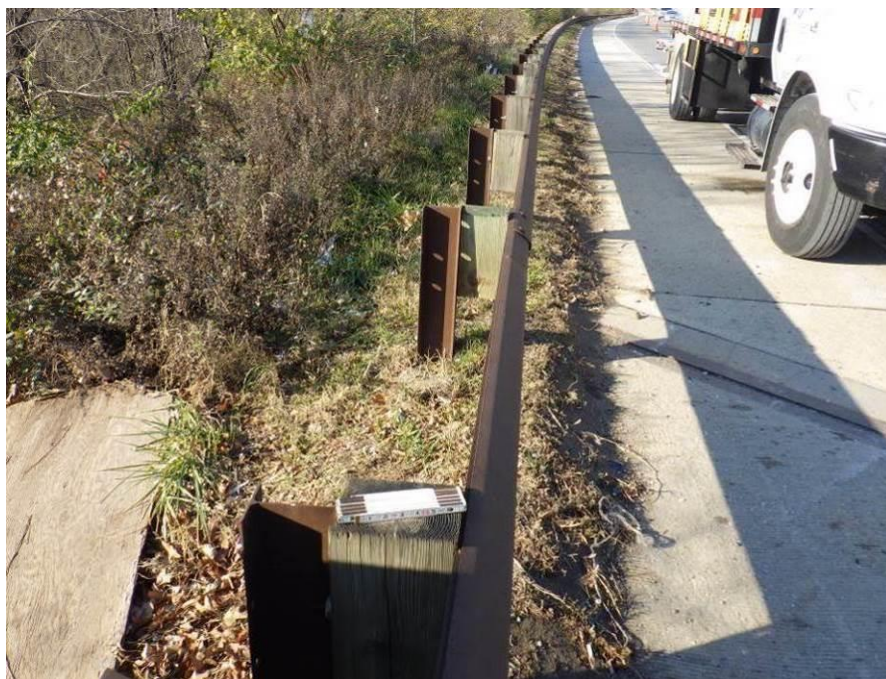
ELEMENT NO.	COMMENTS
321	<p>Approaches (Continued):</p> <p>The approach railings are in satisfactory condition. At the Northeast and Southeast Approaches, the bridge parapets transition into a masonry railing (see Photograph Nos. 74 and 75). Approximately 50' East of the East Approach slab, there is a 10' long section of the median capstone that is displaced up to 9" to the South (see Photograph No. 76). Pointing is missing between the median barrier fascia stones in random areas. This defect is typical to the masonry retaining walls at the Northeast and Southeast Approaches. There is evidence of uneven settlement in the North parapet at the East Approach with up to a 1 1/2" vertical difference. A section of the East Approach South parapet is displaced to the South and there is a minor spall in the adjacent curb. Metal guide rails located at the Northwest and Southwest corners of the bridge are in satisfactory condition with an established patina. The attachment of the Northwest guide rail to the bridge railing is not standard and exhibits moderate impact damage (see Photograph No. 77). The Southwest guide rail is not gradually stiffened at the bridge (see Photograph No. 78).</p>

Photograph No. 78 – Southwest Guide Rail not Properly Stiffened at the Bridge, Looking West

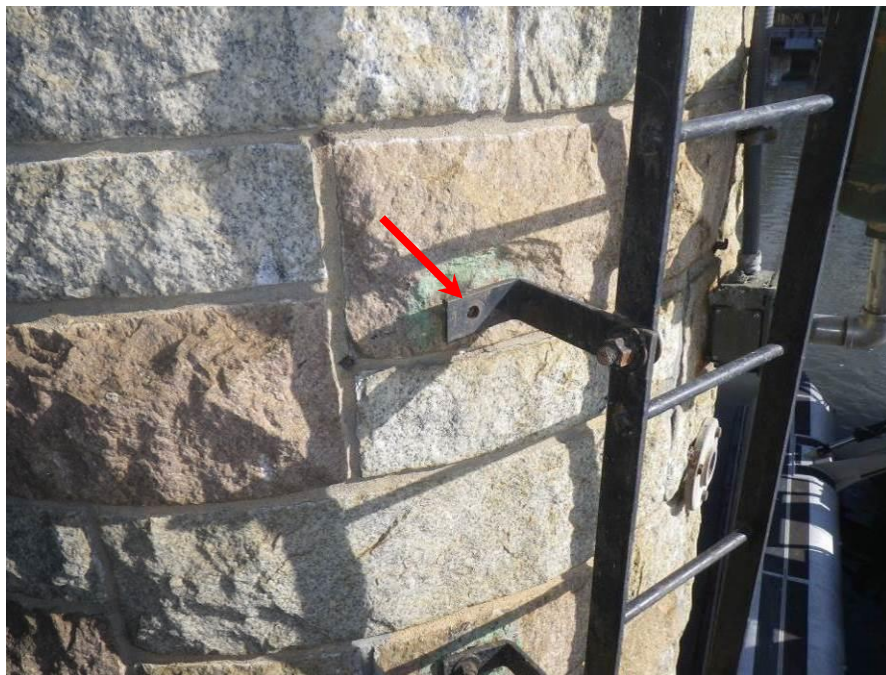
Photograph No. 80 – Missing Bolt in Ladder Connection at South End of Pier 2 (Arrow)

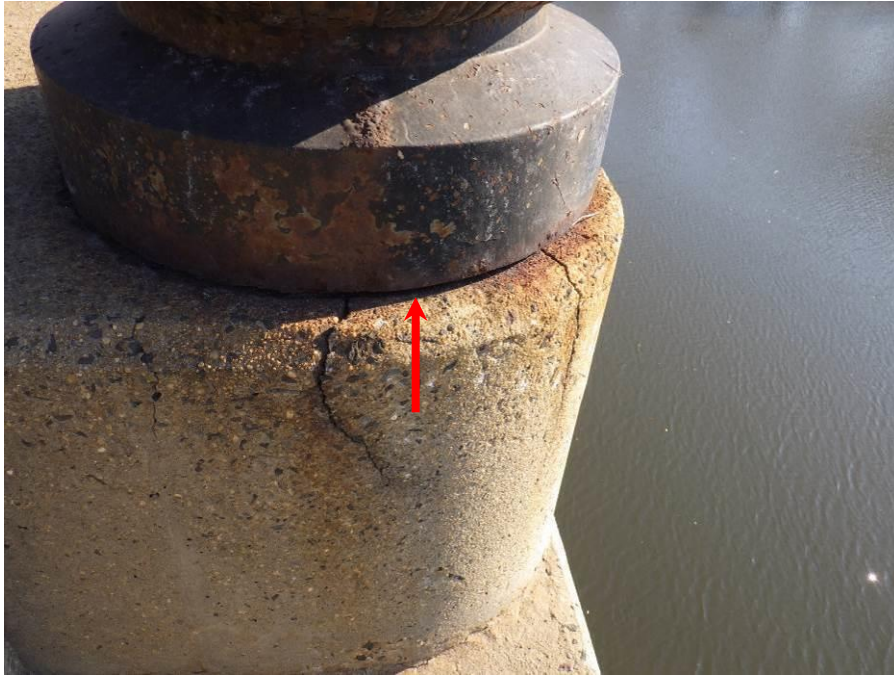
Photograph No. 83 – 1/4" Wide Gap at Bottom of Light Standard and Cracks in Base Concrete, South Light Standard in Span 2 Shown (Arrow)

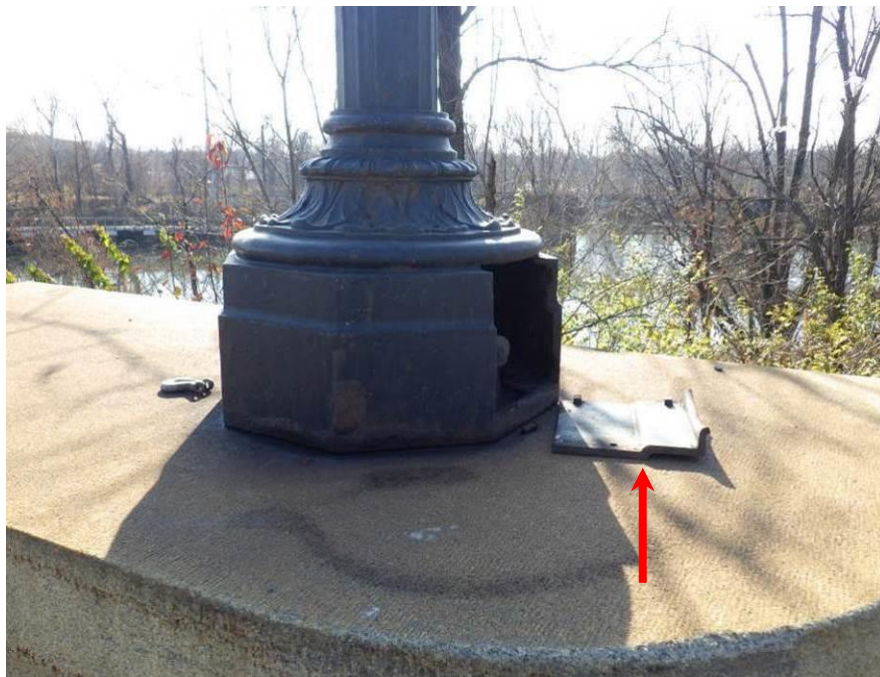
Photograph No. 84 – Displaced Access Panel for the Southwest Light Standard Base Exposing Wires (Arrow)

1
	Replace/secure electrical access cover at the base of the Southwest light standard (1 EA).
