Underwater Inspection of New York Avenue Bridge

DDOT Bridge #0076

May 10th 2016

Bridge No. 76 • New York Avenue over the Anacostia River
Washington, DC • May 2016

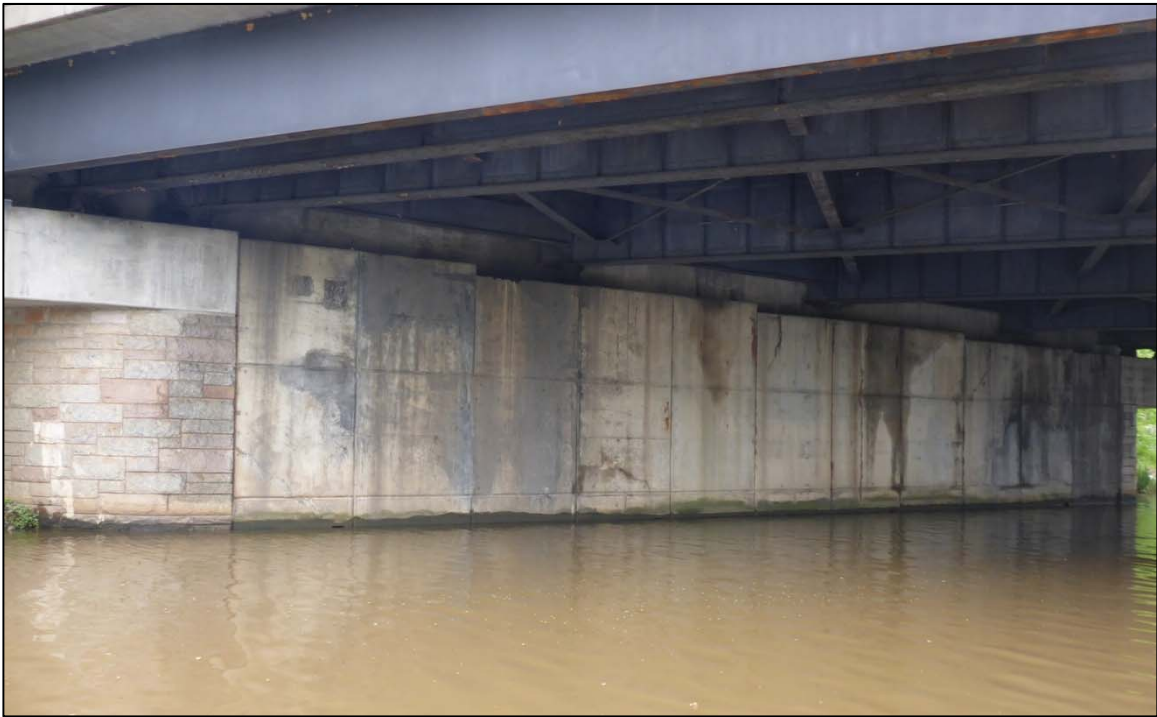
The West Abutment was in overall fair condition. At the upstream and downstream noses there was minor mortar loss in the stone masonry. Several random areas of delamination were present throughout the concrete surfaces extending within 3' of the mudline. Minor areas of soft concrete were adjacent to the delamination. Hairline vertical cracks were present (one was up to 1/16" wide) mainly in the vertical chamfer joints from the mudline to top of the pier. There were several hairline diagonal cracks extending up from the mudline or scuppers. Refer to Figure 4 in Appendix C for specific details and locations and Photograph 3 in Appendix B for views of the West Abutment.

Photograph 3: View of West Abutment, Looking Northwest

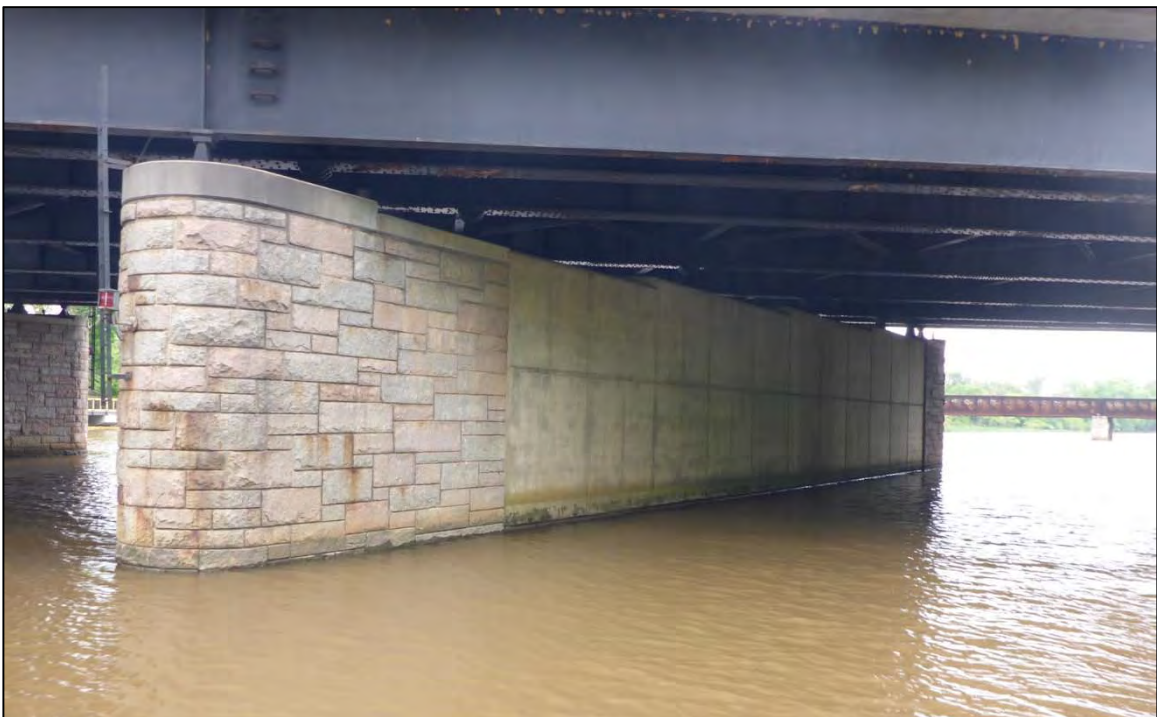
Pier 1 was in overall fair condition, primarily due to the severe scale, 4' wide by 3' high by 3" deep, along the west face with two exposed reinforcing bars. Mortar loss was generally less than 10% at the upstream and downstream ends. A 3/16" wide vertical crack was located in the fascia stones at both ends. Several hairline to 1/16" wide vertical cracks were present along the east and west concrete faces of the pier. Cracking typically extended from the mudline to the top of the pier. A few cracks were up to 1/8" wide on the west face. Refer to Figures 5 and 6 in Appendix C for specific defect details and locations and Photographs 4 through 6 in Appendix B for views of Pier 1.

Photograph 4: View of Pier 1, Looking Southeast

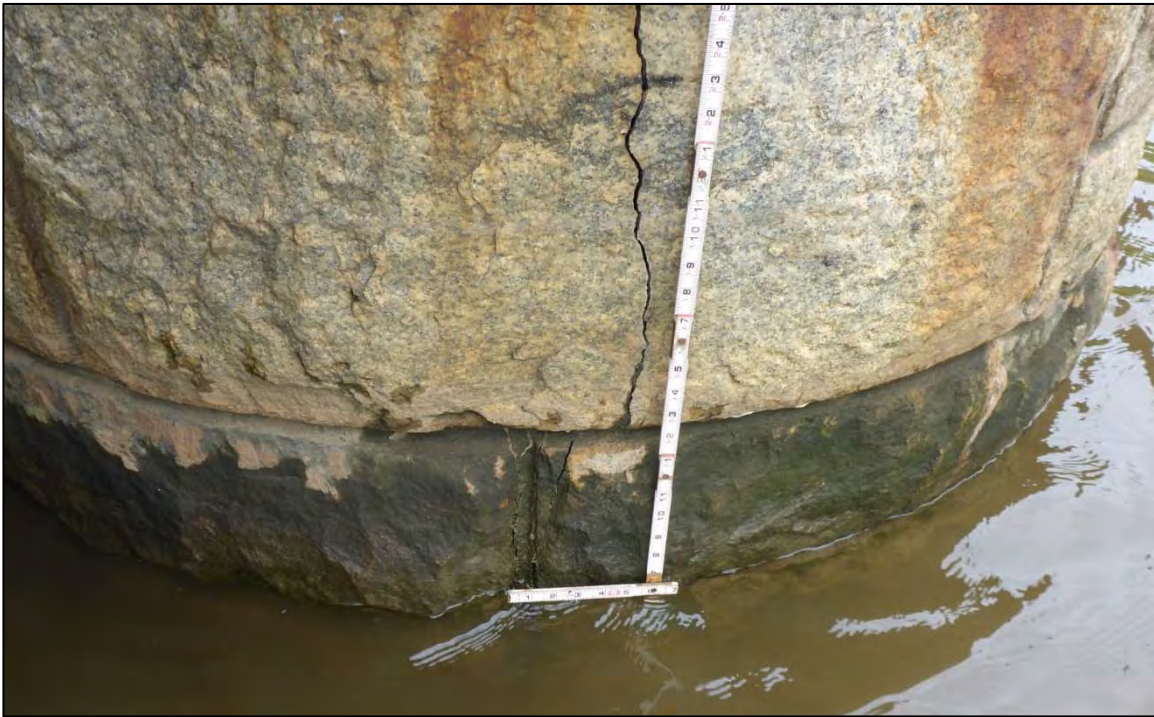
Photograph 5: View of Vertical Crack in Fascia Stones on Pier 1 Upstream Nose, Looking South

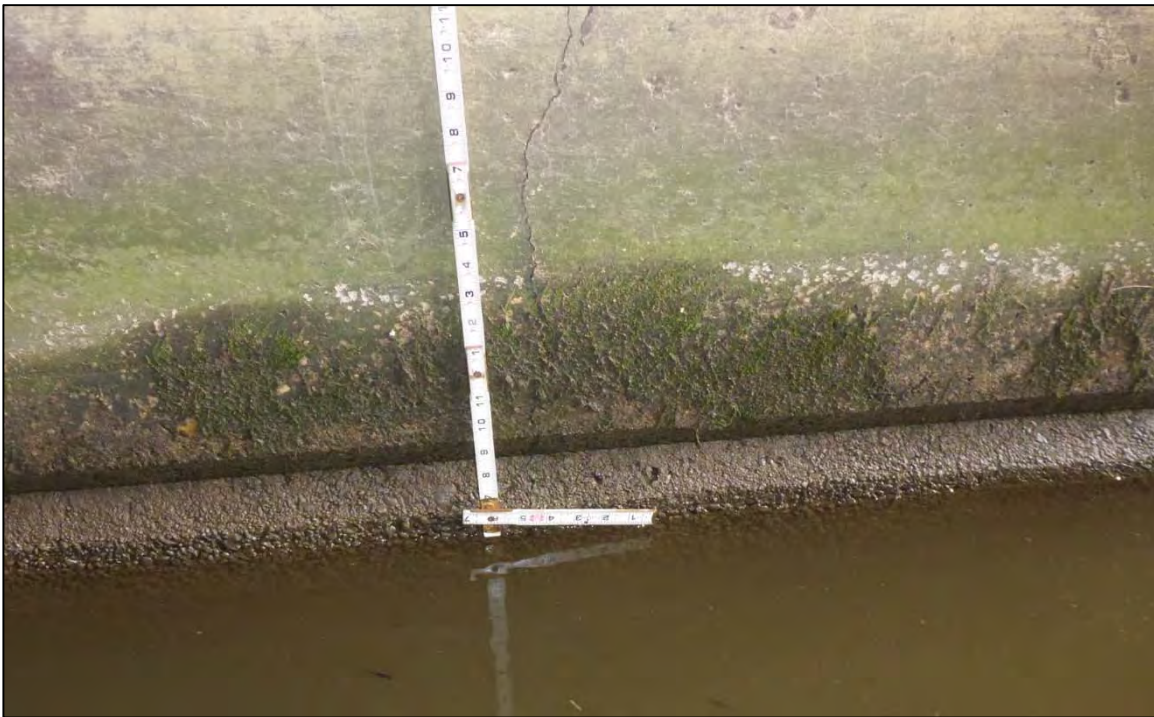
Photograph 6: View of Typical Crack Extending from Mudline to Top of Pier 1, Looking West

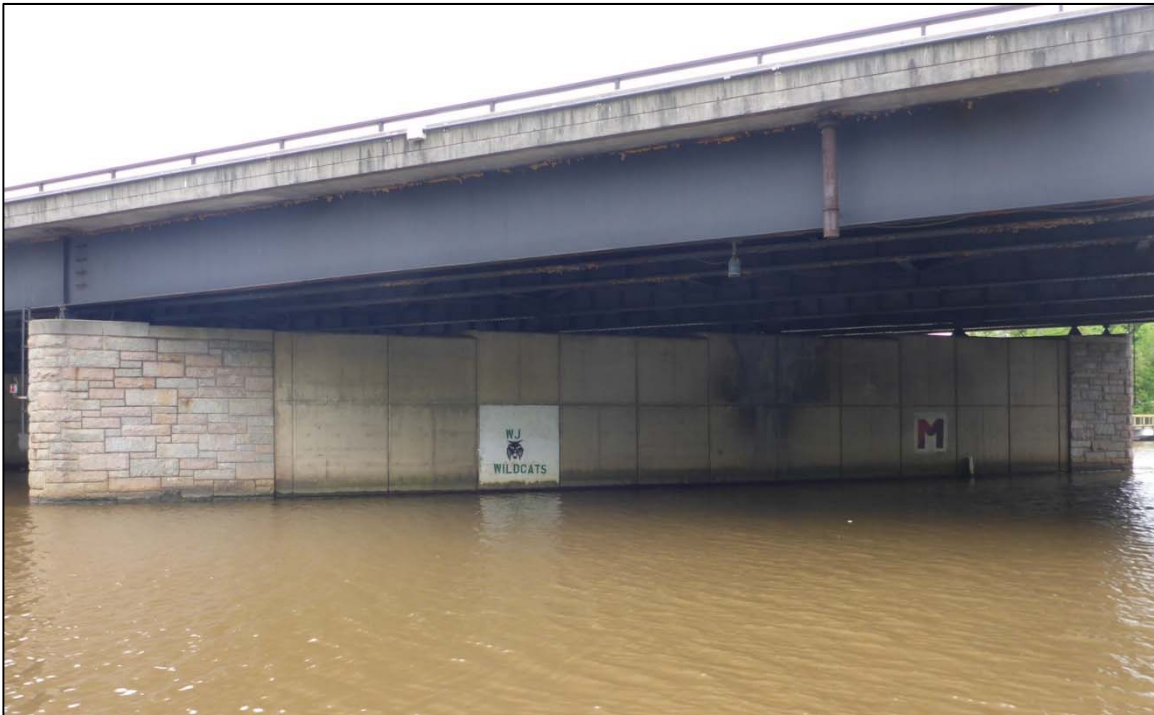
Pier 2 was in overall poor condition, primarily due to the heavy to severe scale full-length by up to 6” deep on the east and west concrete portions below the high waterline. Approximately 30 vertical reinforcing bars were exposed on the west face, several bars had 15% to 30% loss of section, and three vertical reinforcing bars were exposed on the east face. Mortar loss was generally less than 10% at the upstream and downstream ends. Several hairline to 1/16” wide vertical cracks were present on the east and west concrete faces of the pier. Refer to Figures 7 and 8 in Appendix C for specific details and locations and Photographs 7 through 9 in Appendix B for views of Pier 2.

Photograph 7: View of Pier 2, Looking Southeast

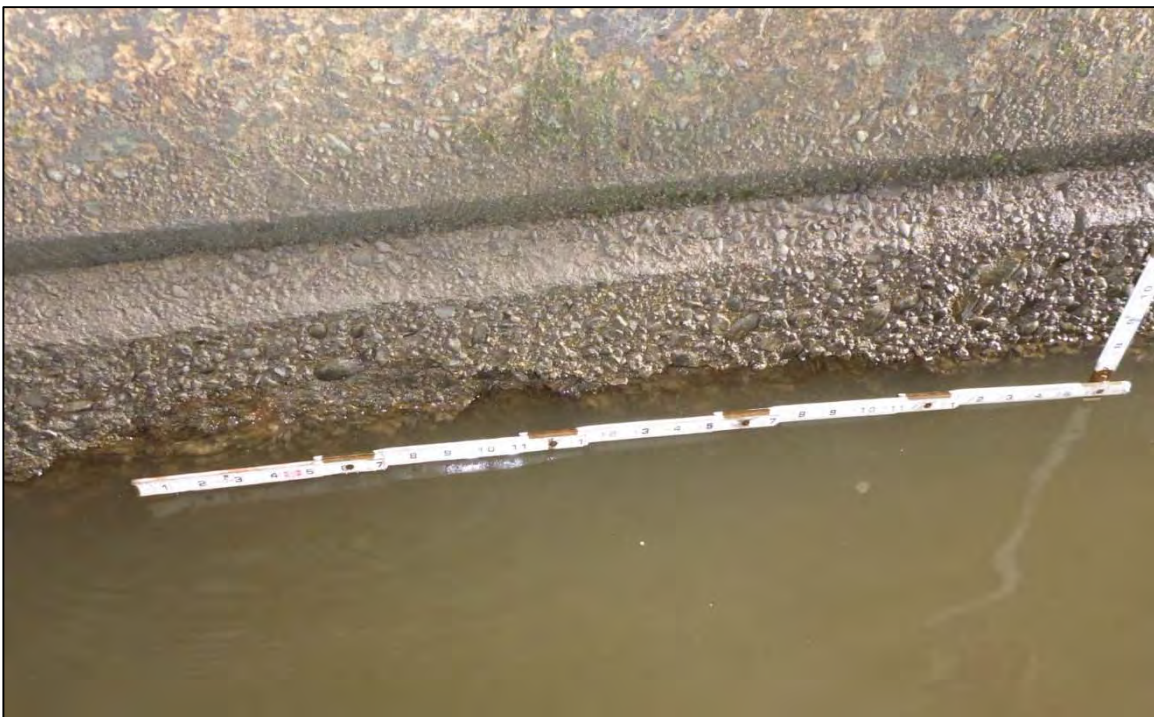
Photograph 8: View of Typical Scale on Pier 2 West Face, Looking East

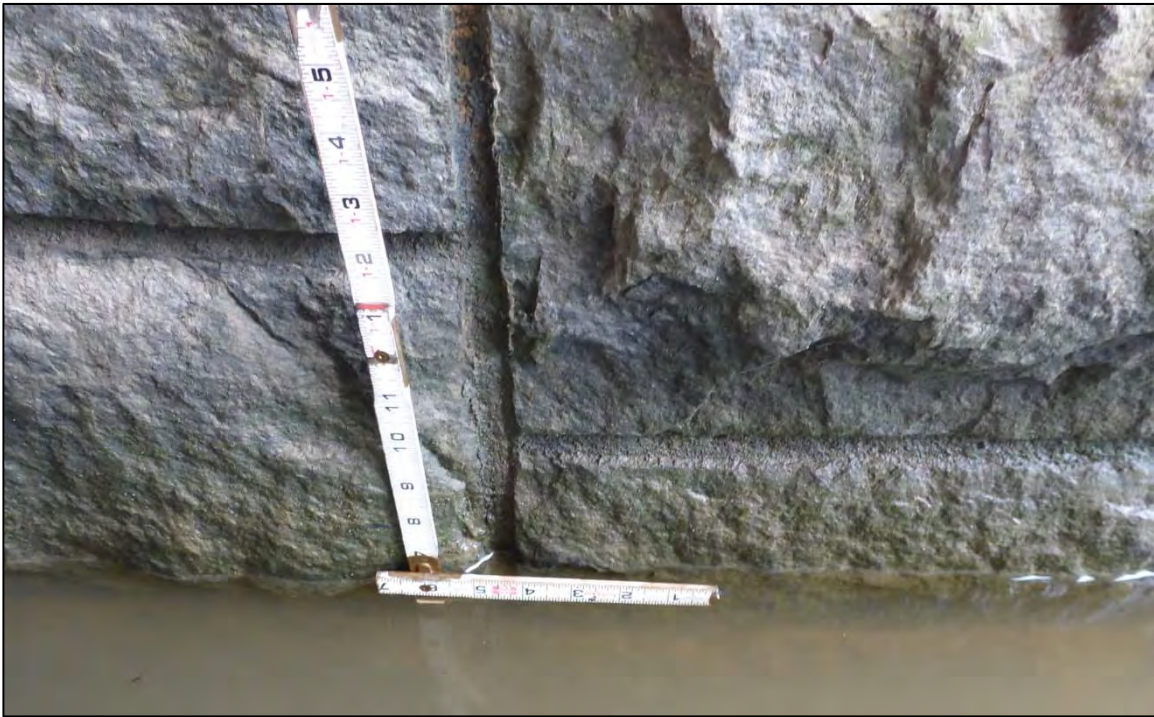
Photograph 9: View of Typical Fascia Stone Mortar Loss at Pier 2 Southwest Face, Looking East

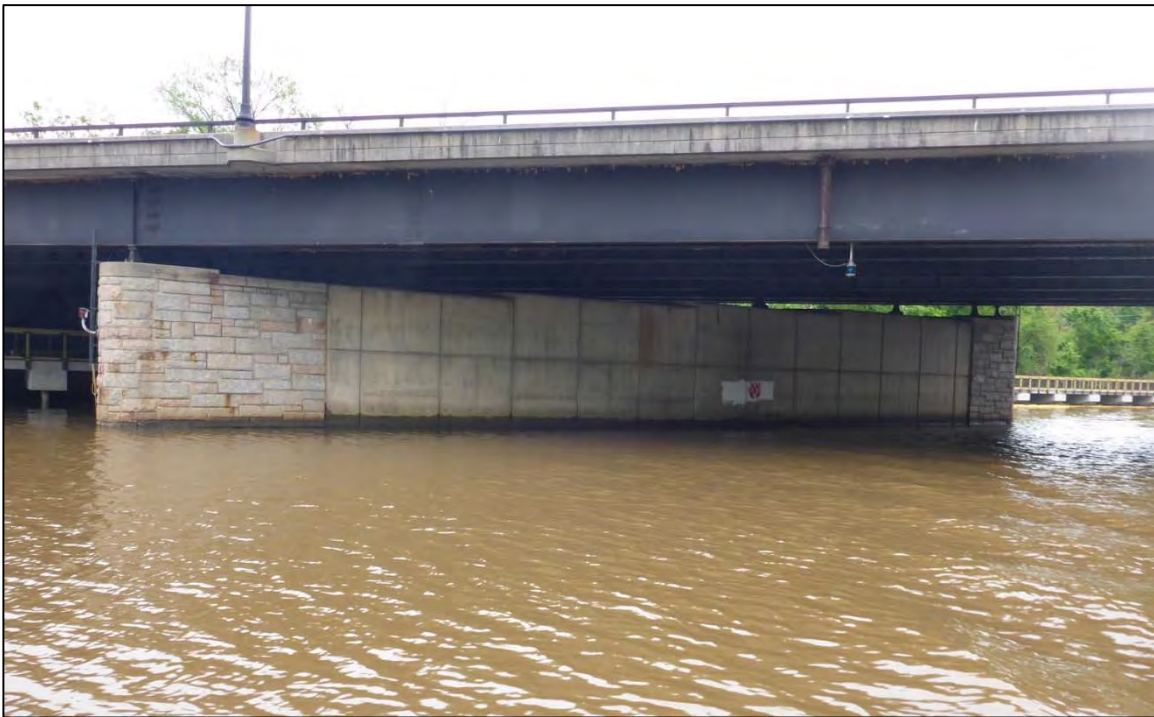
Pier 3 was in overall poor condition, primarily due to the heavy scale full-length by up to 1-1/2” deep on the east and west concrete portions below the high waterline. Mortar loss was generally less than 10% at the upstream and downstream ends. Several hairline to 1/16” wide vertical cracks were present on the east and west concrete faces of the pier. A few cracks were up to 1/8” wide on the east face. A 1/4” wide vertical crack was located in the fascia stones on the west side of the upstream nose, from 2’ above high waterline to the mudline. Many of the cracks extended from the mudline to top of the pier along the vertical chamfer joints. Moderate timber debris was present on the channel bottom at the northwest nose of the pier. Refer to Figures 9 and 10 in Appendix C for specific details and locations and Photographs 10 through 13 in Appendix B for views of Pier 3.

Photograph 10: View of Pier 3, Looking Southeast

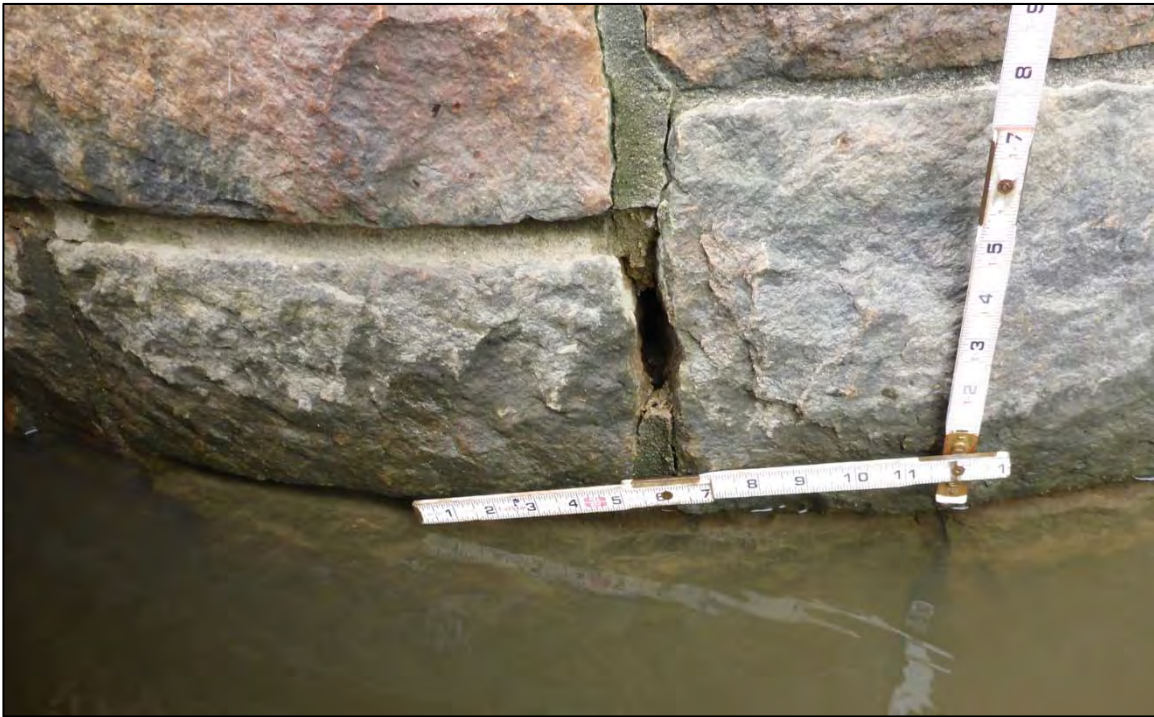
Photograph 11: View of Mortar Loss at Pier 3 Downstream Nose, Looking North

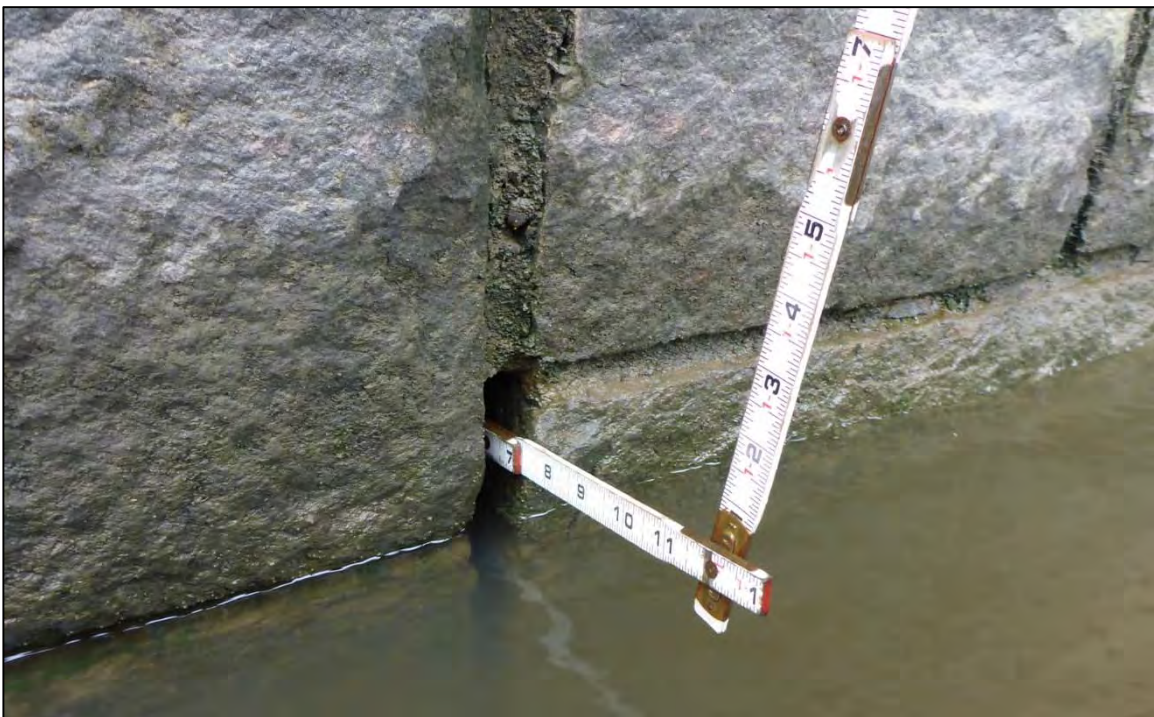
Photograph 12: View of Mortar Loss at Pier 3 Upstream Nose, Looking East

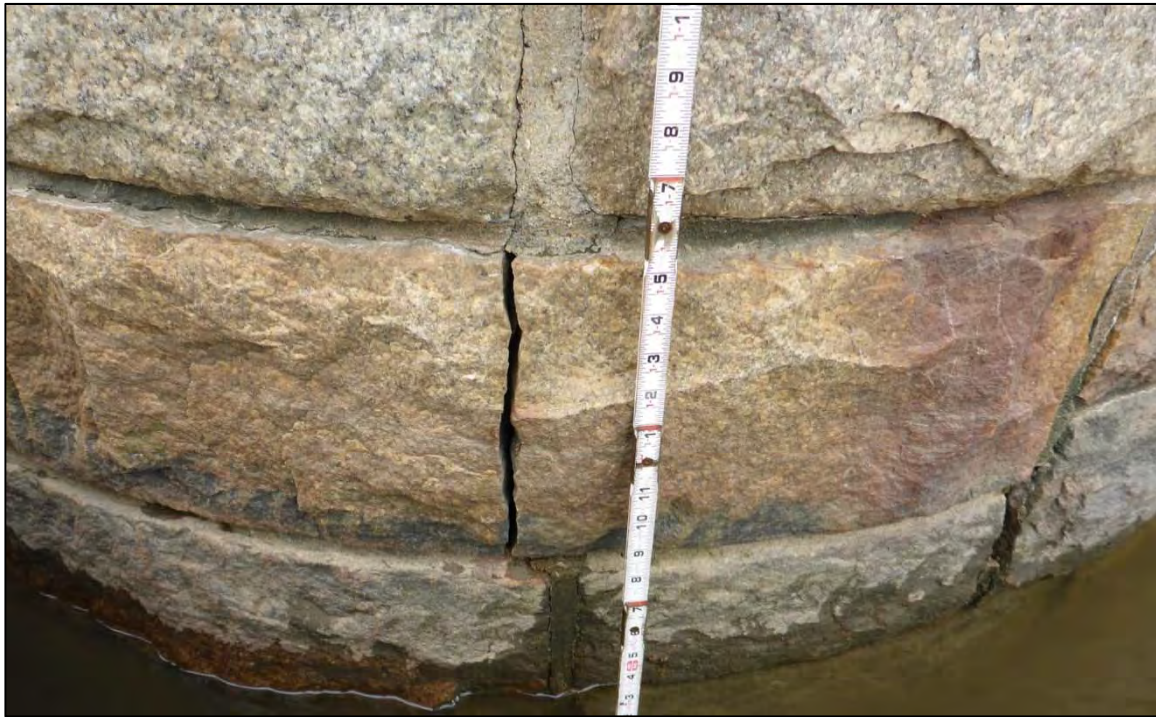
Photograph 13: View of 1/4" Wide Vertical Crack in Fascia Stones at Pier 3 Upstream Nose, Looking South

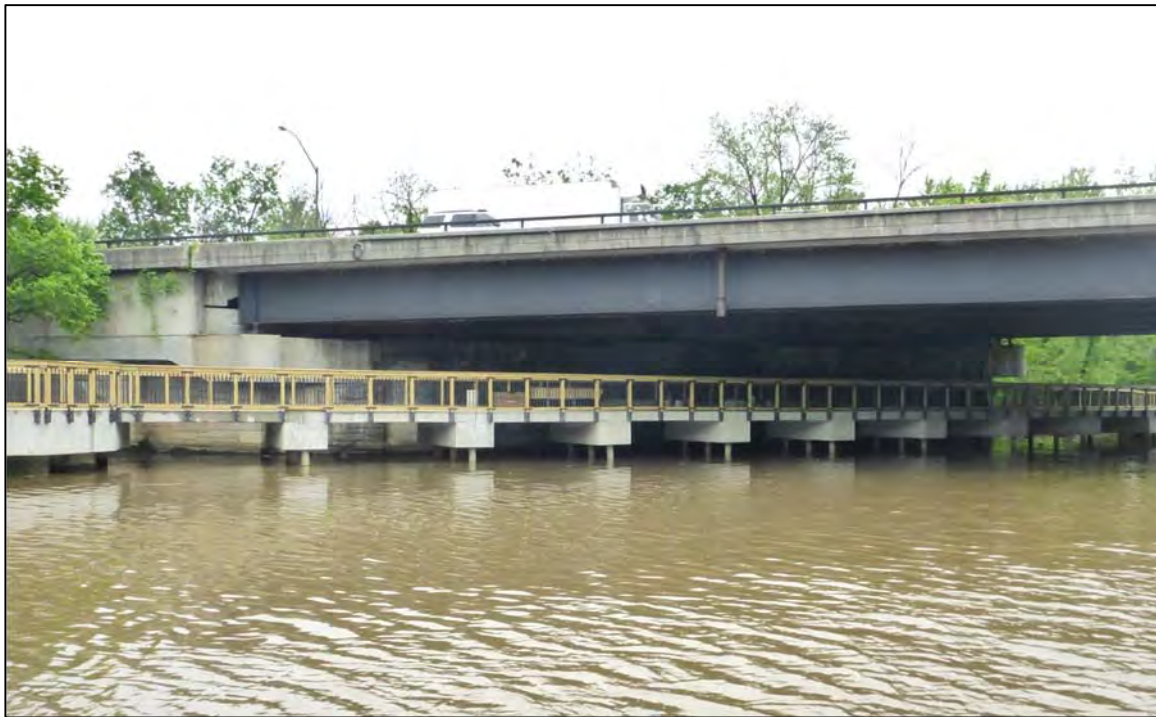
The East Abutment was in overall fair condition, primarily due to the severe scale between Joints 1 and 4. The scale was approximately 30’ long and up to 3 1/2” deep with 5 exposed vertical bars and 2 exposed horizontal bars. There were hairline vertical cracks (one was up to 1/16” wide) mainly in the vertical chamfer joints from the mudline to top of the pier. There were several hairline diagonal cracks extending up from the mudline. Refer to Figure 11 in Appendix C for specific details and locations and Photographs 14 and 15 in Appendix B for views of the East Abutment.

Photograph 14: View of East Abutment and Recently Constructed Pedestrian Riverwalk, Looking Southeast

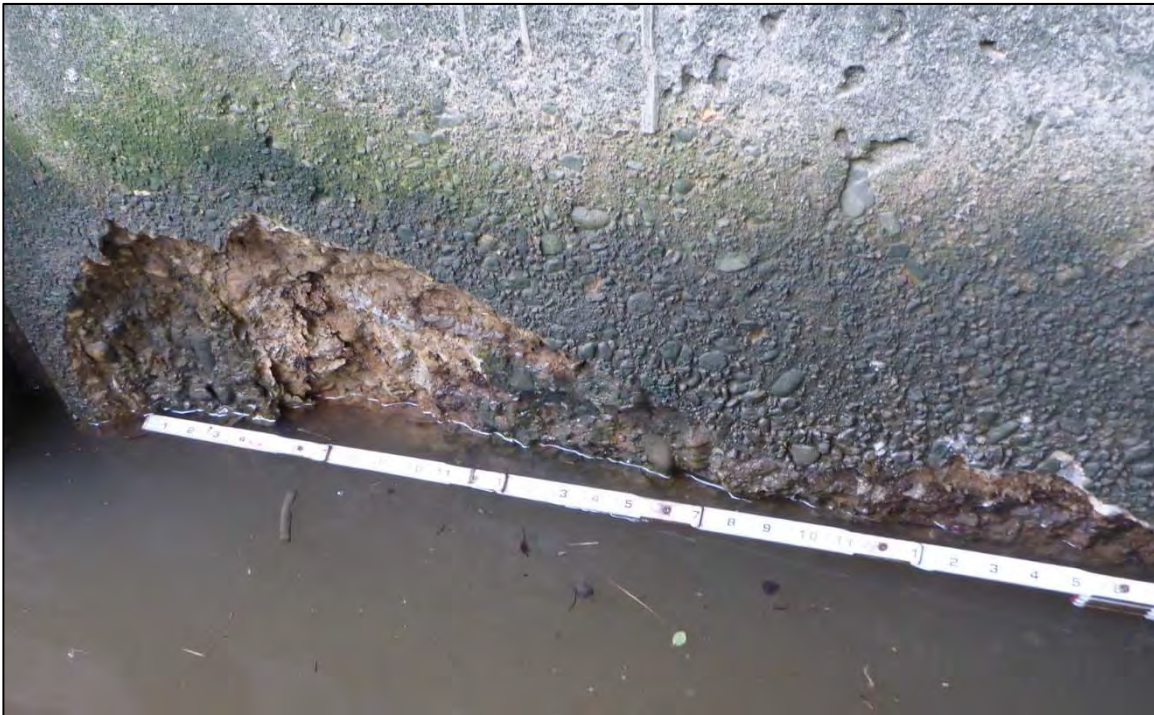
Photograph 15: View of Typical Scale on East Abutment, Looking East

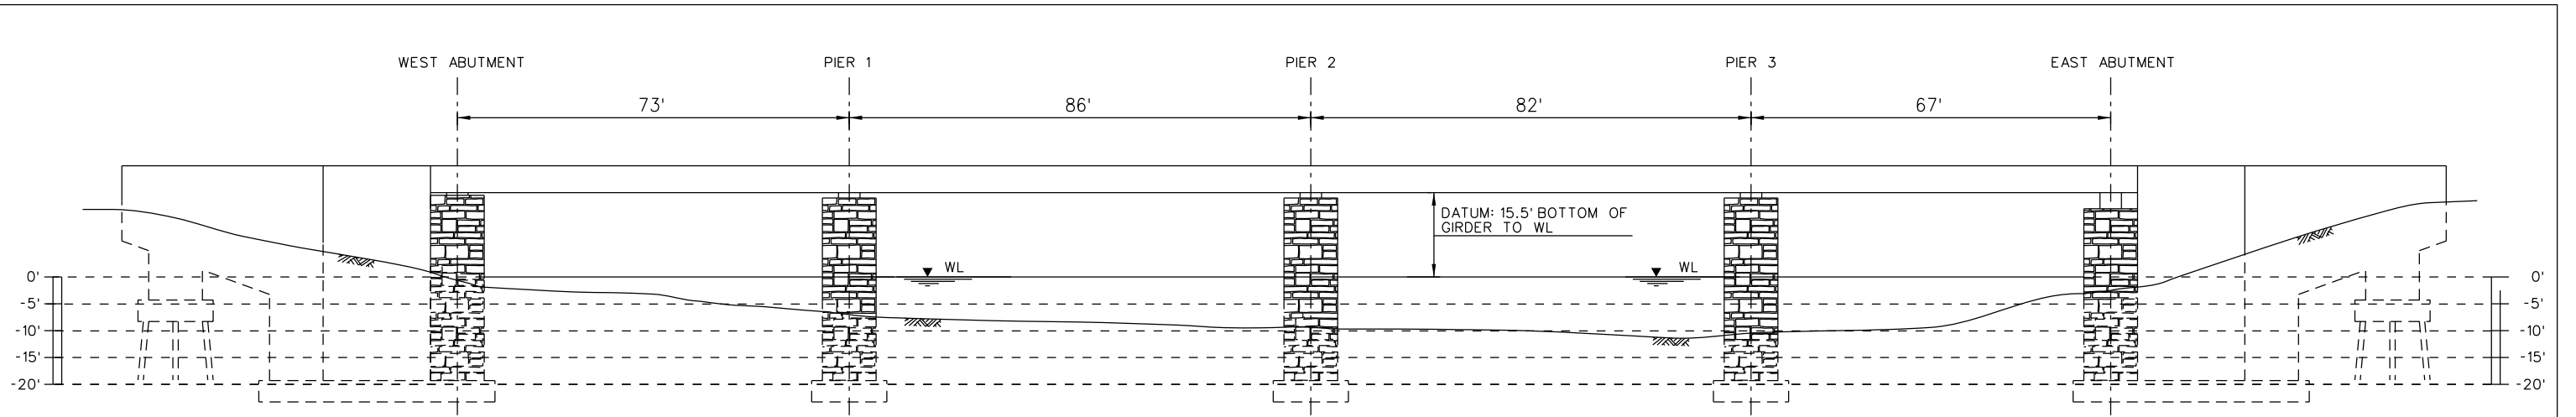
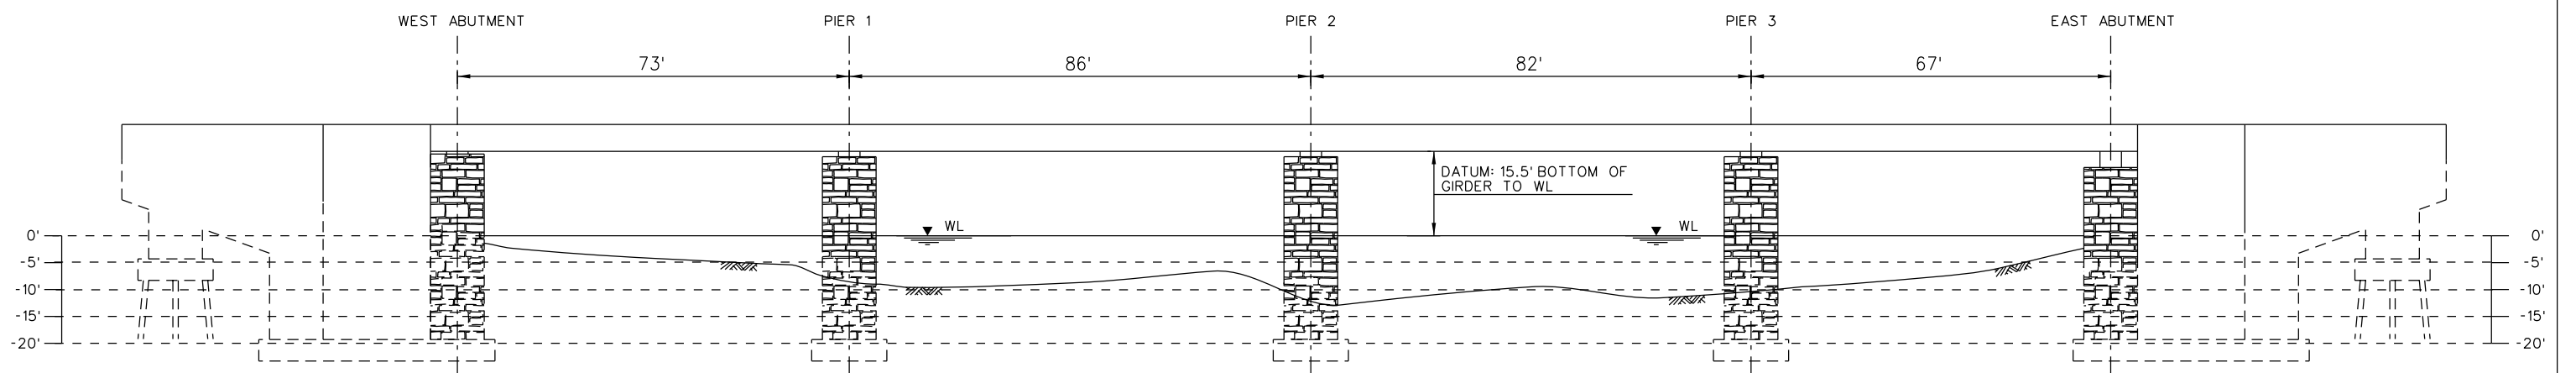
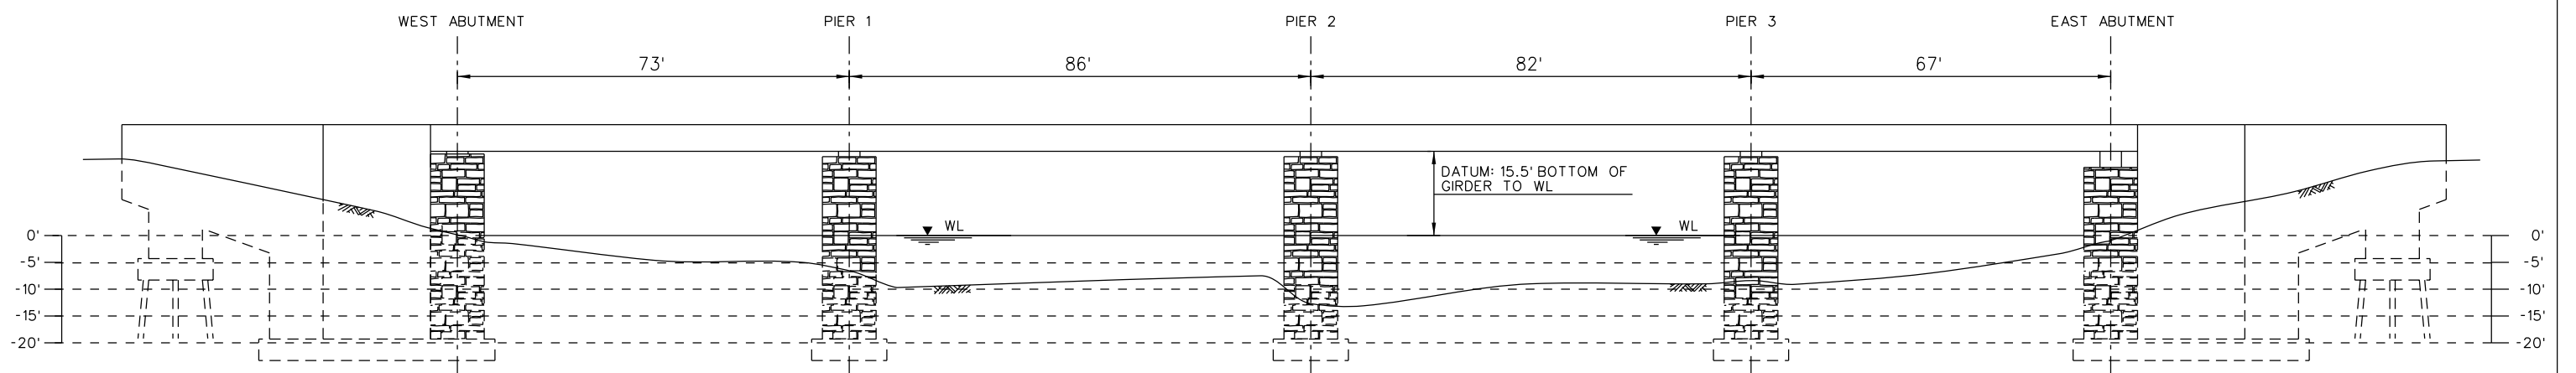
Bridge No. 76 carries New York Avenue (six lanes) over the Anacostia River. All piers and abutments were in water at the time of inspection. The channel bottom primarily consisted of silt and sand. The Anacostia River is tidal with ebb flow from North to South and a maximum tidal range of 4.5'. The river widens as it approaches the bridge, causing the river to flow at an angle relative to the piers. This resulted in heavier scale on the west faces of the piers and localized scour on the east faces of Piers 1 and 2. Areas of scour typically existed at the upstream ends of the piers with sediment accumulation at the downstream ends. Pier 2 had an area of localized scour at the southeast face. There were no significant changes to the channel bottom profile when compared to the previous sounding data. A moderate amount of timber debris had accumulated at the northwest end of Pier 3.

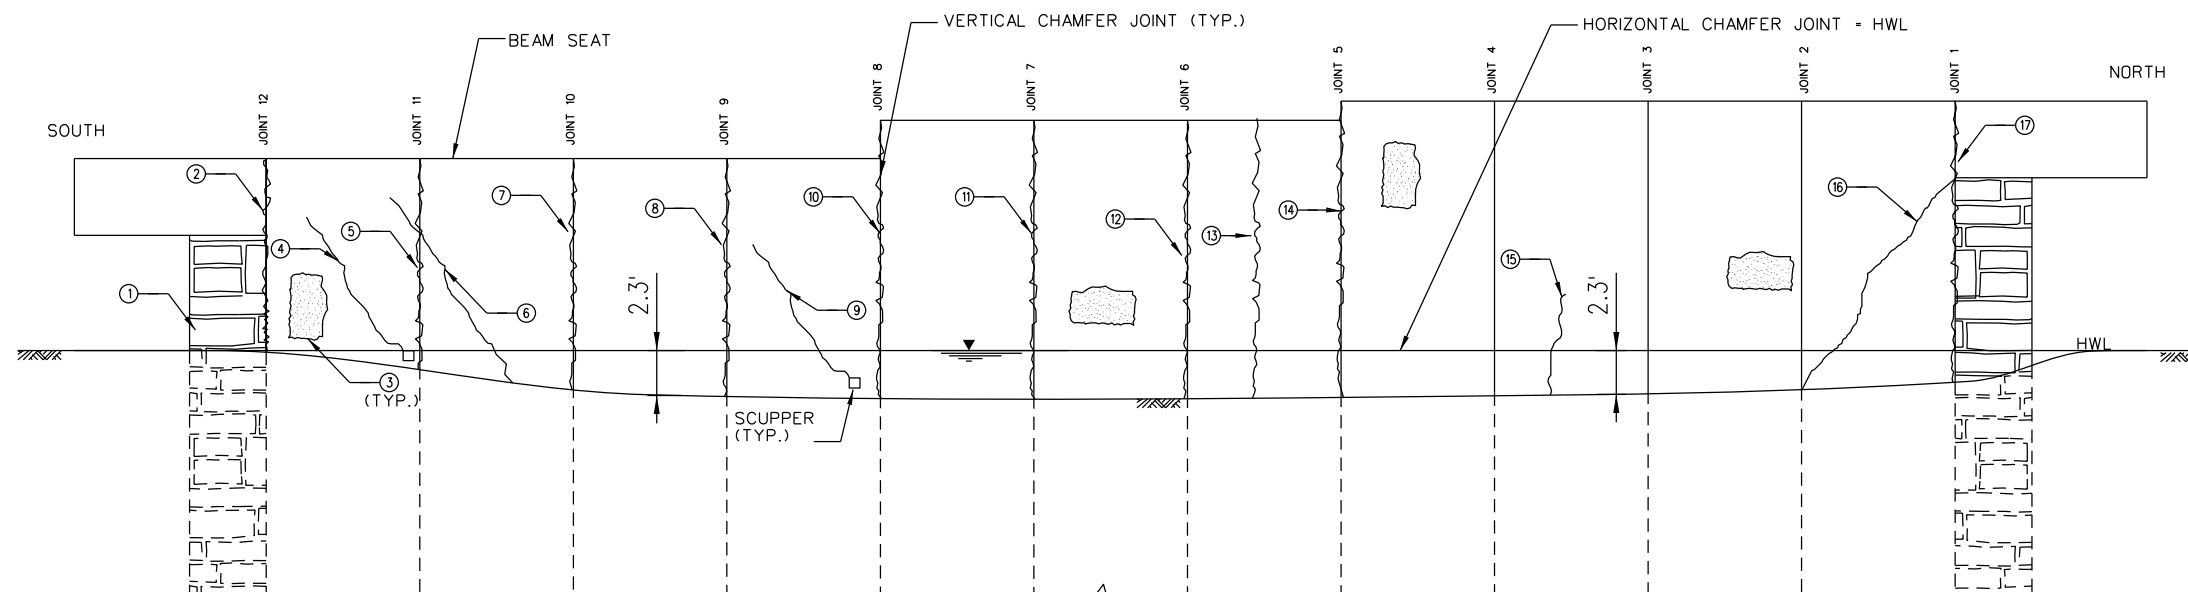
ELEVATION - WEST ABUTMENT

- ① 5% LOSS OF MORTAR AT UPSTREAM AND DOWNSTREAM ENDS.
- ② HL V.C. FROM ML TO TOP OF PIER ALONG JOINT 12.
- ③ RANDOM DELAMINATED AREAS THROUGHOUT CONCRETE SURFACES EXTENDING TO WITHIN 3' OF ML. TYPICALLY 1-2 SOFT AREAS OF CONCRETE NEAR DELAMINATION.

- ④ 10' LONG HL D.C. FROM ML EXTENDS UPWARDS TO THE SOUTH TO JOINT 12 FROM SCUPPER.
- ⑤ HL V.C. FROM ML TO TOP OF PIER ALONG JOINT 11.
- ⑥ 12' LONG HL D.C. FROM HWL EXTENDS UPWARDS TO THE SOUTH. CRACK EXTENDS PAST JOINT 11.

- ⑦ HL V.C. FROM ML TO TOP OF PIER ALONG JOINT 10.
- ⑧ V.C. UP TO 1/16" W. FROM ML TO TOP OF PIER ALONG JOINT 9.
- ⑨ 8' LONG HL D.C. FROM SCUPPER BETWEEN JOINTS 8 AND 9 EXTENDS UPWARDS TO THE SOUTH.

- ⑩ HL V.C. FROM ML TO TOP OF PIER ALONG JOINT 8.
- ⑪ HL V.C. FROM ML TO TOP OF PIER ALONG JOINT 7.
- ⑫ HL V.C. FROM ML TO TOP OF PIER ALONG JOINT 6.
- ⑬ HL V.C. FROM ML TO TOP OF PIER BETWEEN JOINTS 5 AND 6.

- ⑭ HL V.C. FROM ML TO TOP OF PIER ALONG JOINT 5.
- ⑮ 5' LONG X HL V.C. FROM ML BETWEEN JOINTS 3 AND 4.
- ⑯ HL D.C. FROM ML AT JOINT 1 TO JOINT 2. CRCK EXTENDS UPWARDS TO THE NORTH.

- ⑰ HL V.C. W/ MOD. EFFLO. FROM ML TO TOP OF PIER ALONG JOINT 1.

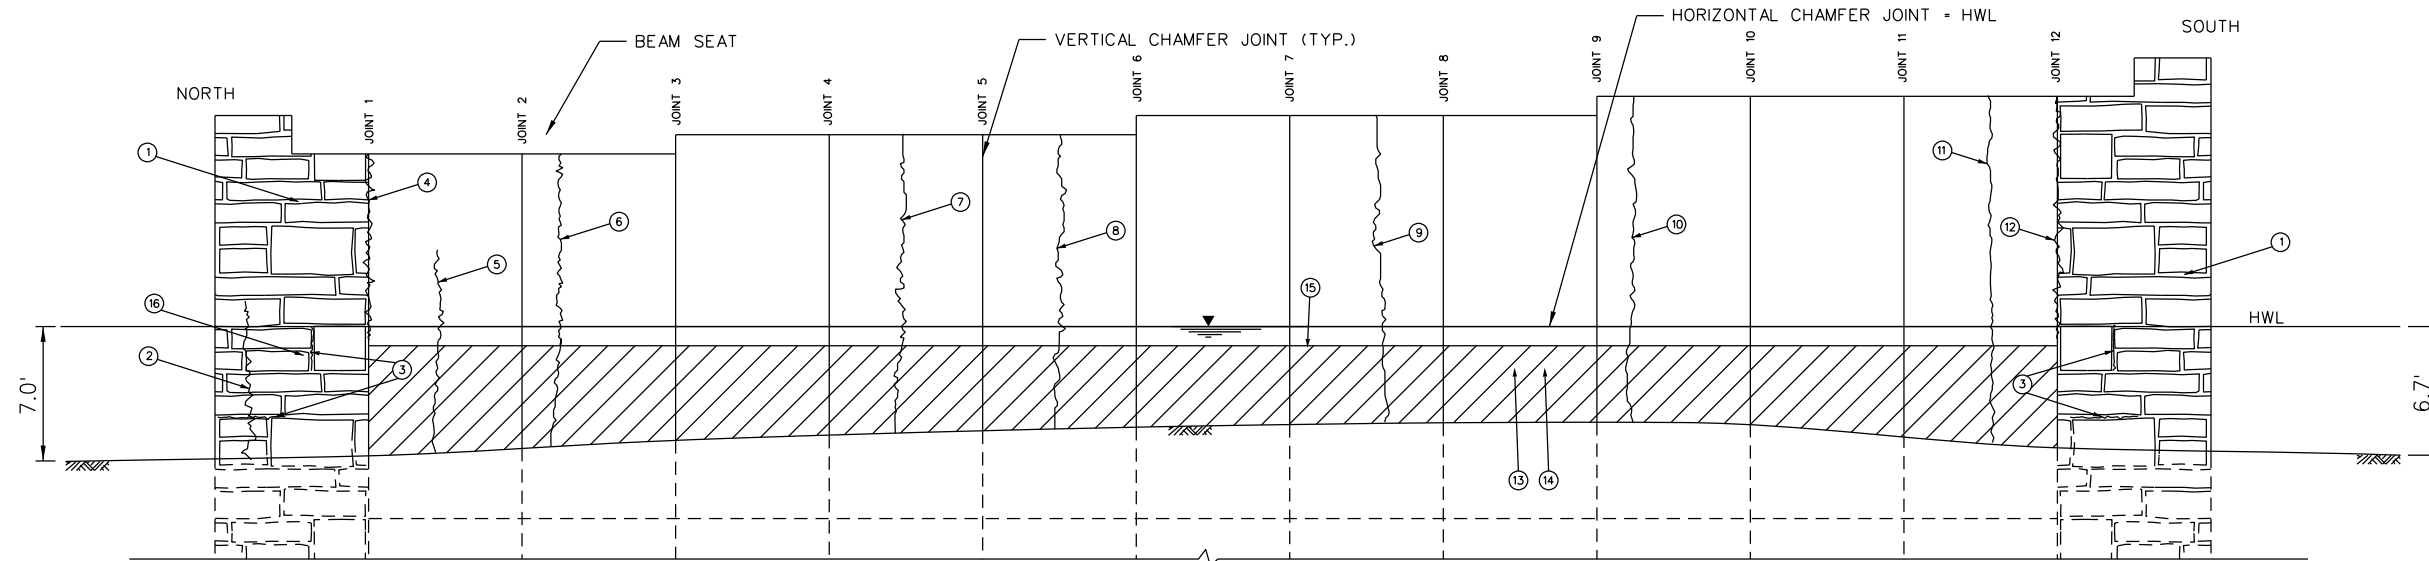
WEST ELEVATION - PIER 1

- ① GENERALLY LESS THAN 10% LOSS OF MORTAR AT UPSTREAM AND DOWNSTREAM ENDS.
- ② 3/16" W V.C. IN FASCIA STONE IN UPSTREAM NOSE FROM ML TO APPROX. 2' ABOVE HWL.

- ③ HAIRLINE CRACKS THROUGHOUT MORTAR.
- ④ HL V.C. ALONG JOINT 1 EXTENDING UP FROM HWL TO TOP OF PIER.
- ⑤ HL V.C. BETWEEN JOINTS 1 AND 2 EXTENDING UP FROM ML TO WITHIN 5' OF TOP OF PIER.

- ⑥ V.C. UP TO 1/16" W. FROM ML TO TOP OF PIER AT 2' SOUTH OF JOINT 2.
- ⑦ HL V.C. FROM ML TO TOP OF PIER BETWEEN JOINTS 4 AND 5.
- ⑧ V.C. UP TO 1/16" W. FROM ML TO TOP OF PIER BETWEEN JOINTS 5 AND 6.

- ⑨ V.C. UP TO 1/16" W. FROM ML TO TOP OF PIER BETWEEN JOINTS 7 AND 8.
- ⑩ V.C. UP TO 1/8" W. FROM ML TO TOP OF PIER BETWEEN JOINTS 9 AND 10.
- ⑪ V.C. UP TO 1/16" W. FROM ML TO TOP OF PIER BETWEEN JOINTS 11 AND 12.

- ⑫ HL V.C. FROM HWL TO TOP OF PIER ALONG JOINT 12.
- ⑬ RANDOM AREAS OF SOFT CONCRETE FROM 1' BELOW WL TO ML ALONG FULL-LENGTH OF PIER.
- ⑭ SCALE PRESENT ALONG FULL-LENGTH OF PIER, UP TO 3/4" D. FROM 1' TO 3' BELOW HWL, 1/4" D. NEAR WL, AND 1" D. FROM 3' BELOW HWL TO ML.

- ⑮ SEVERE SCALE 4' W X 3' V X 3" D, 1' BELOW THE HIGH WATERLINE NEAR JOINT 7, WITH 2 EXPOSED REINFORCING BARS WITH UP TO 15% LOSS OF SECTION. THERE IS A 6" DIA. STEEL PIPE IN CENTER OF THE SCALE.

- ⑯ MISSING STONE MASONRY 6" H X 6" V X 8"D, 8' FROM THE NORTH NOSE AT 1.5' BELOW HWL.

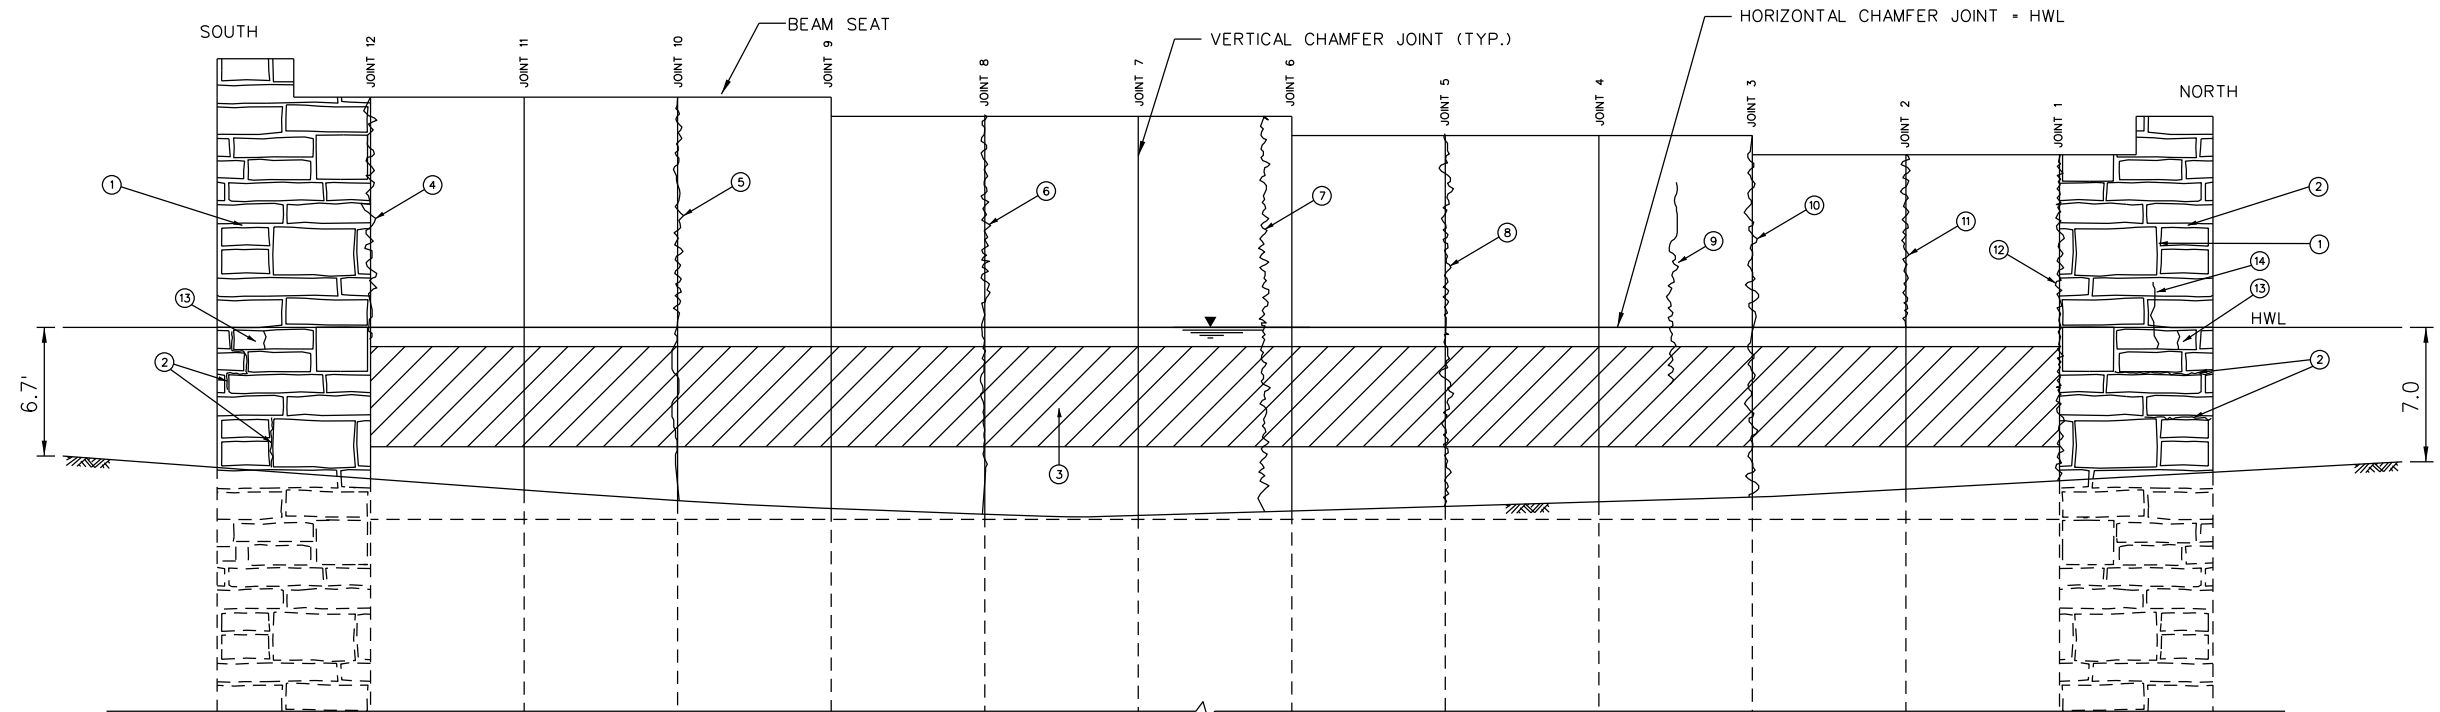
EAST ELEVATION - PIER 1

- ① GENERALLY LESS THAN 10% LOSS OF MORTAR AT UPSTREAM AND DOWNSTREAM ENDS.
- ② HAIRLINE CRACKS THROUGHOUT MORTAR.
- ③ HEAVY SCALE, 1.5" D, ALONG FULL-LENGTH OF PIER FROM 1' BELOW HWL TO 2' ABOVE ML.
- ④ HL V.C. FROM HWL TO TOP OF PIER ALONG JOINT 12.
- ⑤ HL V.C. FROM ML TO TOP OF PIER ALONG JOINT 10.
- ⑥ HL V.C. FROM ML TO TOP OF PIER ALONG JOINT 8.
- ⑦ 1/16" W. V.C. FROM ML TO TOP OF PIER 1' SOUTH OF JOINT 6.
- ⑧ HL V.C. FROM ML TO TOP OF PIER ALONG JOINT 5.
- ⑨ HL V.C. FROM 7' ABOVE HWL TO 3' BELOW HWL BETWEEN JOINTS 3 AND 4.
- ⑩ 1/16" W. V.C. FROM ML TO TOP OF PIER ALONG JOINT 3.
- ⑪ FINE HL V.C. FROM HWL TO TOP OF PIER ALONG JOINT 2.
- ⑫ 1/16" V.C. FROM ML TO TOP OF PIER ALONG JOINT 1.
- ⑬ FULL-HEIGHT X 1/32" W. V.C. IN SINGLE STONE, 6" BELOW HWL AT THE UPSTREAM AND DOWNSTREAM NOSE.
- ⑭ 3/16" W. V.C. IN STONE, 6" BELOW HWL AND EXTENDING INTO COURSE ABOVE HWL.

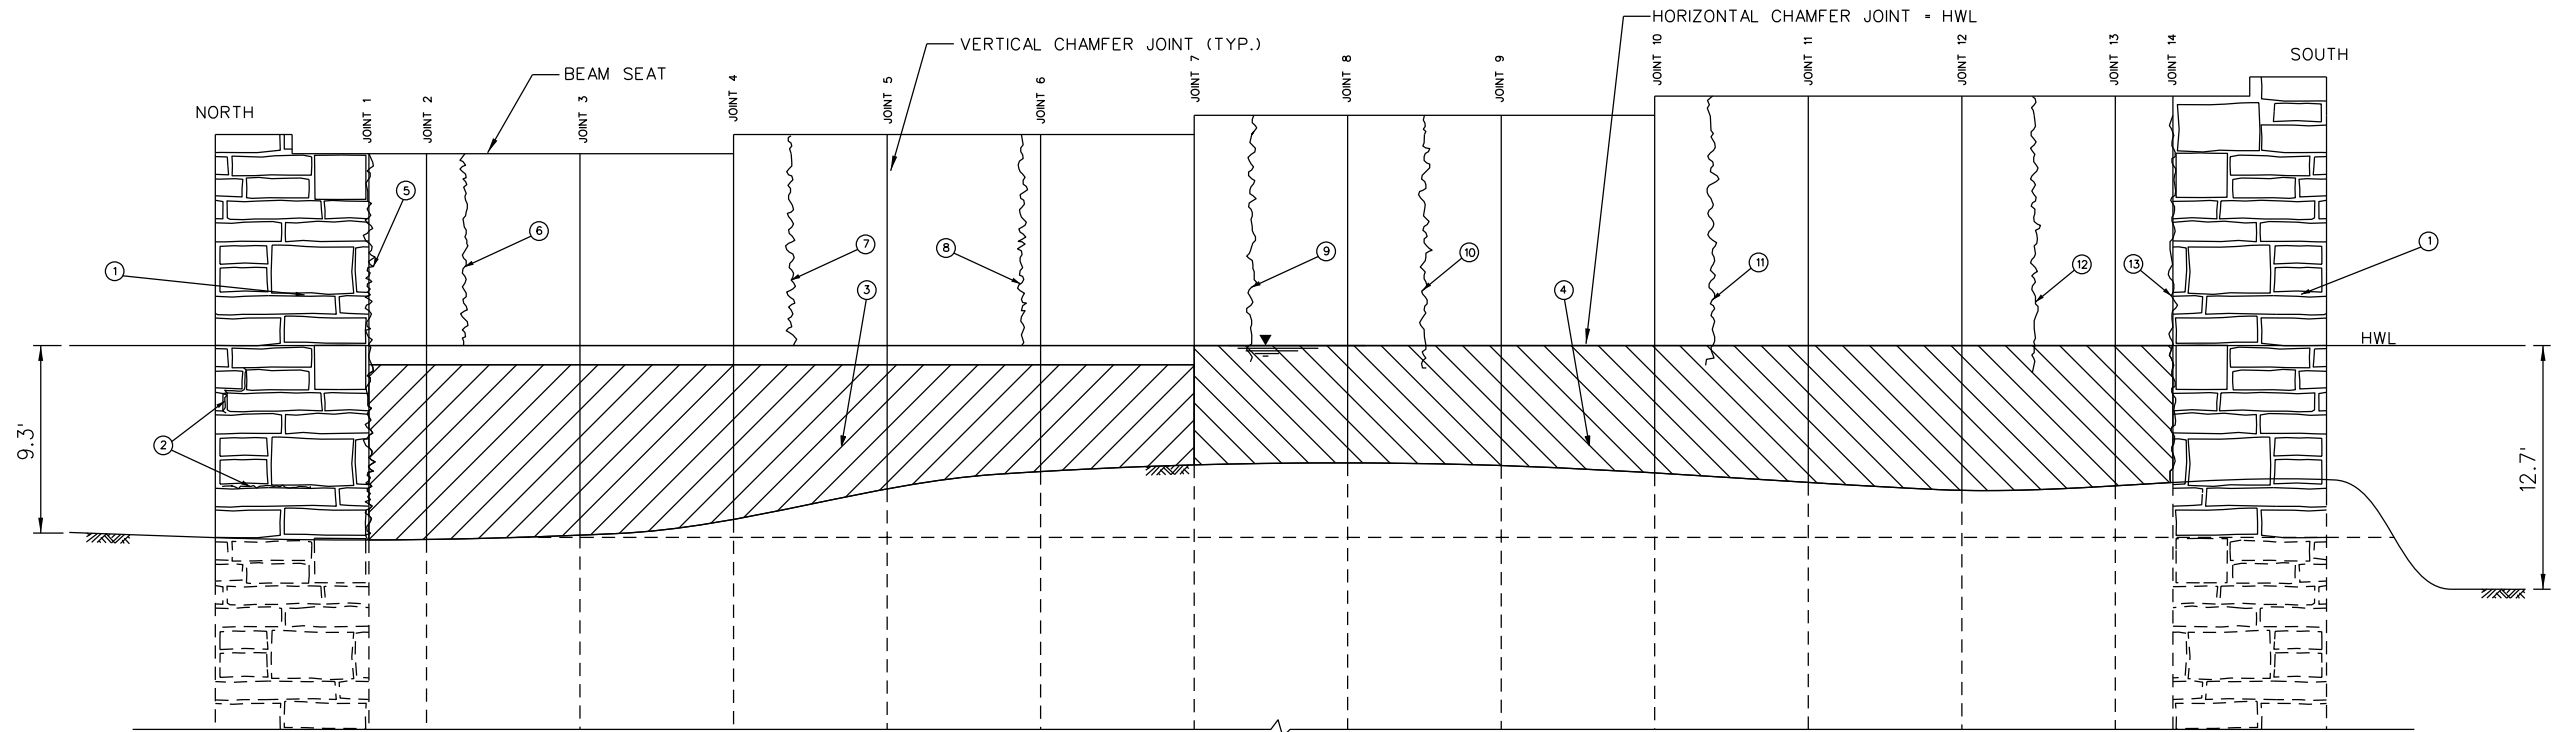
WEST ELEVATION - PIER 2

| <ul style="list-style-type: none"> ① GENERALLY 10% LOSS OF MORTAR AT UPSTREAM AND DOWNSTREAM ENDS. ② HAIRLINE CRACKS THROUGHOUT MORTAR. ③ AREA OF SEVERE SCALE ON UPSTREAM HALF OF FACE UP TO 2"D, FROM 1' BELOW HWL TO 18" ABOVE ML, WITH 1 VERTICAL BAR EXPOSED AND RANDOM AREAS OF SOFT CONCRETE UP TO 2"D. ④ AREA OF SEVERE SCALE ON DOWNSTREAM HALF OF FACE UP TO 6" DEEP FROM HWL TO 12" ABOVE ML, 30 VERTICAL BARS EXPOSED, FULL CIRCUMFERENCE OF SEVERAL BARS EXPOSED WITH 15% TO 30% LOSS OF SECTION. ⑤ HL V.C. EXTENDING UP FROM ML TO TOP OF PIER ALONG JOINT 1. ⑥ HL V.C. EXTENDING UP FROM HWL TO TOP OF PIER 2' SOUTH OF JOINT 2. | <ul style="list-style-type: none"> ⑦ 1/16" V.C. EXTENDING UP FROM HWL TO TOP OF PIER 3' SOUTH OF JOINT 4. ⑧ HL V.C. FROM HWL TO TOP OF PIER 1' NORTH OF JOINT 6. ⑨ HL V.C. FROM SCALE AREA TO TOP OF PIER 3' SOUTH OF JOINT 7. ⑩ HL V.C. FROM SCALE AREA TO TOP OF PIER 4' SOUTH OF JOINT 8. ⑪ V.C. UP TO 1/16" W. FROM SCALE AREA TO TOP OF PIER 3' SOUTH OF JOINT 10. ⑫ HL V.C. FROM SCALE AREA TO TOP OF PIER 3' SOUTH OF JOINT 12. ⑬ HL V.C. FROM ML TO TOP OF PIER ALONG JOINT 14. |
