Underwater Inspection of New York Avenue Bridge

DDOT Bridge #0076

May 10th 2016

Bridge No. 76 • New York Avenue over the Anacostia River
Washington, DC • May 2016

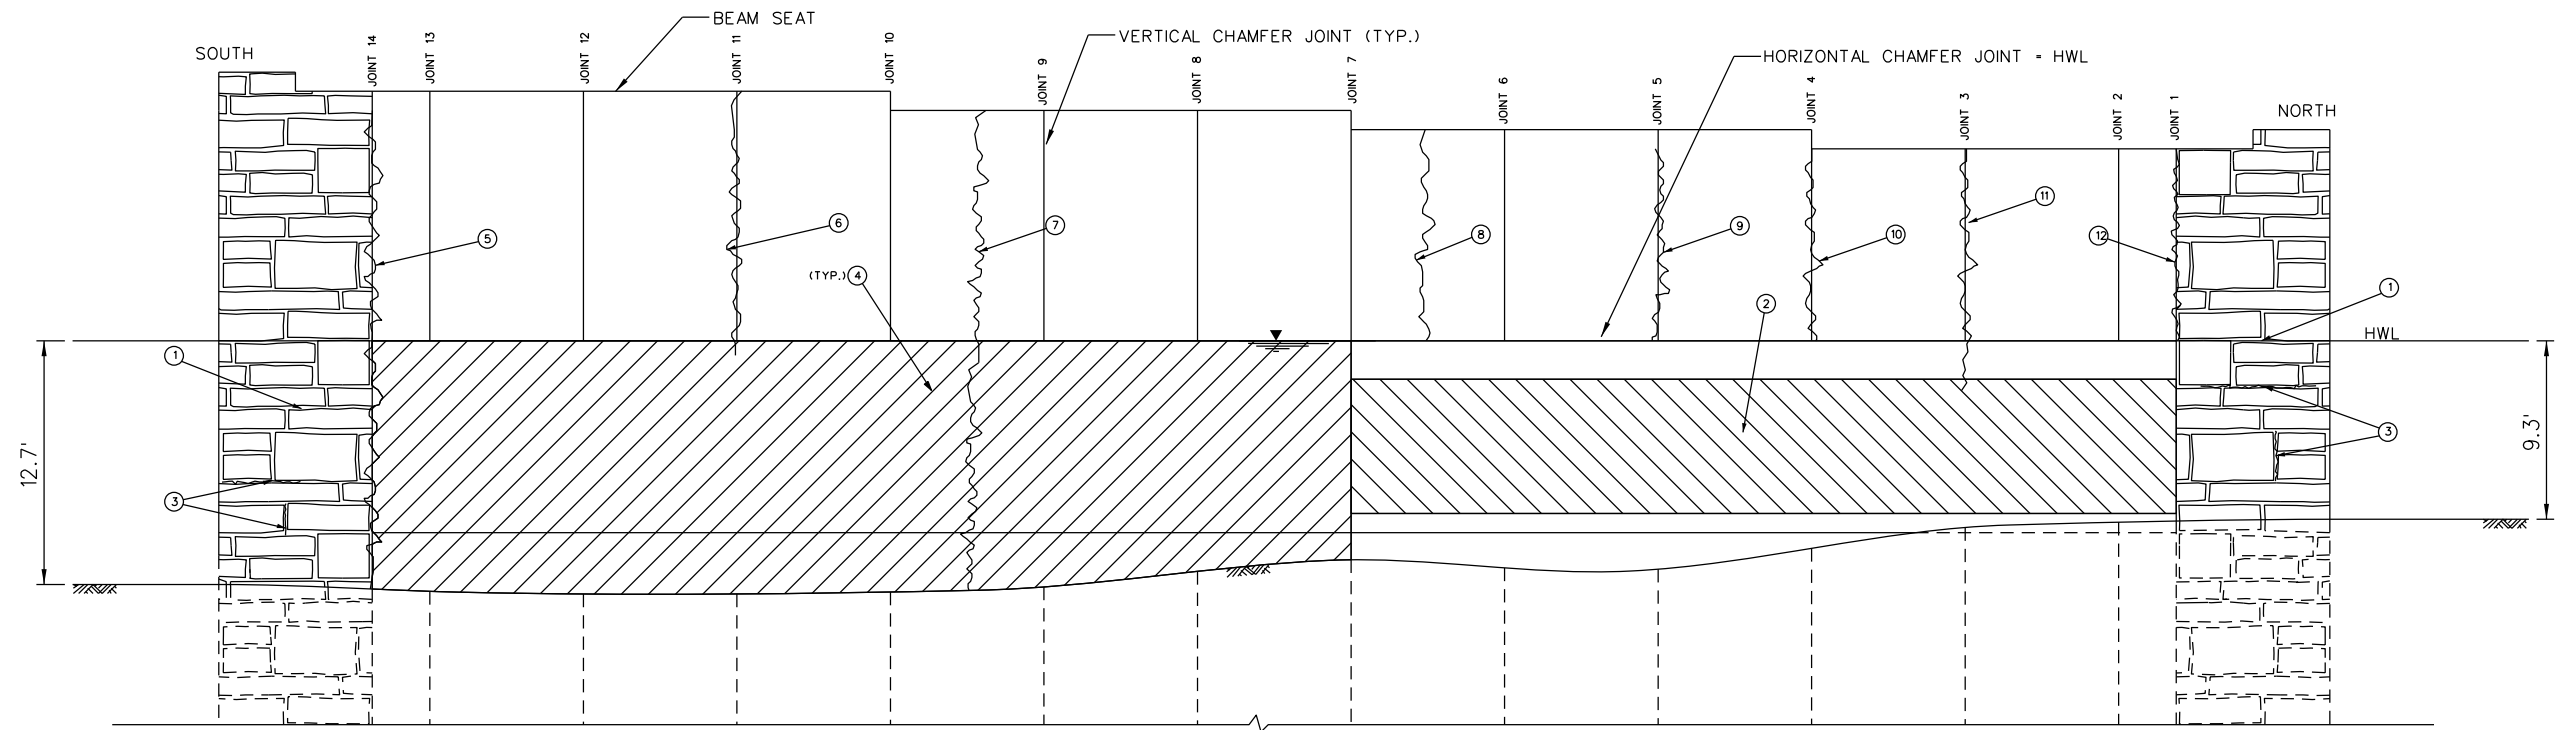
EAST ELEVATION - PIER 2

| ③ HAIRLINE CRACKS THROUGHOUT MORTAR. | ⑨ HL V.C. EXTENDING UP FROM HWL TO TOP OF PIER ALONG JOINT 5. |

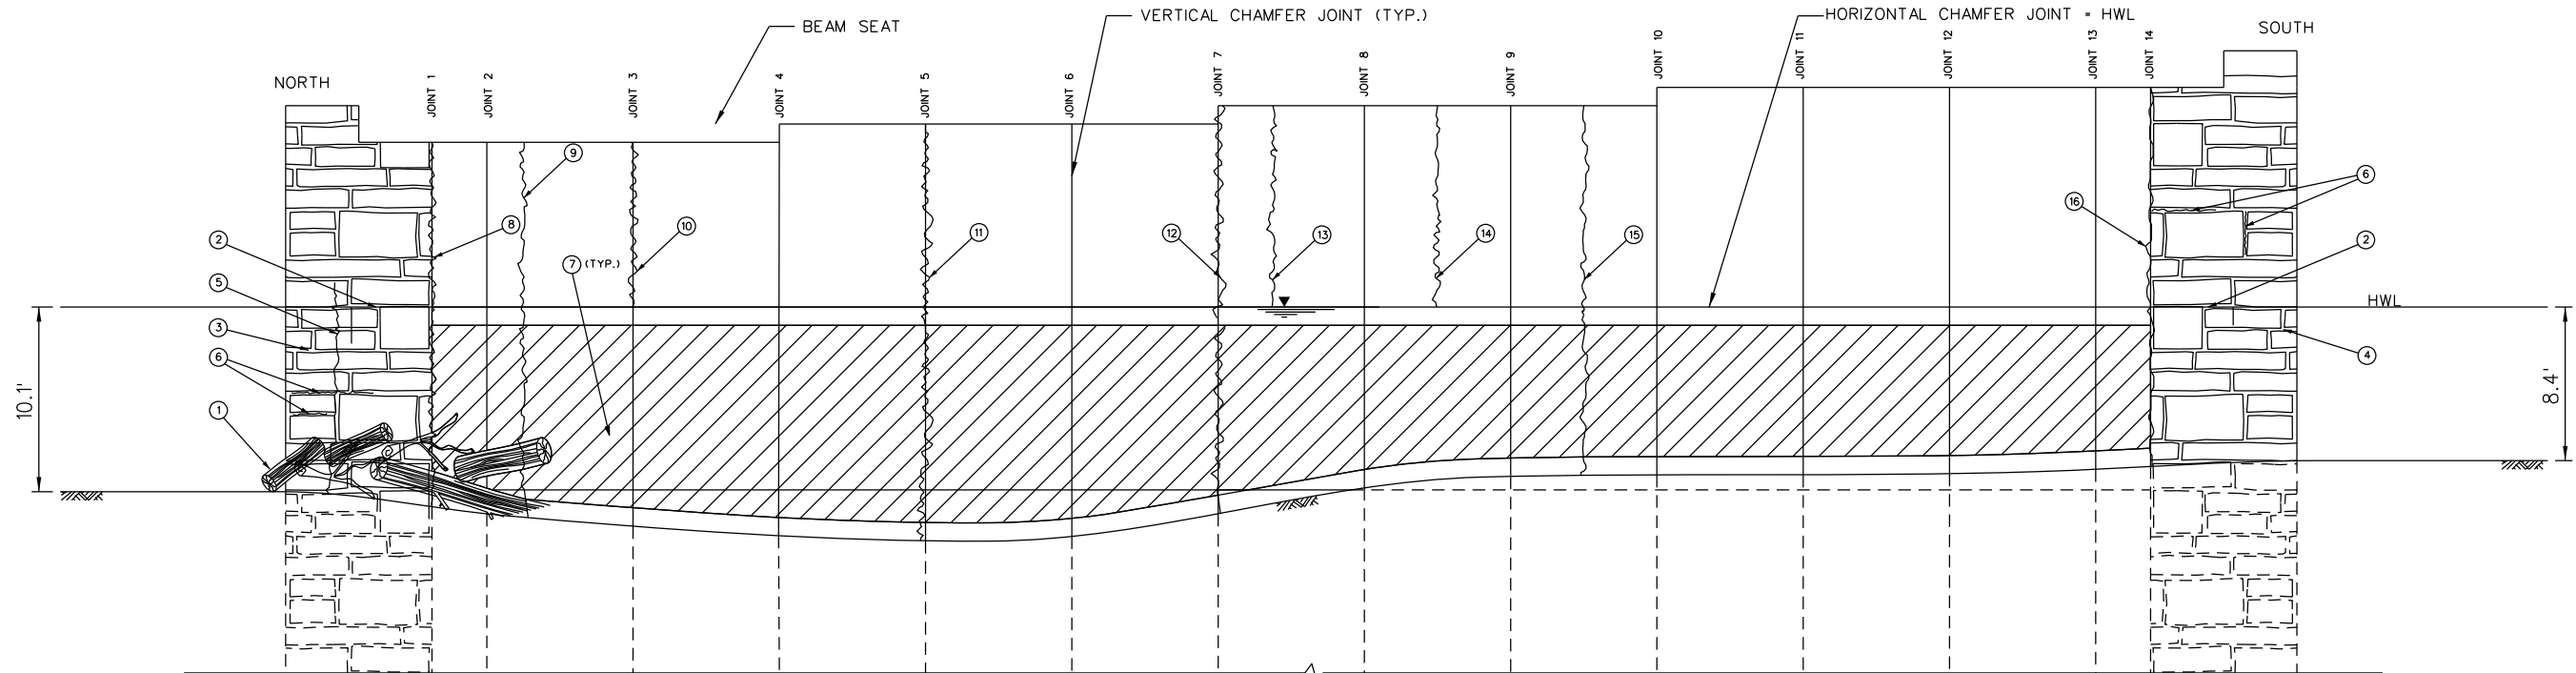
WEST ELEVATION - PIER 3

- ④ MORTAR LOSS 9" V X 4" D AT DOWNSTREAM NOSE 6" BELOW HWL.
- ⑤ 1/4" W. V.C. IN FASCIA STONES IN UPSTREAM NOSE FROM ML TO 2' ABOVE HWL.
- ⑥ HAIRLINE CRACKS THROUGHOUT MORTAR.

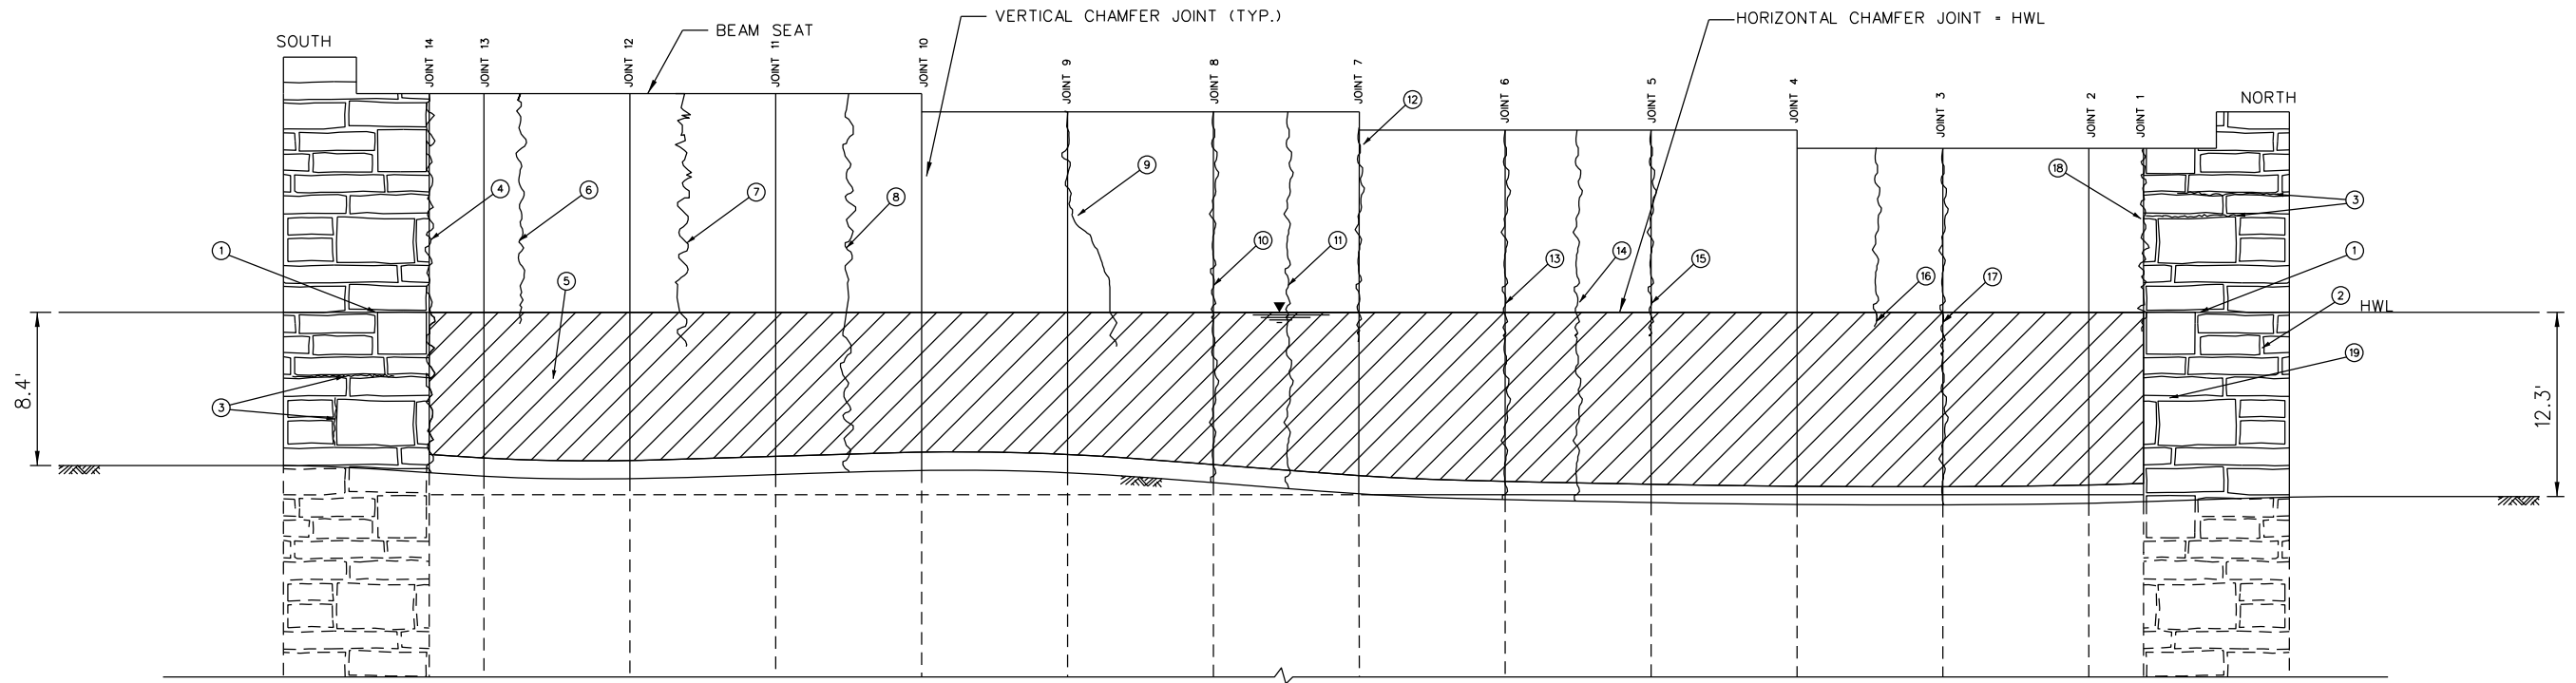
EAST ELEVATION - PIER 3

- ③ HAIRLINE CRACKS THROUGHOUT MORTAR.
- ④ HL V.C. EXTENDING UP FROM ML TO TOP OF PIER ALONG JOINT 14 .
- ⑤ HEAVY SCALE THROUGHOUT FACE UP TO 1" D FROM HWL TO 12" ABOVE ML.

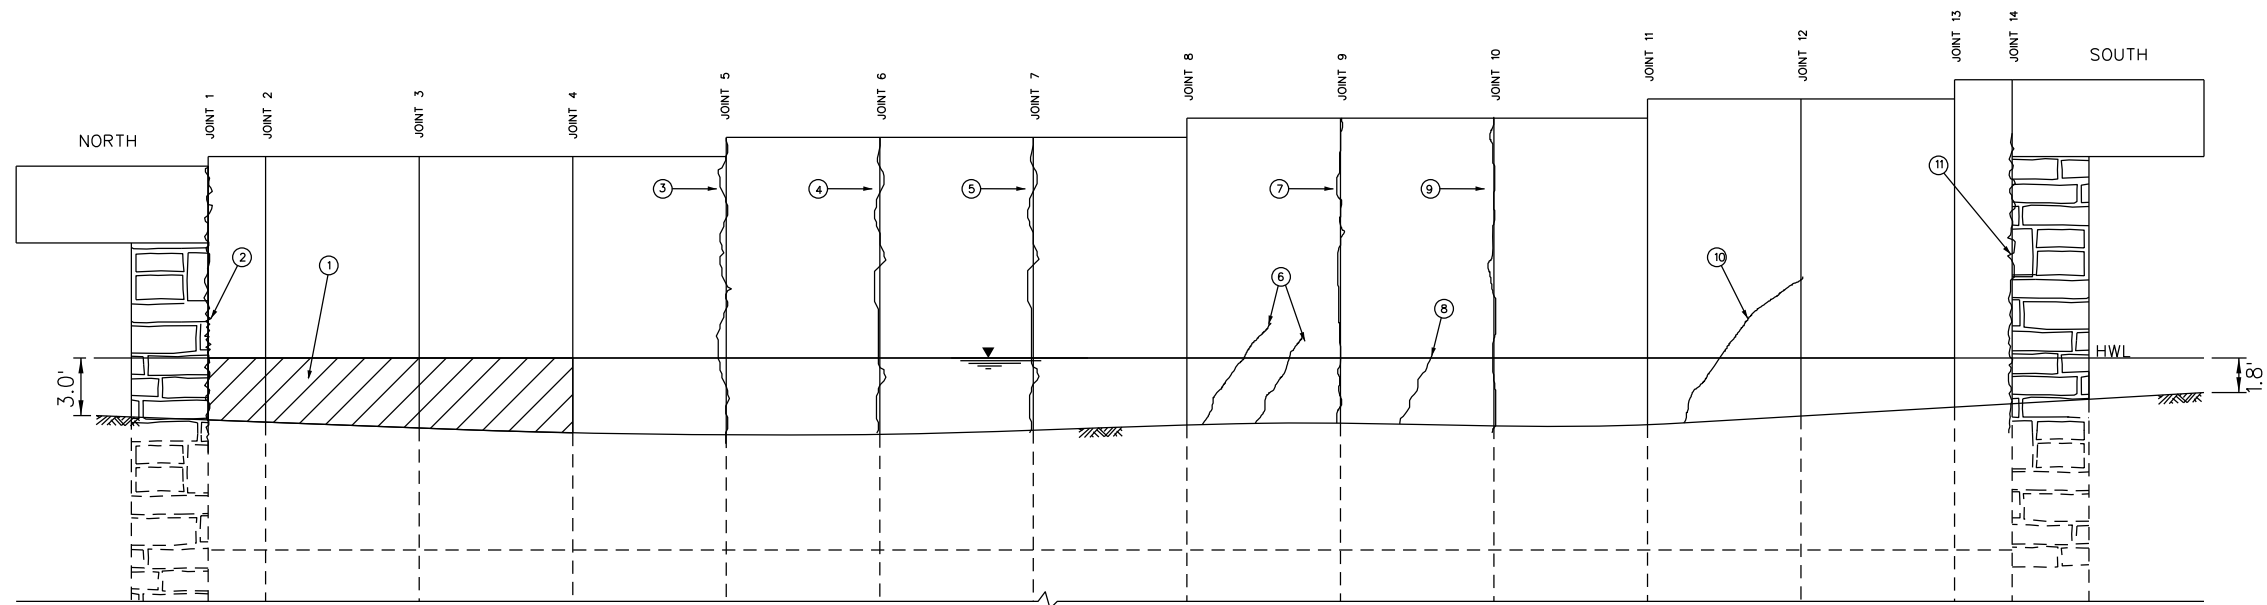
ELEVATION - EAST ABUTMENT

- ① SEVERE SCALE TYPICALLY 3 1/2" D FROM JOINT 1 TO JOINT 4 WITH AREA UP TO 7" D NEAR NORTH SCUPPER, APPROXIMATELY 30'L WITH 5 EXPOSED VERTICAL BARS AND 2 EXPOSED HORIZONTAL BARS.
- ② HL V.C. FROM ML TO TOP OF PIER ALONG JOINT 1.
- ③ HL V.C. FROM ML TO TOP OF PIER ALONG JOINT 5.
- ④ HL V.C. FROM ML TO TOP OF PIER ALONG JOINT 6.
- ⑤ V.C. UP TO 1/16" FROM ML TO TOP OF PIER ALONG JOINT 7.
- ⑥ 2 TOTAL HL DIAGONAL CRACKS 6' LONG EACH FROM ML EXTENDING UP TOWARDS THE SOUTH BETWEEN JOINTS 8 AND 9
- ⑦ HL V.C. FROM ML TO TOP OF PIER ALONG JOINT 9.
- ⑧ HL D.C. FROM ML EXTENDING UP TOWARDS THE SOUTH BETWEEN JOINTS 9 AND 10.
- ⑨ INT. HL V.C. FROM ML TO TOP OF PIER ALONG JOINT 10.
- ⑩ HL D.C. FROM ML EXTENDING UP TOWARDS THE SOUTH BETWEEN JOINTS 11 AND 12.
- ⑪ HL V.C. FROM ML TO TOP OF PIER ALONG JOINT 14.
