DISTRICT DEPARTMENT OF TRANSPORTION

BRIDGE INSPECTION MANUAL

August 2021

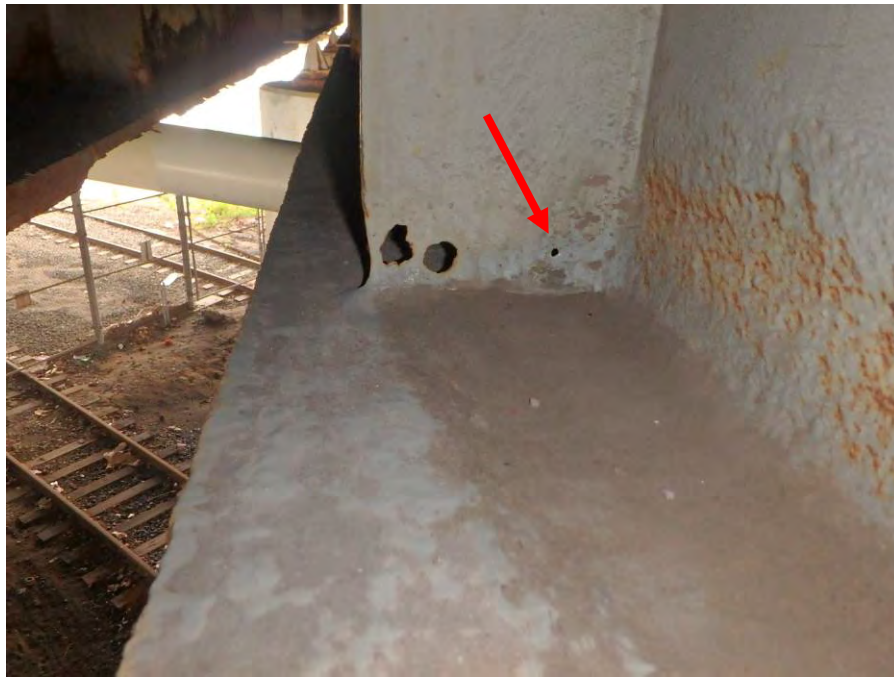
Photograph No. 4 – Two 1" Diameter Corrosion Holes and a 3/16" Diameter Corrosion Hole (Arrow) in a West Cross Girder Stiffener at Bent 1 near Column 3. Note Section Loss in Girder Web

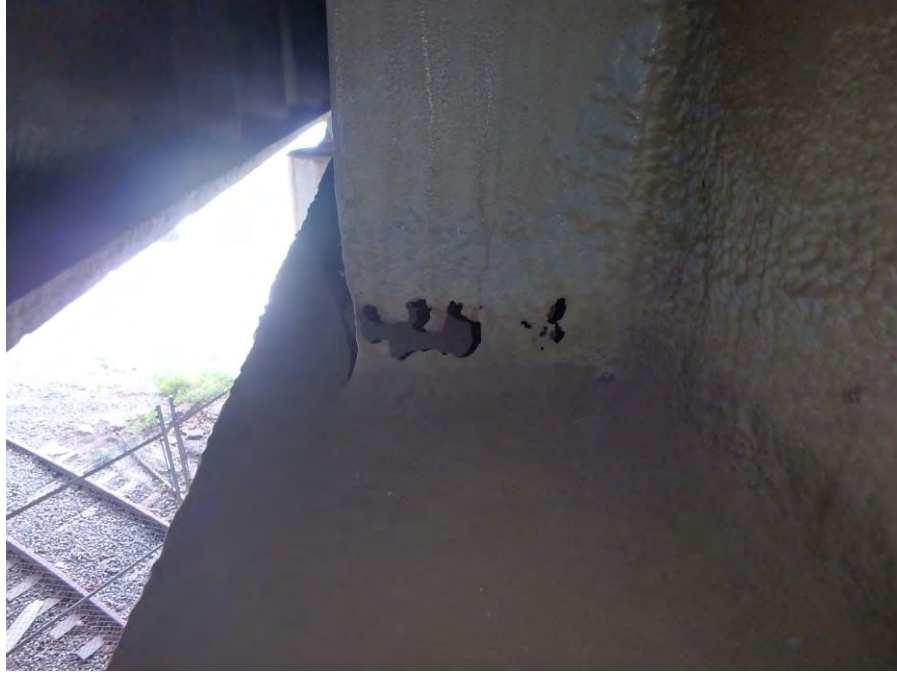
Photograph No. 5 – Two Corrosion Holes (1/2" x 1" and 2 1/2" x 1")
at the Base of the East Cross Girder Stiffener at Bent 1

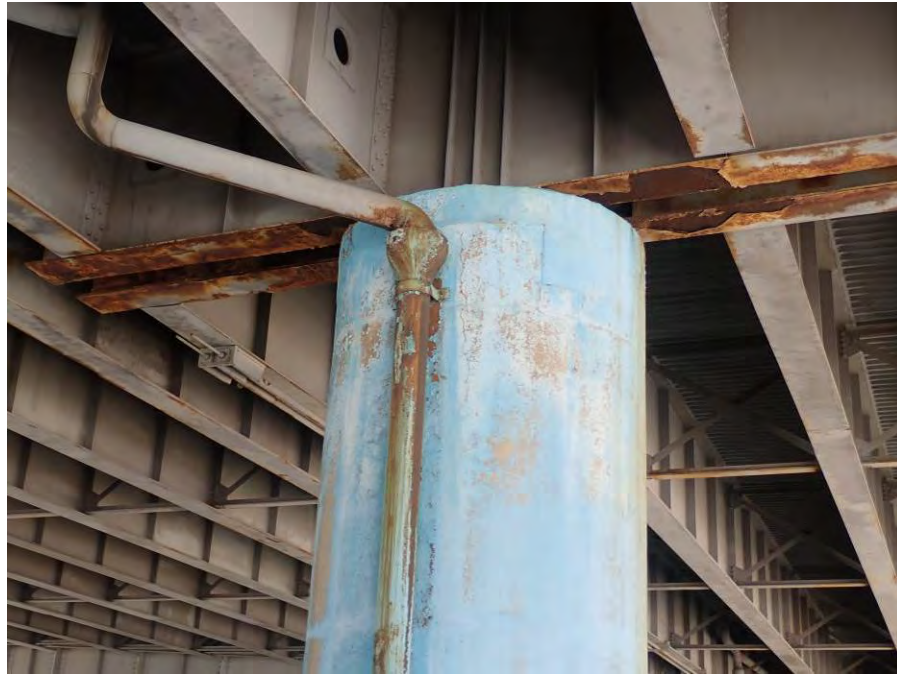
Photograph No. 6 – Moderate Corrosion on the Cross Girder Bottom Flanges
at Column 3 of Bent 8

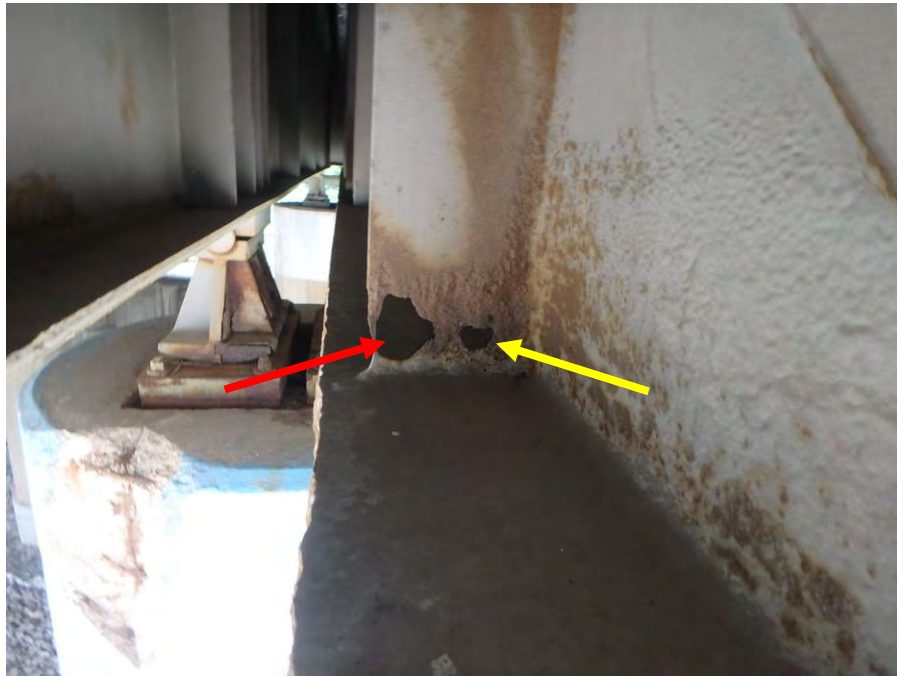
Photograph No. 8 – 3" Diameter (Red Arrow) and 1" Diameter (Yellow Arrow) Corrosion Holes in the Base of the East Cross Girder Stiffener (West Face) at Bent 9 near Column 4

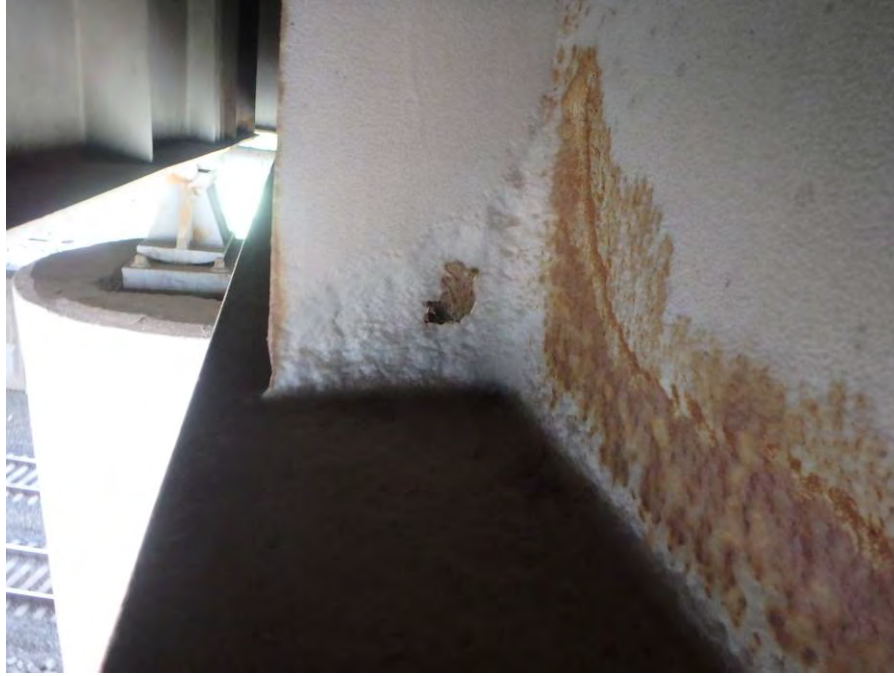
Photograph No. 9 – Corrosion Hole in the Base of the East Cross Girder Stiffener (West Face) at Bent 9 near Column 3. Note Section Loss in the Girder Web

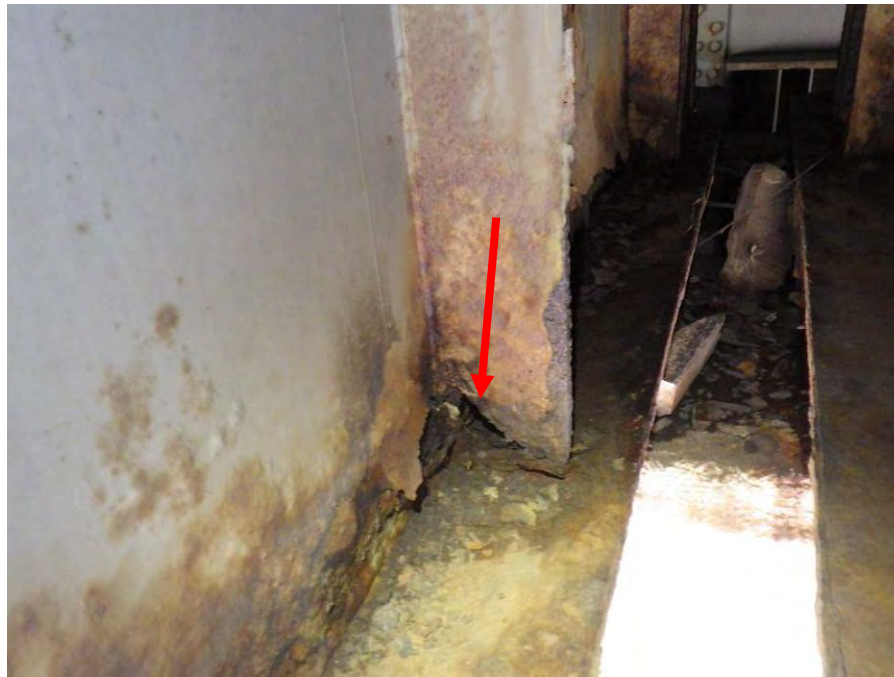
Photograph No. 10 – Active Up to 3" Diameter Corrosion Hole in West Cross Girder Stiffener at Bent 10 near Column 2

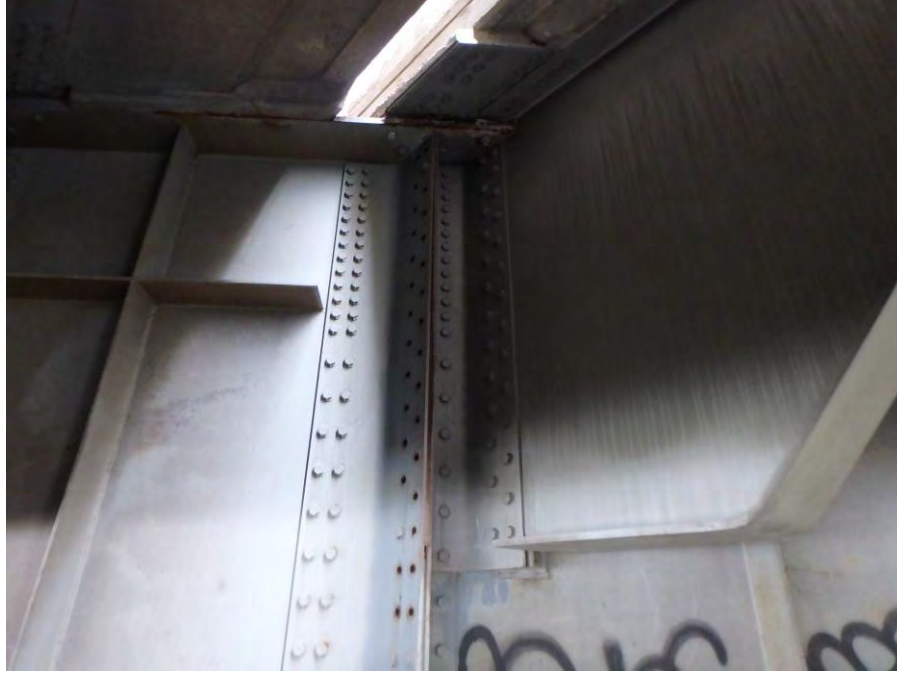
Photograph No. 11 – 29 Fasteners Missing in Stiffener North of Girder 1 at Bent 10

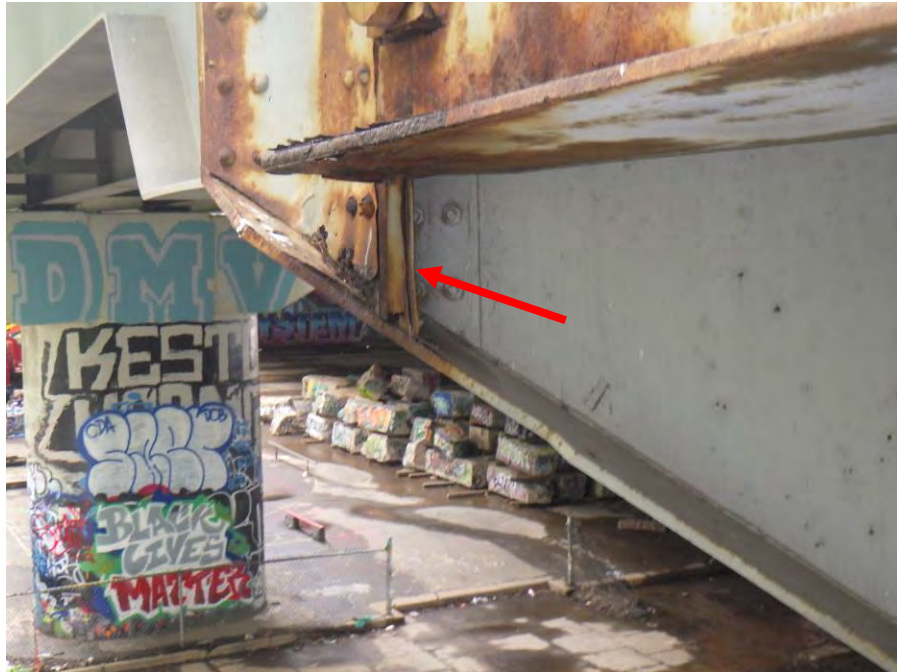
Photograph No. 12 – 1/4" Crevice Corrosion at Bottom of Stiffener at Connection to Girder 1 at Bent 10 in Span 10A

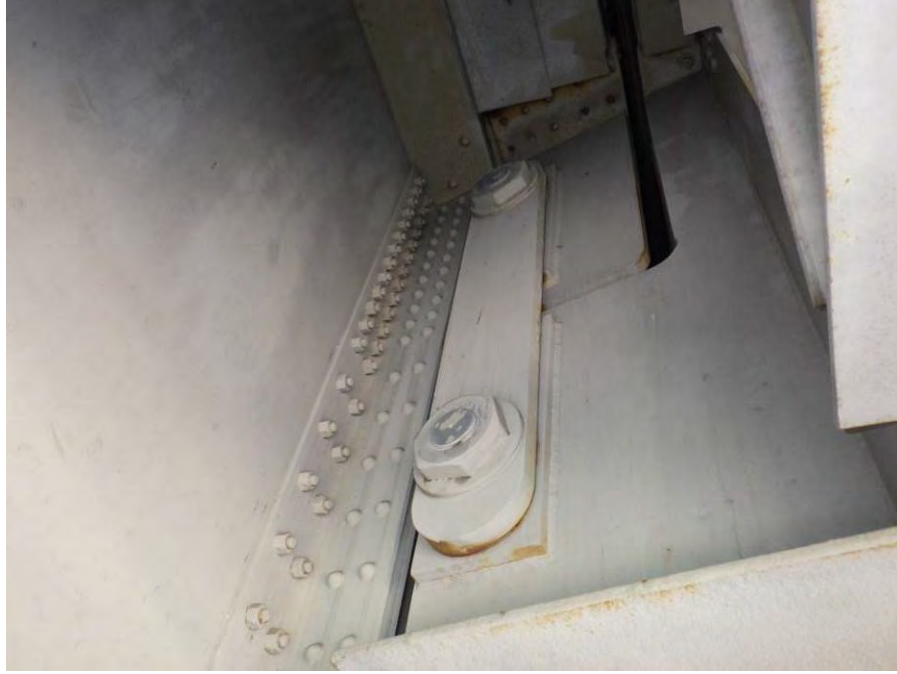
Photograph No. 13 – Typical Pin and Hanger Assembly. Note Areas of Minor Corrosion (North Side of Girder 3 of Span 9 at Bent 9 Shown)

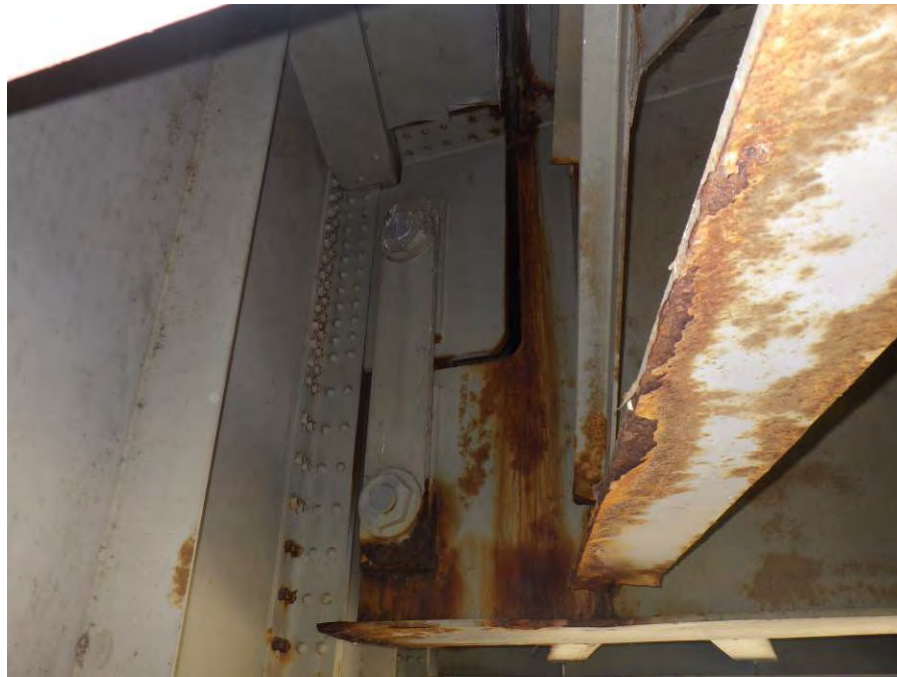
Photograph No. 14 – Minor Corrosion on the Pin and Hanger Assembly at Girder 6 in Span 9, Looking South

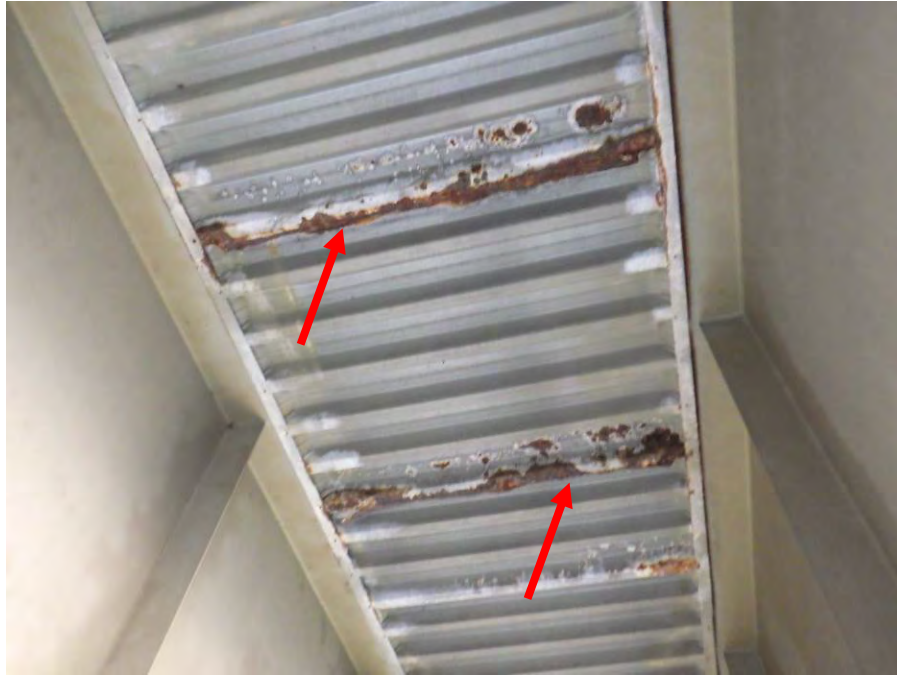
Photograph No. 15 – Minor Corrosion on Stay-In-Place Deck Forms in Bay 5 of Span 9

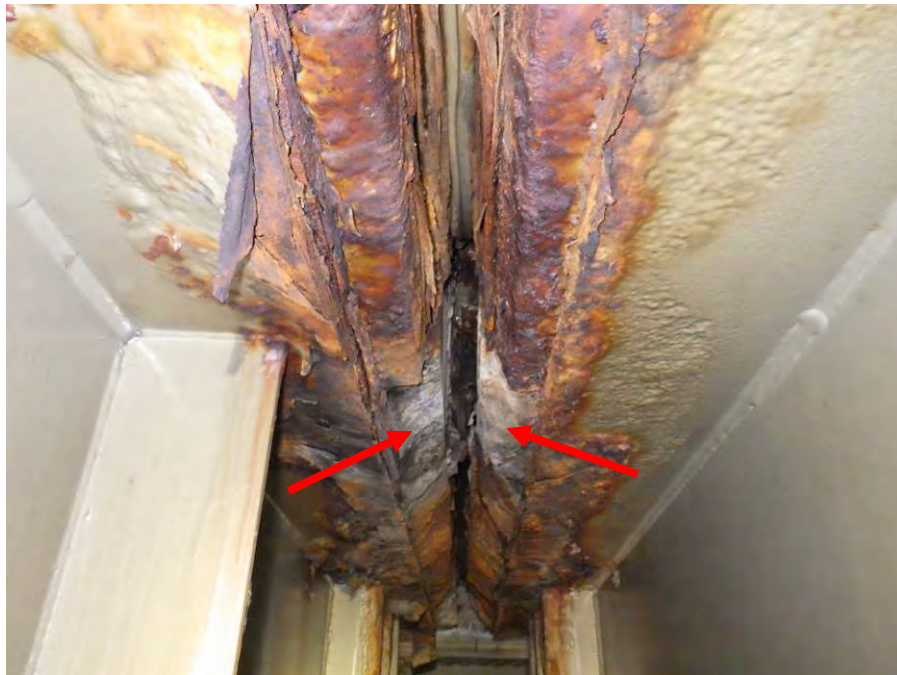
Photograph No. 16 – Moderate Corrosion of the Bent 10 Joint under the Eastbound Lanes. Note the Spalls in Each Side of the Joint (Arrows)

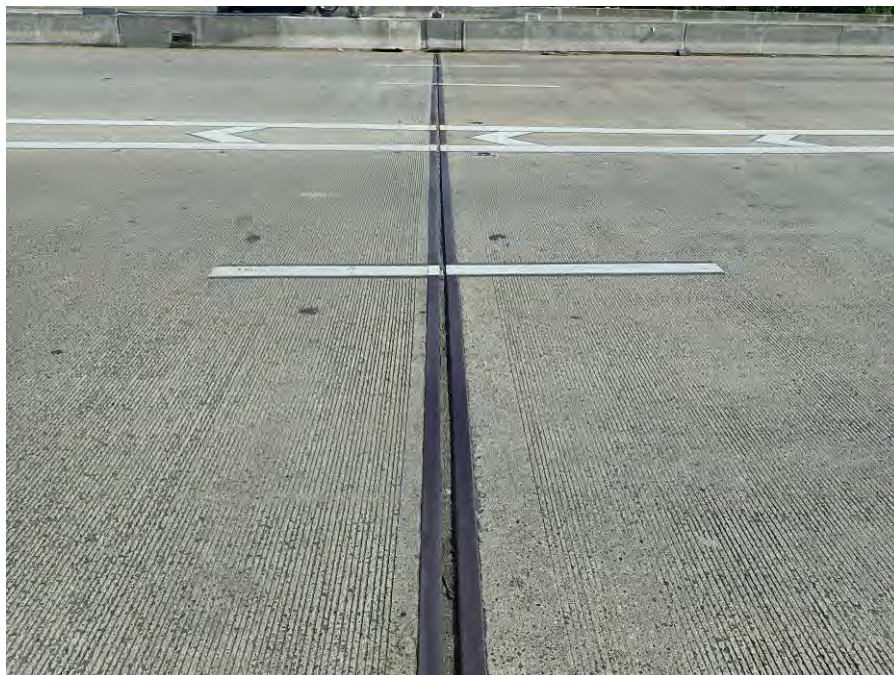
Photograph No. 18 – Typical Deck Joint with Minor to Moderate Debris Accumulation in Seal, Eastbound Lanes at Bent 1 Shown, Looking North

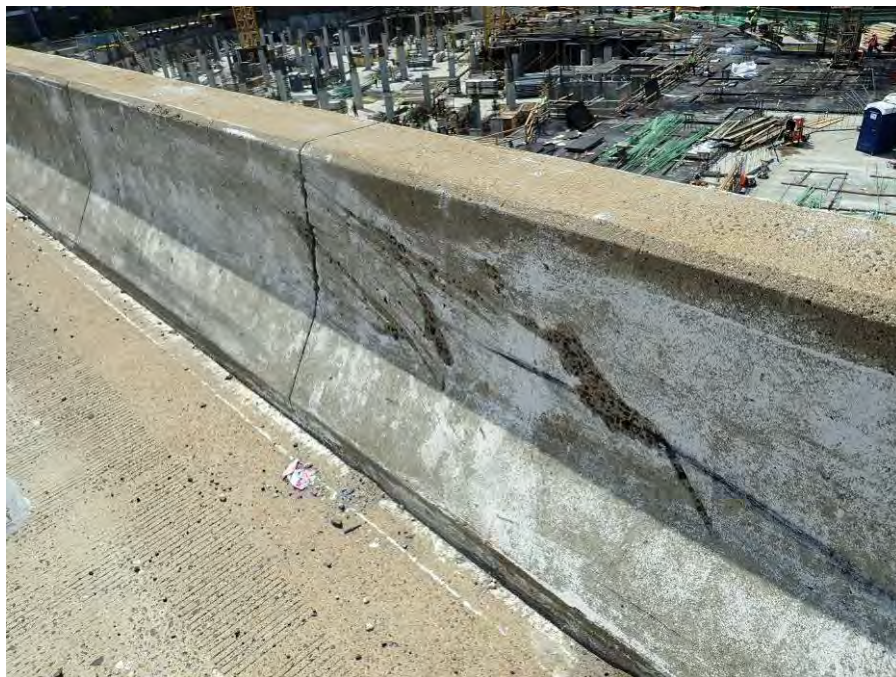
Photograph No. 20 – Minor Spalls, Scrapes and Gouges in the South Parapet – Span 4 Shown, Looking Southeast

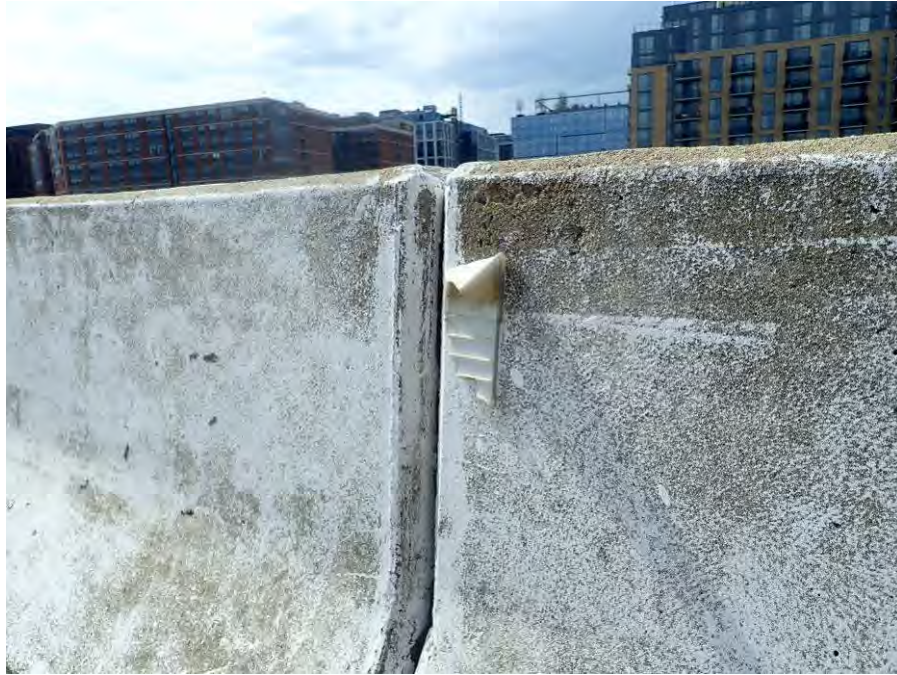
Photograph No. 21 – Typical Broken Reflector Attached to Parapets and Median (South Parapet in Span 1 Shown, Looking Southeast)

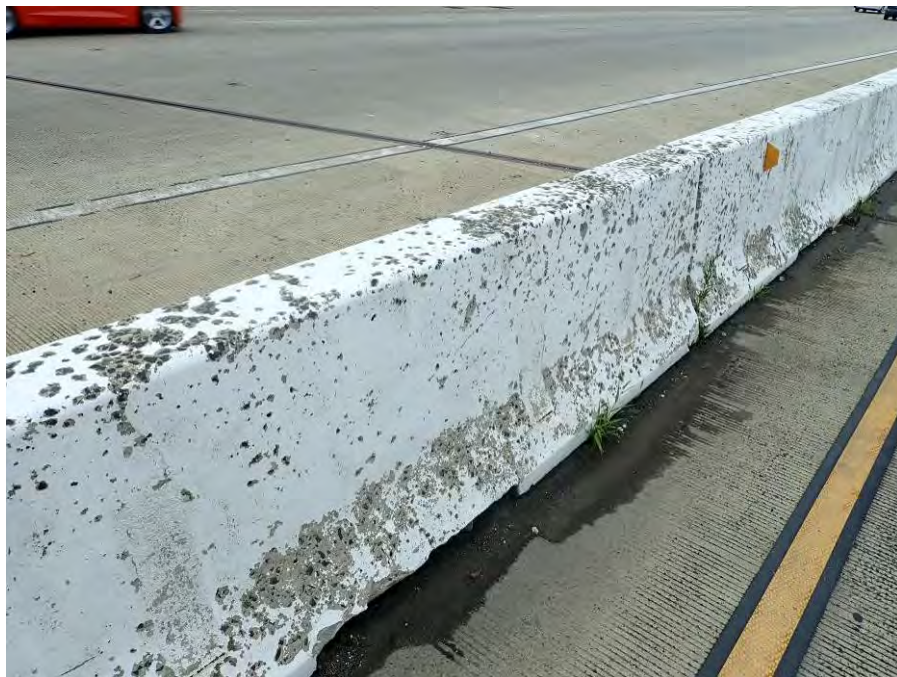
Photograph No. 22 – Paint Deterioration on South Barrier of the North Ramp Section in Span 10, Looking Southwest

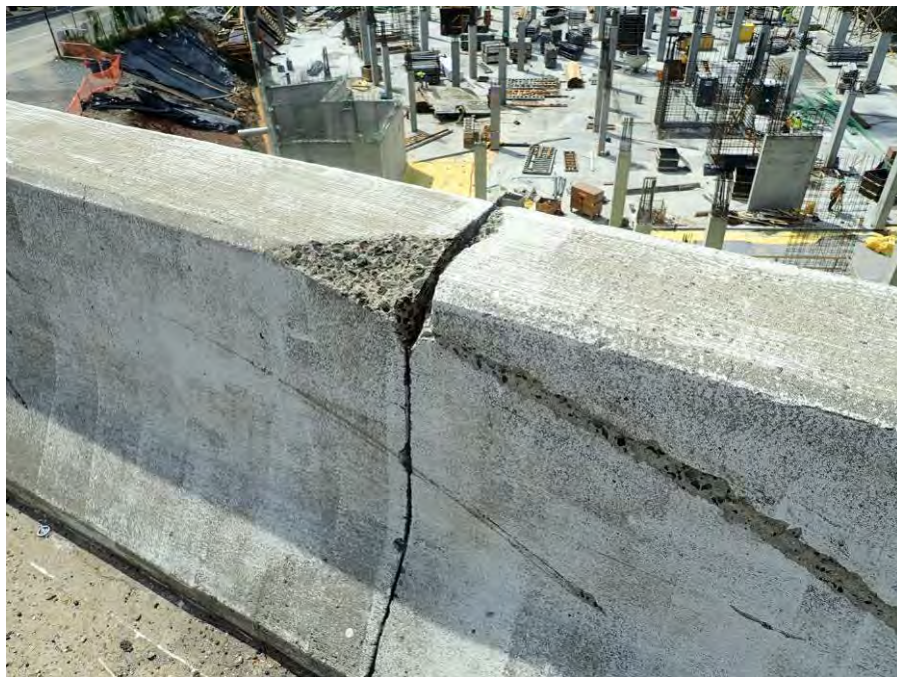
Photograph No. 26 – 12" Long x 12" Wide x Up to 5" Deep Spall in the Top of the
South Parapet in Span 6, Looking Southeast

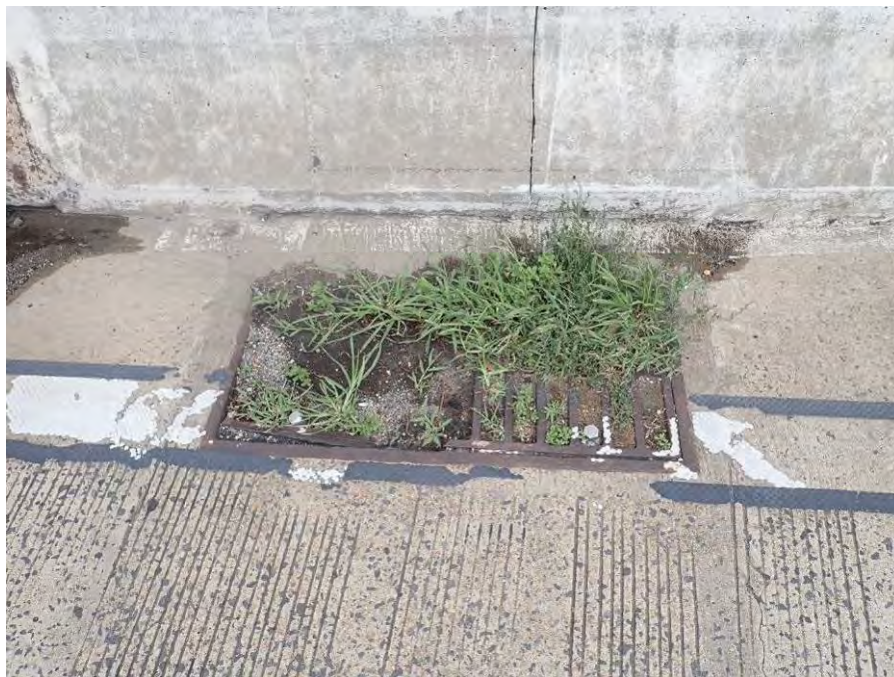
Photograph No. 28 – Westbound Lanes – Broken Drainage Grate in Span 8. Scupper Completely Clogged with Debris

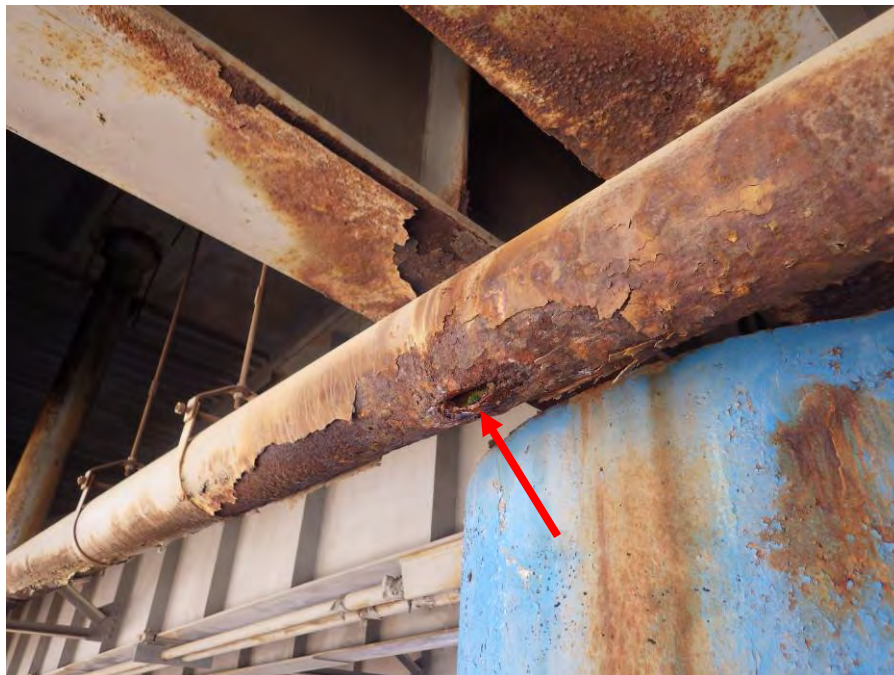
Photograph No. 30 – Minor to Severe Corrosion in the Horizontal Drain Pipe at Bent 4, Column 2 with a 6" Long x 2" Wide Corrosion Hole, Looking Northwest

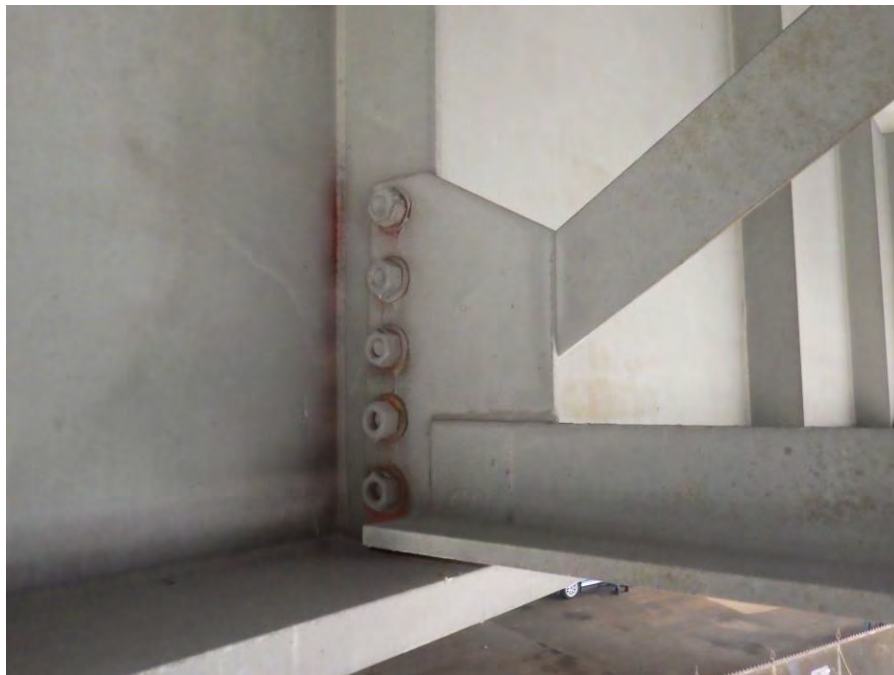
Photograph No. 36 – Five Loose Bolts and Up to 7/8” Gap between Connection Plate and Stiffener of Cross-frame Connection on South Side of Girder 18 at Mid-span of Span 11

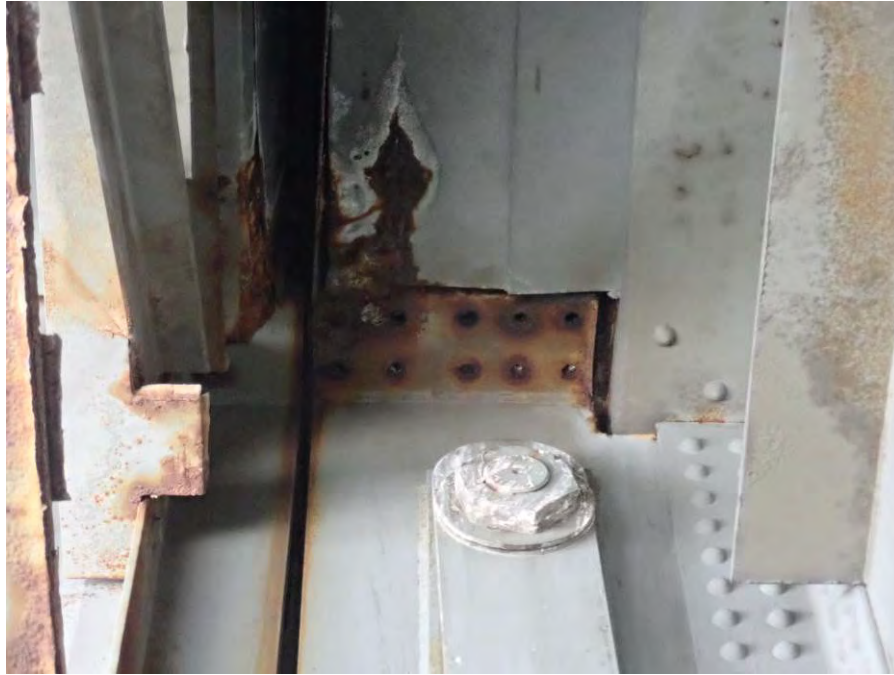
Photograph No. 37 – Girder Top Flange Connection Fasteners Missing above the Pin and Hanger Connections – Girder 16 at Bent 11 Shown, Looking North

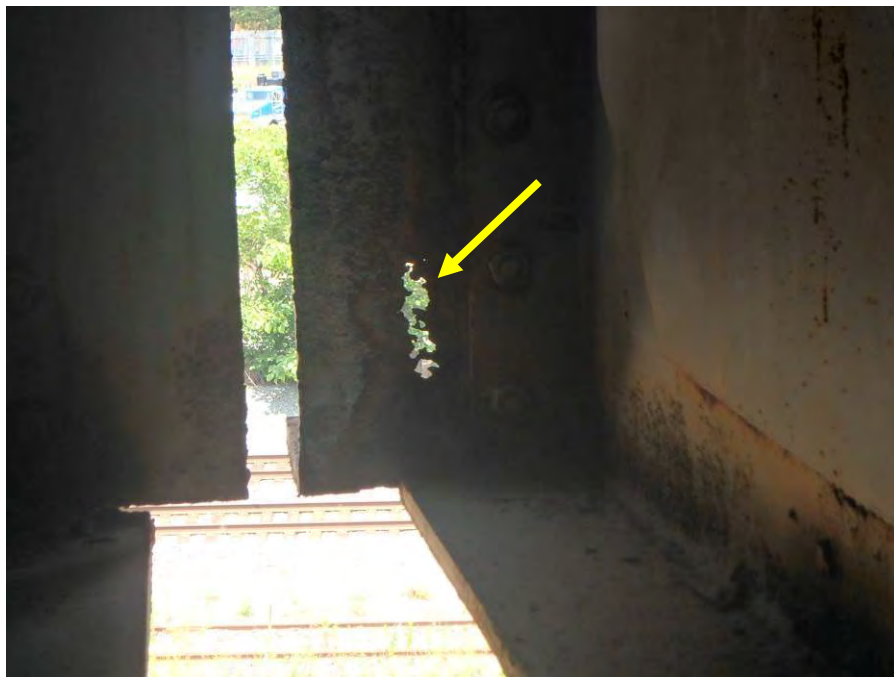
Photograph No. 38 – Corrosion Hole in the Web End of Girder 1 between the Cross Girders at Bent 4, Looking North

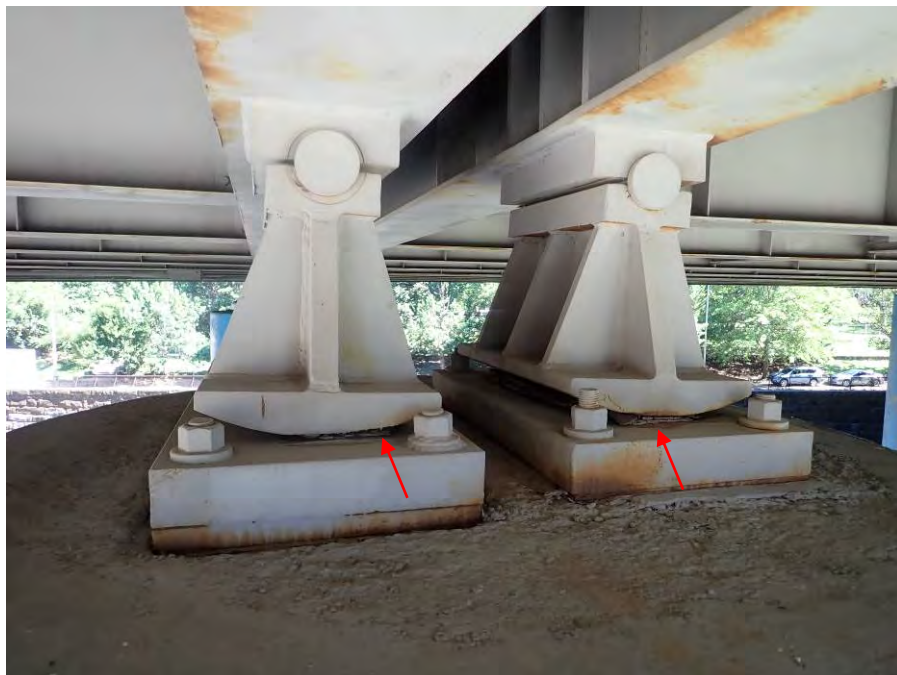
Photograph No. 42 – Bent 7, Typical Painted Over Crevice Corrosion Possibly Restricting Normal Rotation of Bearings

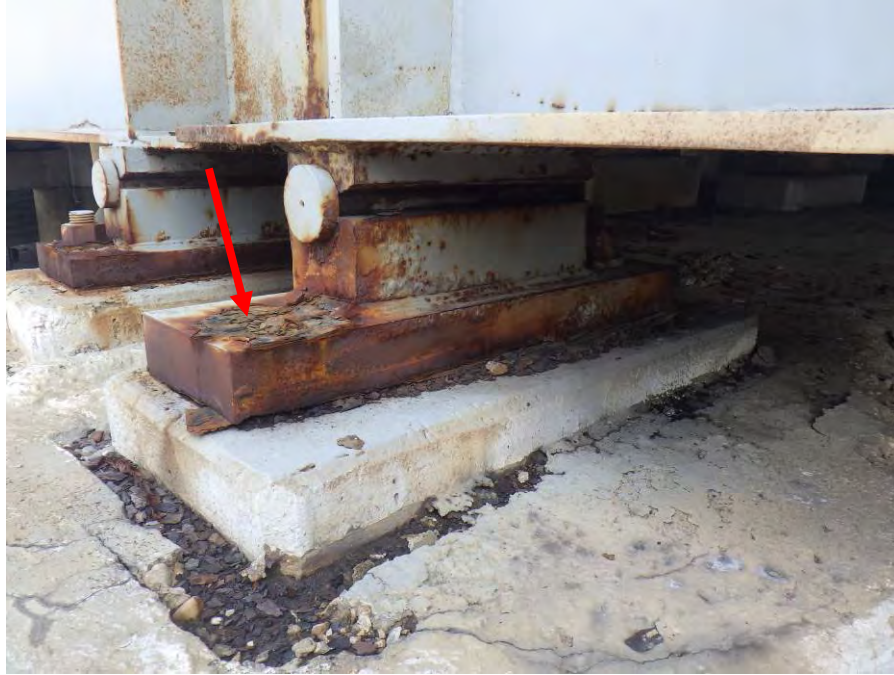
Photograph No. 43 – Fixed Bearing Anchor Bolt for Girder 20 at the West Pier is Broken/Missing (Arrow)

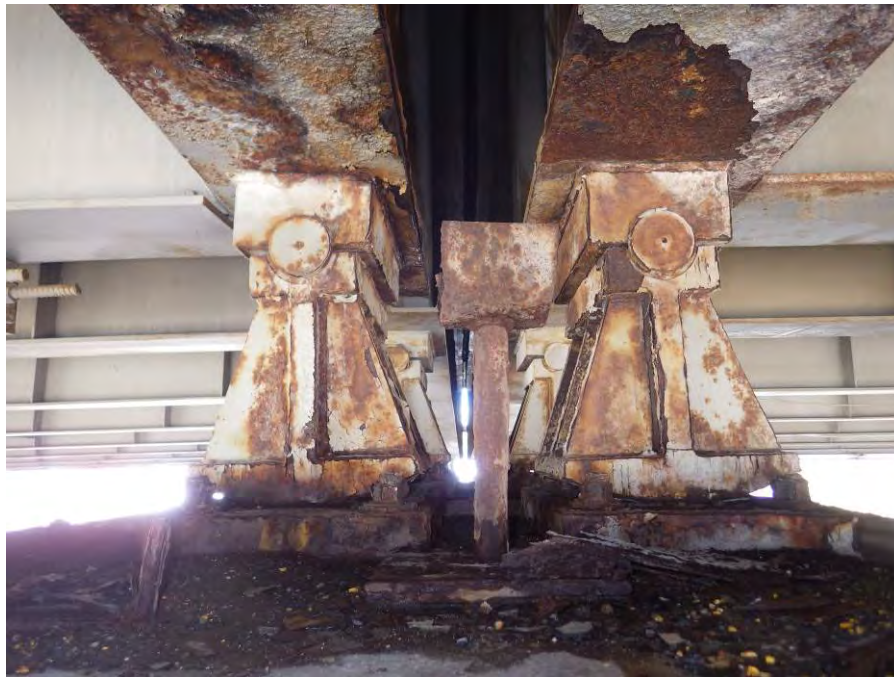
Photograph No. 44 – Moderate Section Loss on Bearing and Anchor Bolt Nuts of the Rocker Bearings (Column 2 of Bent 3 Shown, Looking North)

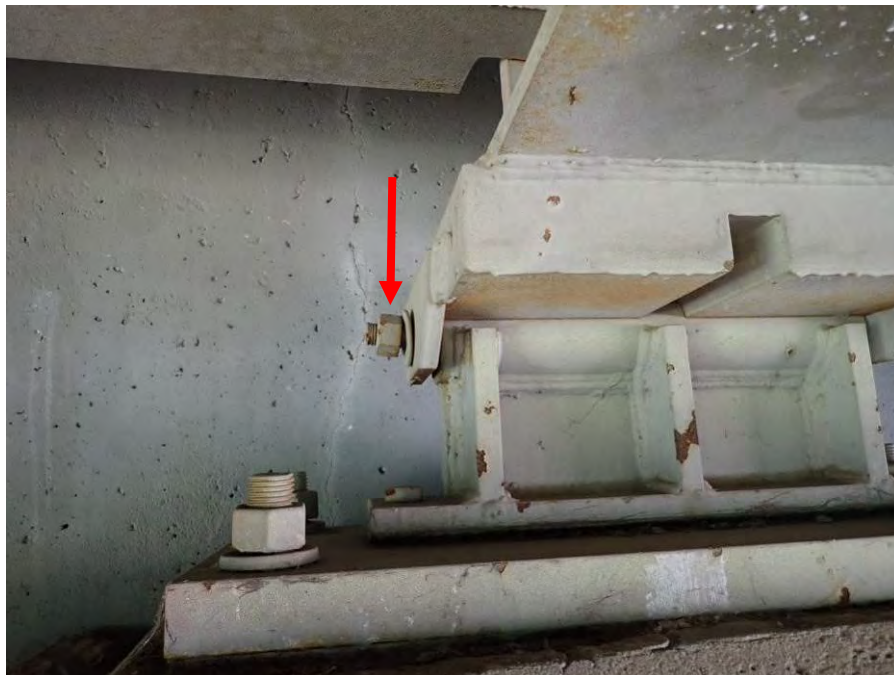
Photograph No. 48 – Bearing 3 at the East Abutment –
Loose Shoulder Rod with South Nut Backed Off 3/4" – North Nut Shown

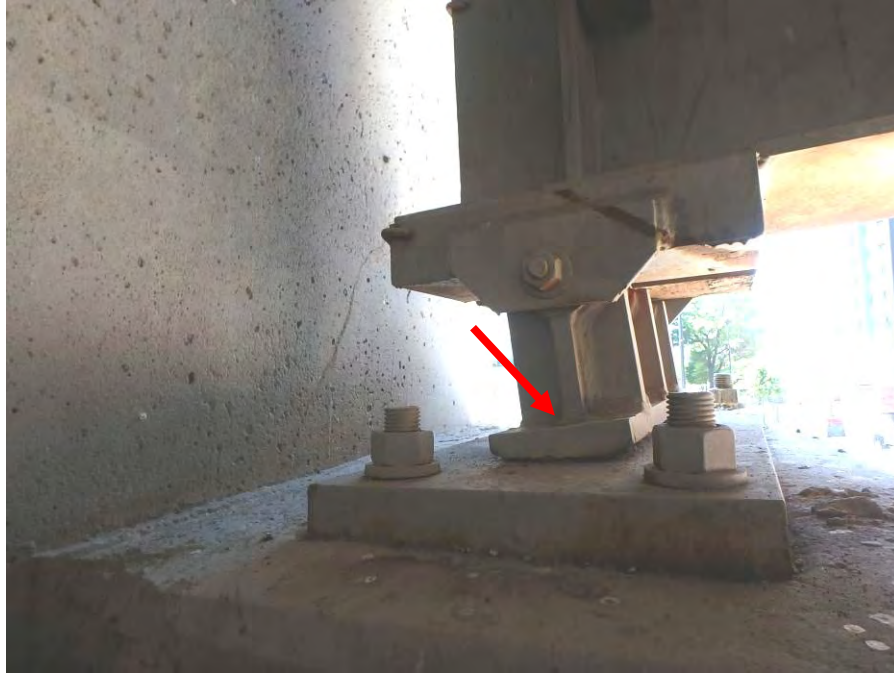
Photograph No. 49 – Bearing 15 at the East Abutment – North Anchor Bolt Broken/Missing (Arrow) and Bearing Leaning Excessively to the East

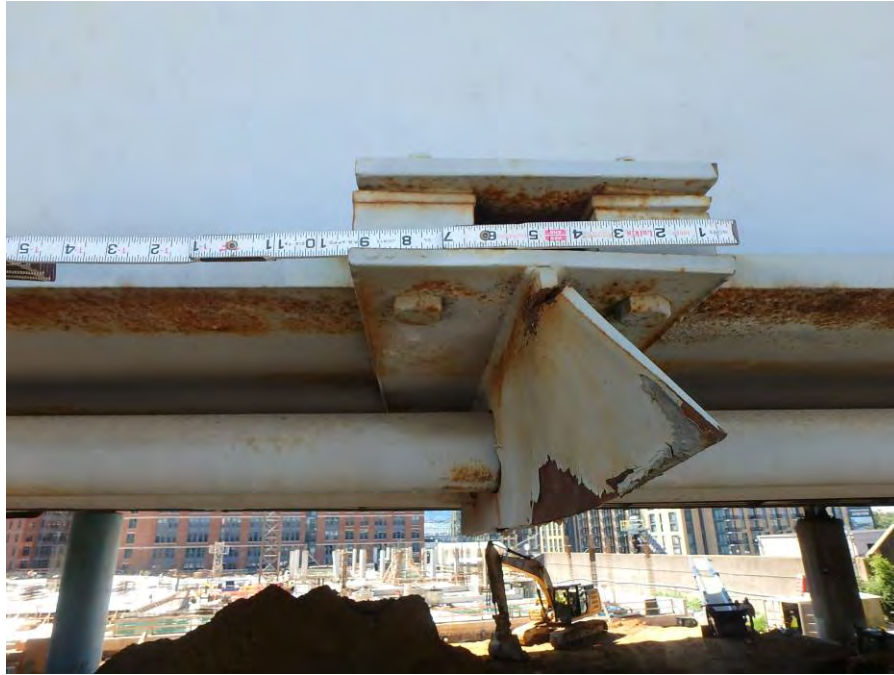
Photograph No. 51 – Post-Tension Reinforcement on Girder 1 in Span 4 – Impact Damage to the 4th Intermediate Support from the West End

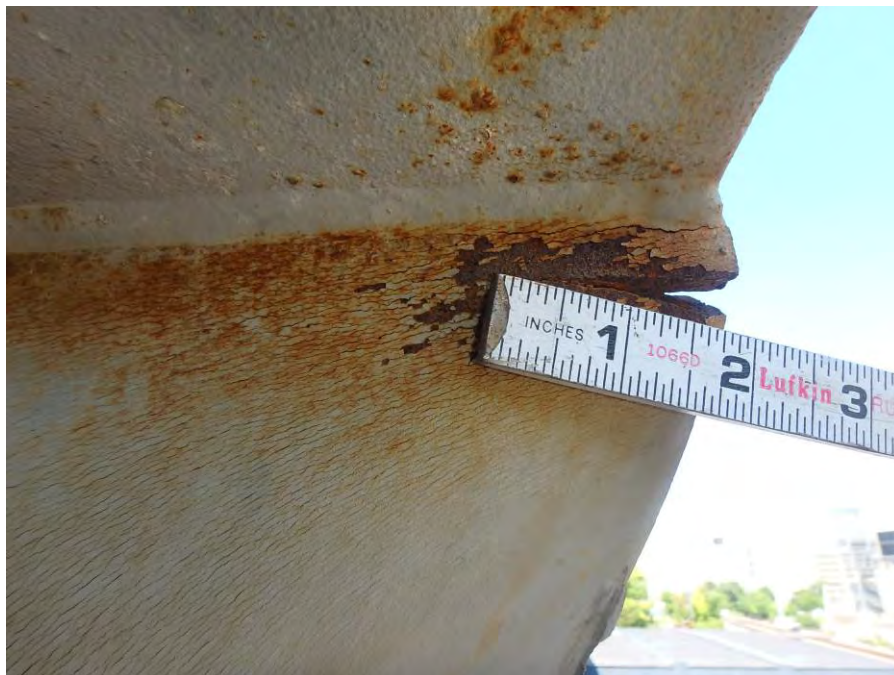
Photograph No. 52 – Girder 1, Span 4, Post-Tension Reinforcing System: 1 3/4" Long Crack in Vertical Portion of the 4th Intermediate Support from the West

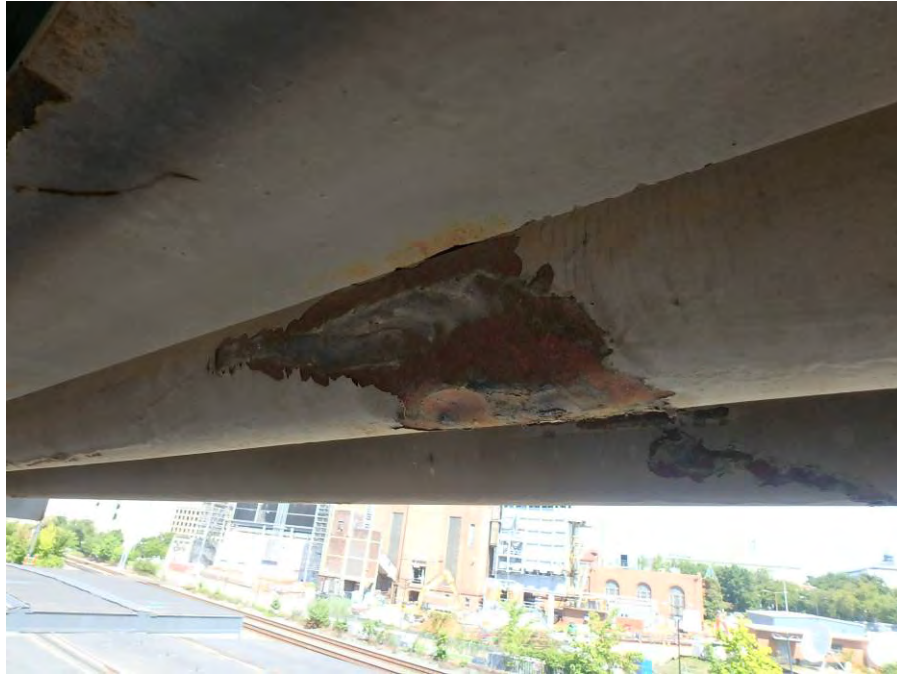
Photograph No. 53 – Girder 1, Span 4, Post-Tension Reinforcing System: Impact Damage to Sheathing

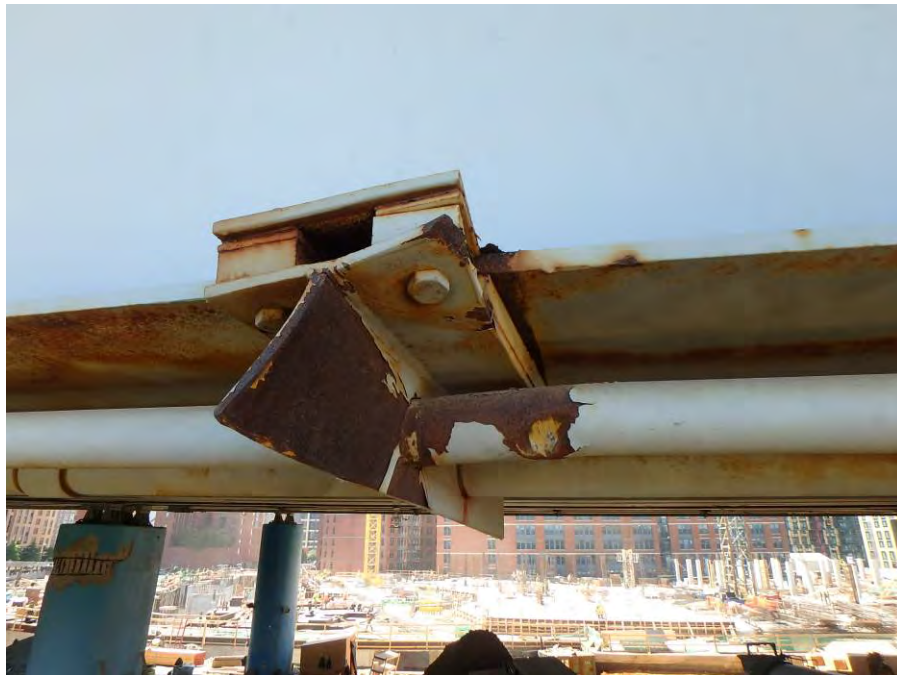
Photograph No. 54 – Impact Damage to the 3rd Intermediate Support from the West of the Post-Tension Reinforcement on Girder 1 in Span 5. Note Damage to Rod Sheathing

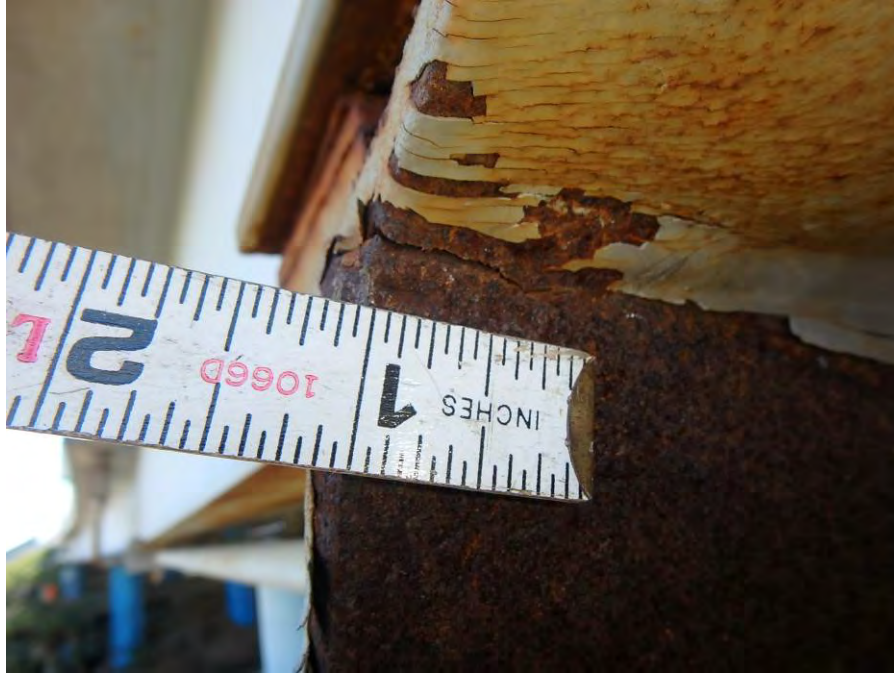
Photograph No. 55 – Girder 1, Span 5, Post-Tension Reinforcing System: 1 1/8" Long Crack in Vertical Leg of the 3rd Intermediate Support from the West

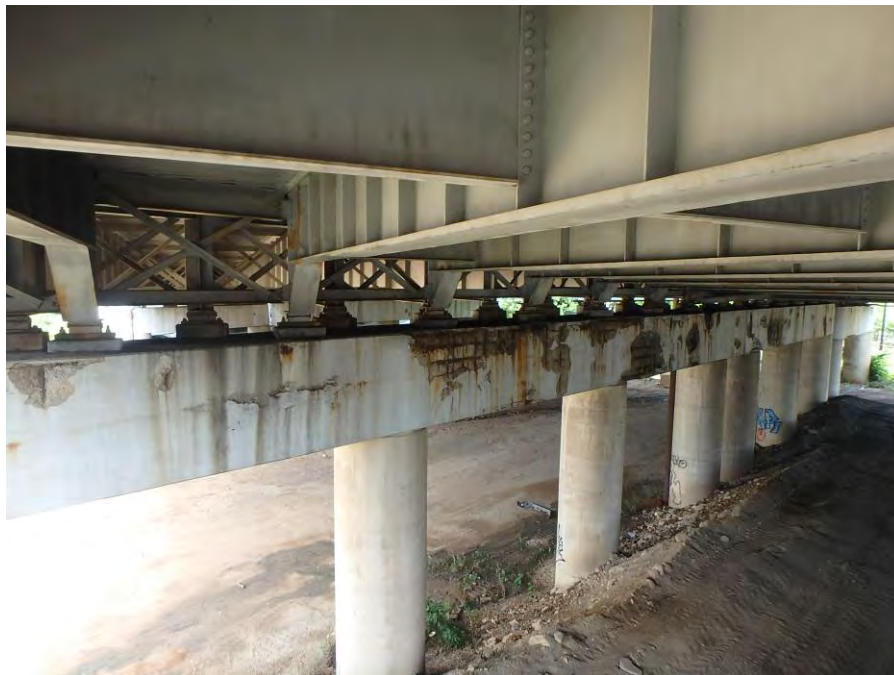
Photograph No. 56 – East Face of the West Pier with Numerous Cracks and Spalls with Exposed Corroded Reinforcing Steel

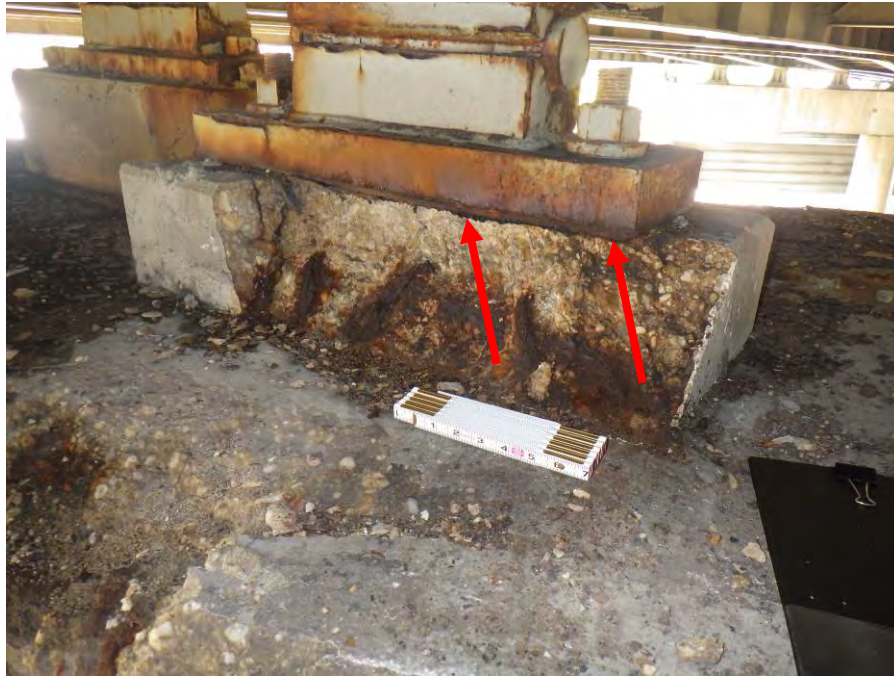
Photograph No. 57 – 23” Long x 6 3/4” High x Up to 5” Deep Spall with Exposed Reinforcing Steel Undermining the Masonry Plate (Arrows) in the Northeast Corner of the Girder 16 Bearing Pedestal at the West Pier

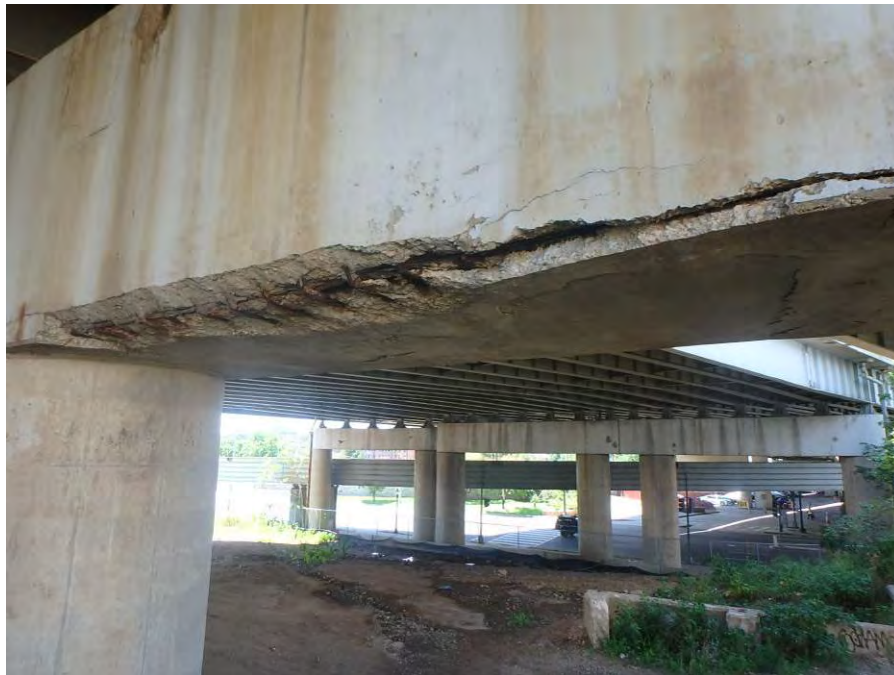
Photograph No. 58 – 14'-6” Wide x 12” High x 3'-0” Under Delamination/Spall with Exposed Corroded Reinforcing Steel and a 1/8” Wide Horizontal Crack in the West Pier Cap at the North Ramp Section

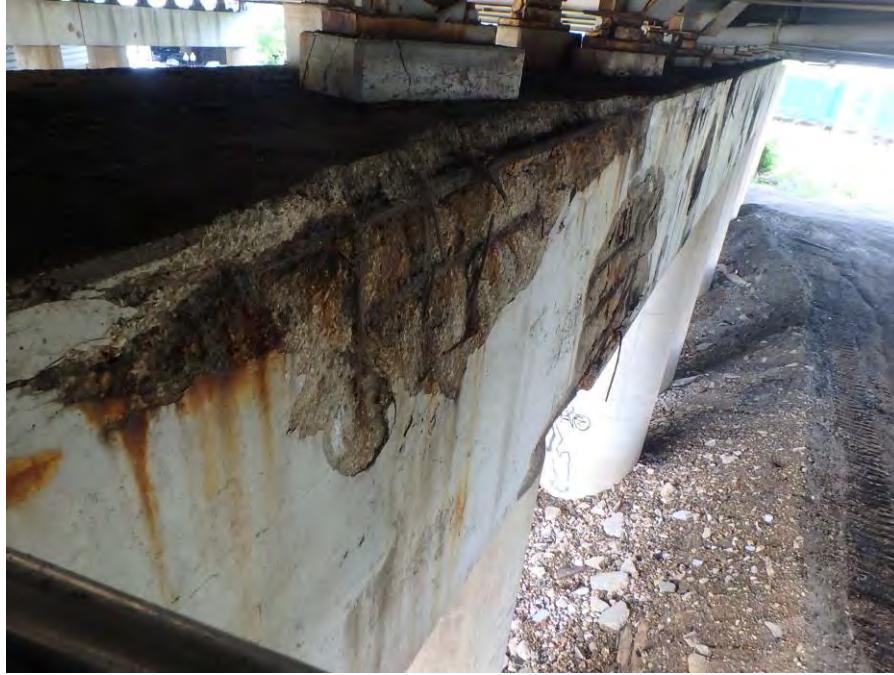
Photograph No. 59 – Spalls with Exposed Corroded Reinforcing Steel in the East Face of the West Pier below Girders 15 through 17, Looking Northwest
