DISTRICT DEPARTMENT OF TRANSPORTION

BRIDGE INSPECTION MANUAL

August 2021

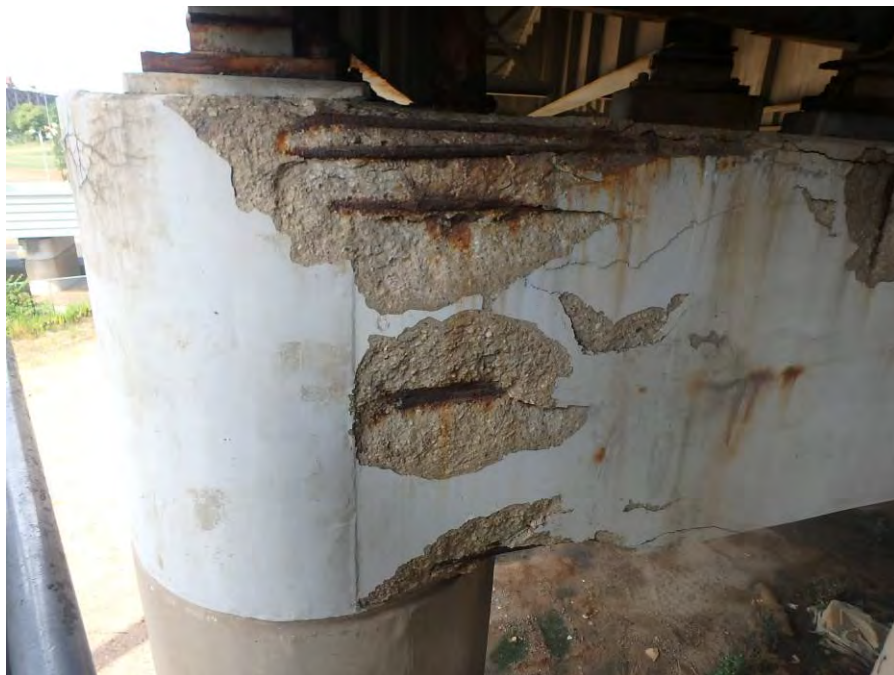
Photograph No. 60 – Spalls with Exposed Corroded Reinforcing Steel in the East Face of the West Pier at the South End

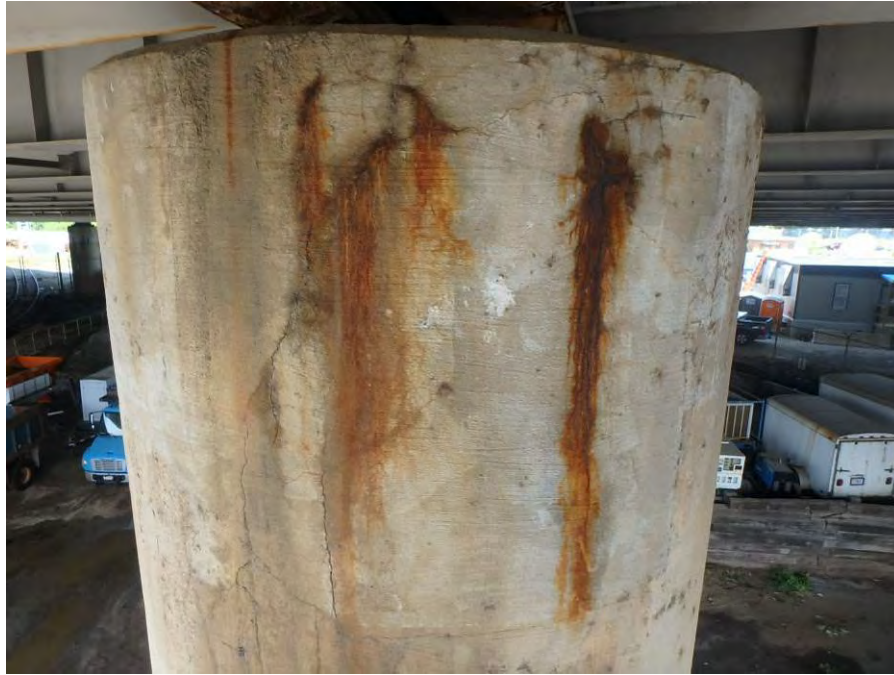
Photograph No. 61 – Bent 2, Column 4 – Cracking with Corrosion Staining near Top of Column

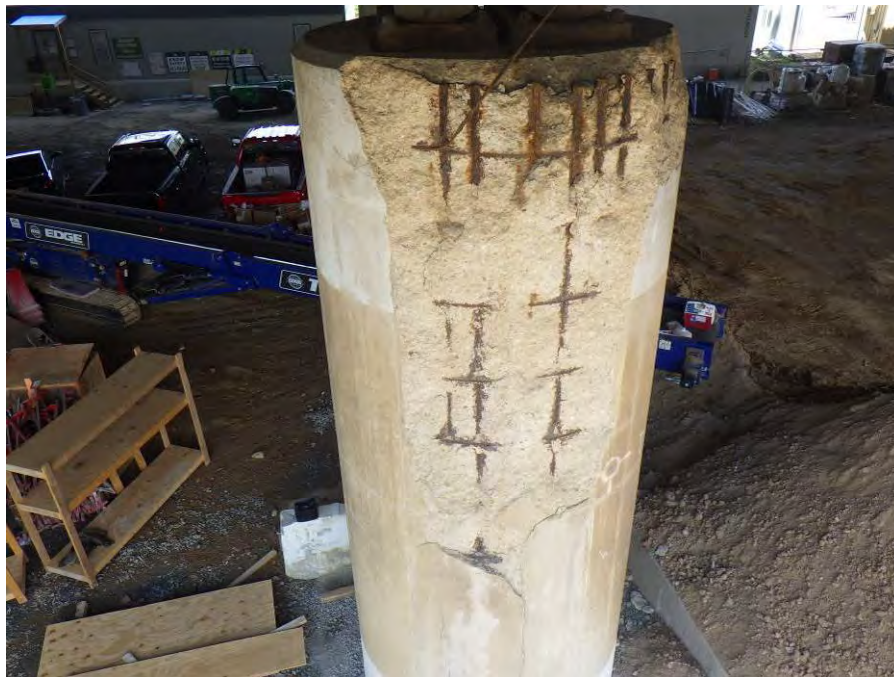
Photograph No. 62 – Bent 3, Column 3, South Face – Up to 3'-0" Wide x 10'-0" High x Up to 8" Deep Spall/Delamination with Exposed Corroded Reinforcing Steel

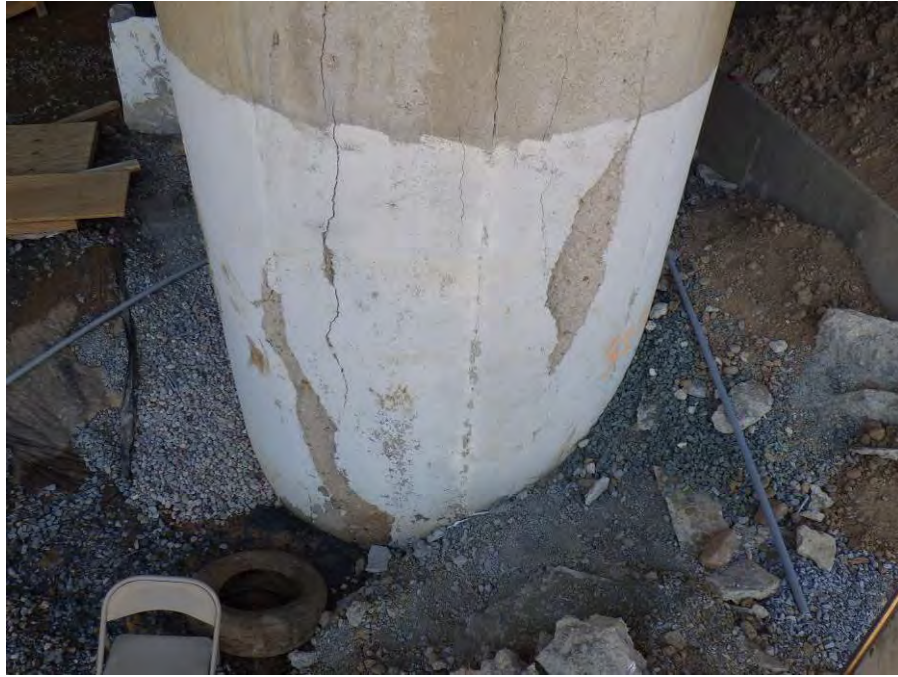
Photograph No. 63 – Bent 3, Column 3, South Face – 6'-0" High x 3'-0" Wide x Up to 2" Deep Spalled/Delaminated Area at Base

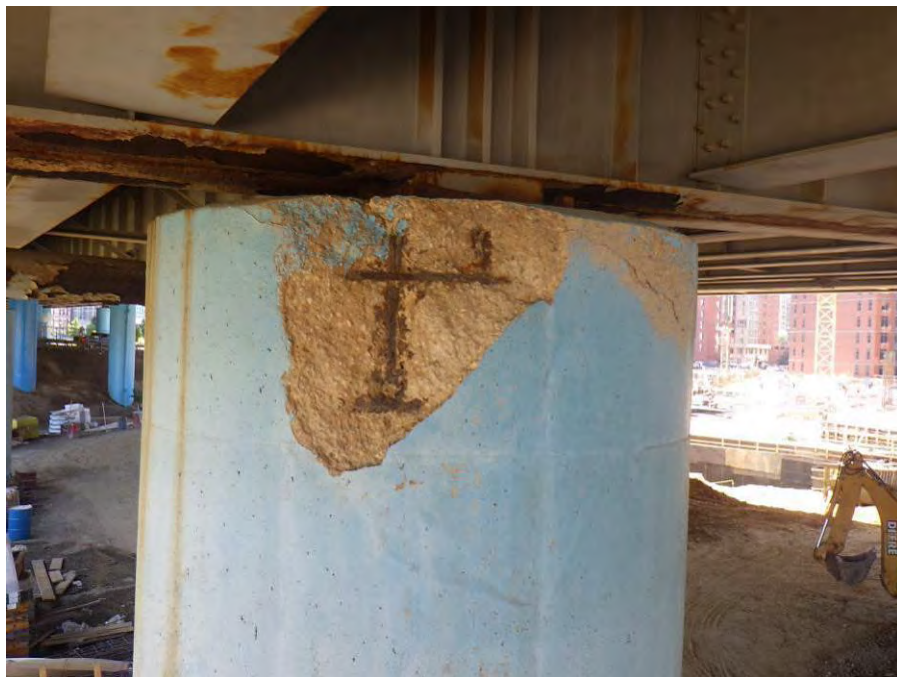
Photograph No. 64 – Bent 4, Column 1, West Face – Unsound /Spalled Area of Concrete at the Top of the Column

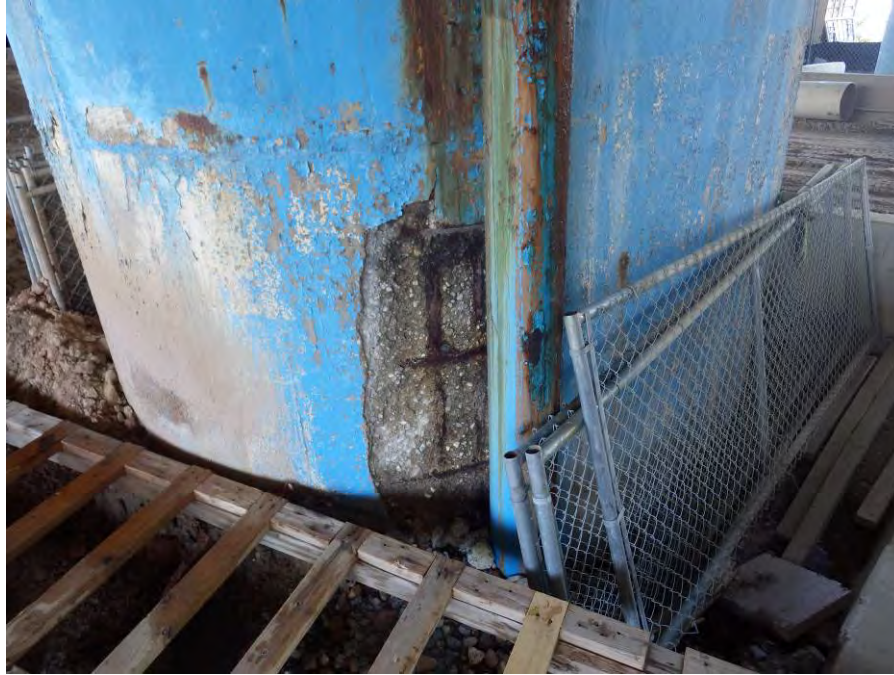
Photograph No. 65 – Bent 4, Column 2, 24” Wide x 6’-0” High x Up to 2 1/2” Deep Spall with Exposed Corroded Reinforcing Steel at the Base of the East Face behind the Drain Pipe

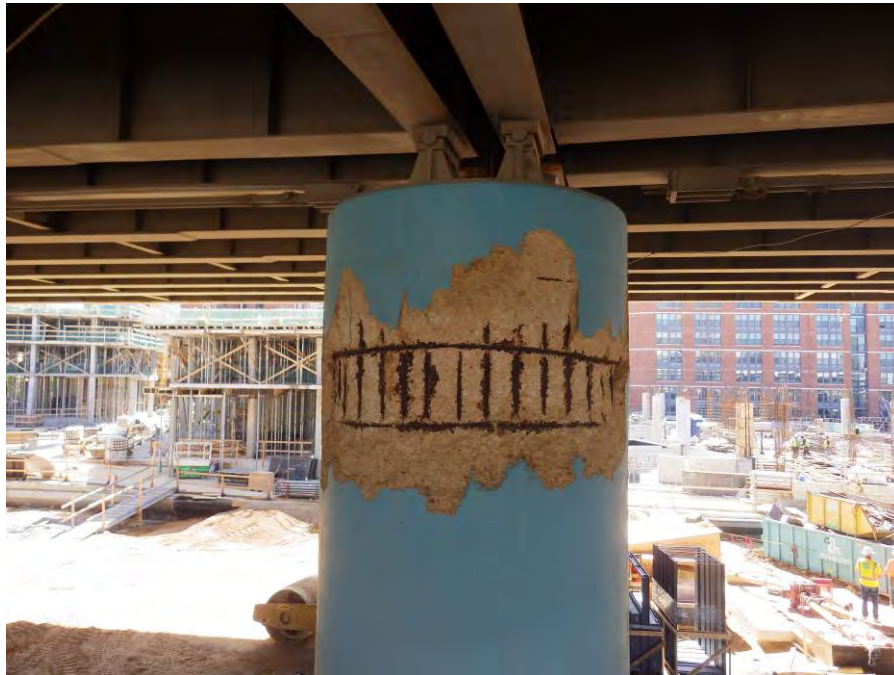
Photograph No. 66 – Bent 5, Column 2, North Face – 5’-0” High x 12’-0” Wide x Up to 4” Deep Area of Spalled/Delaminated Concrete with Exposed Corroded Reinforcing Steel

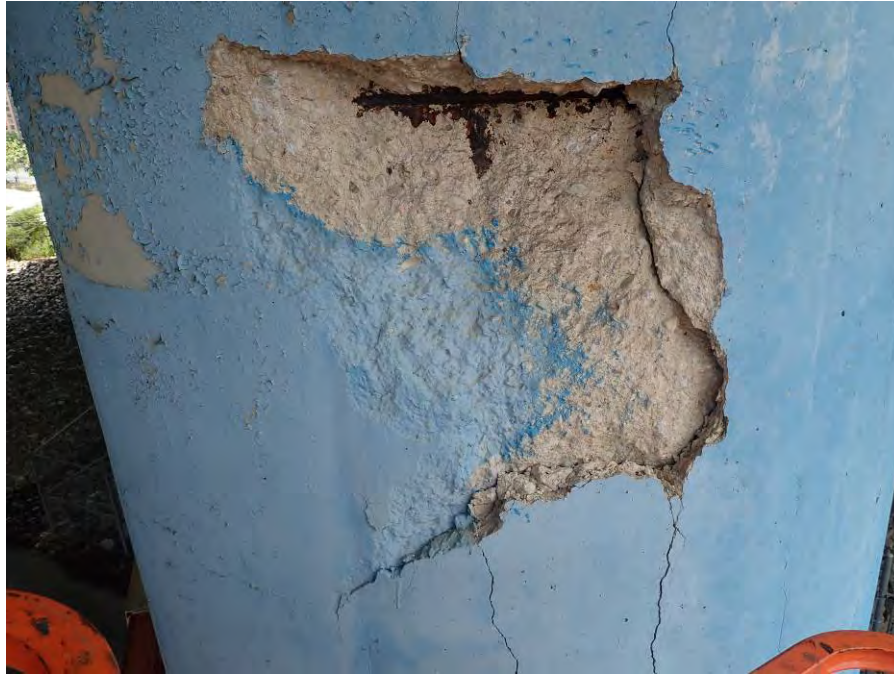
Photograph No. 67 – Bent 7, Column 1, 4'-0" Wide x 7'-0" High x Up to 4" Deep Spalled/Unsound Area with Exposed Corroded Reinforcing Steel in the North Face at the Top of the Column

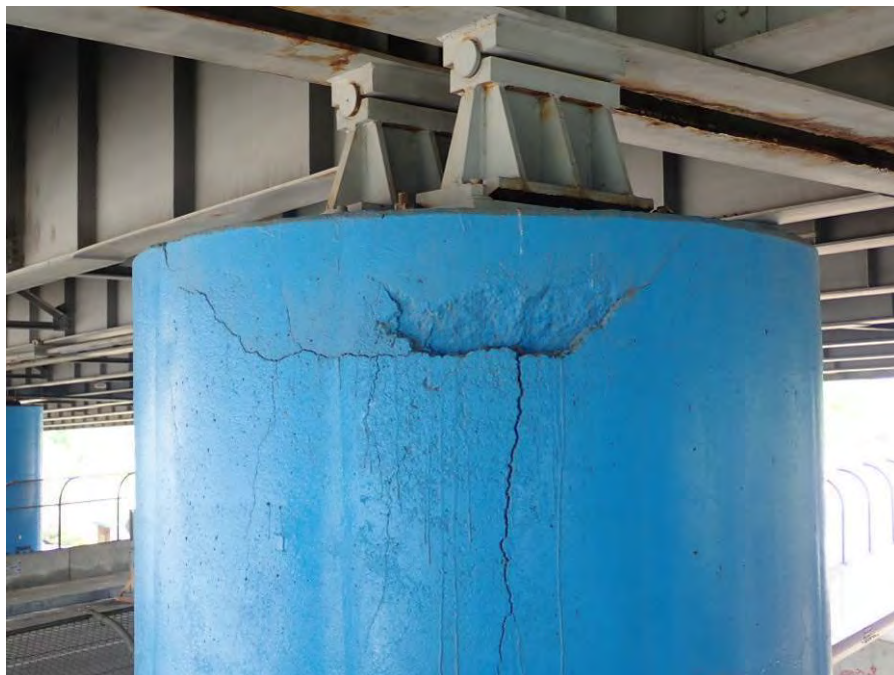
Photograph No. 68 – Bent 7, Column 3, Southeast Face – Area of Unsound Concrete with a 24" Wide x 7" High x 3" Deep Spall

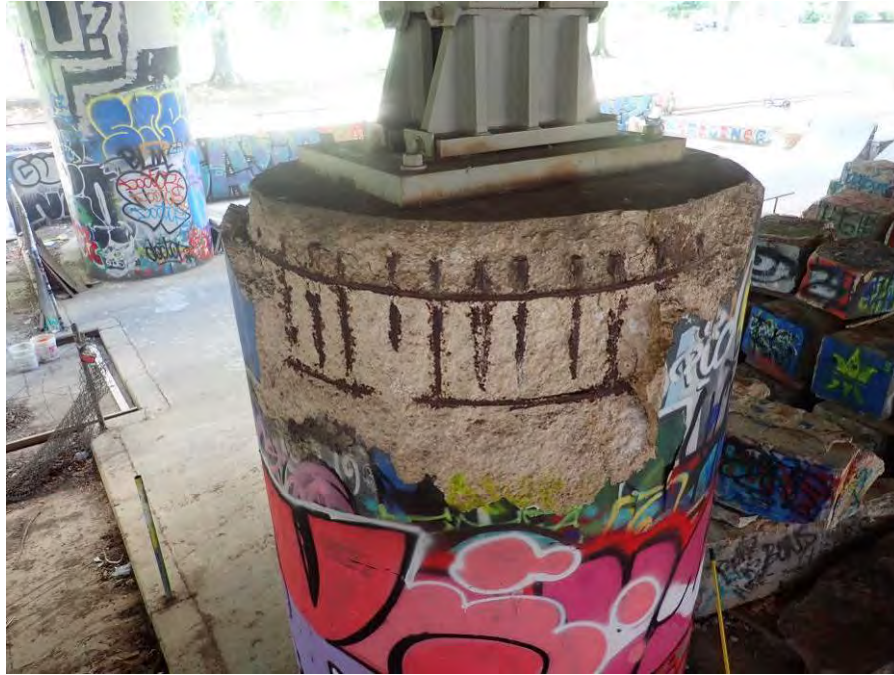
Photograph No. 69 – Bent 11, Column 1, South and West Faces –
Unsound and Spalled Concrete with Exposed Corroded Reinforcing Steel

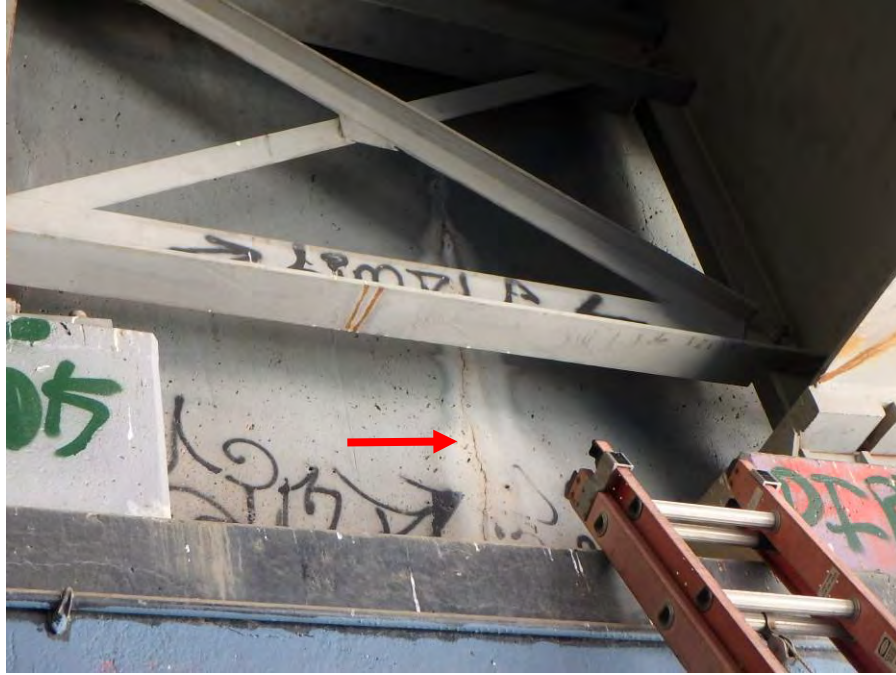
Photograph No. 71 – Typical Vertical Hairline Crack with Efflorescence in the East Abutment Backwall (Arrow), Bay 13 Shown

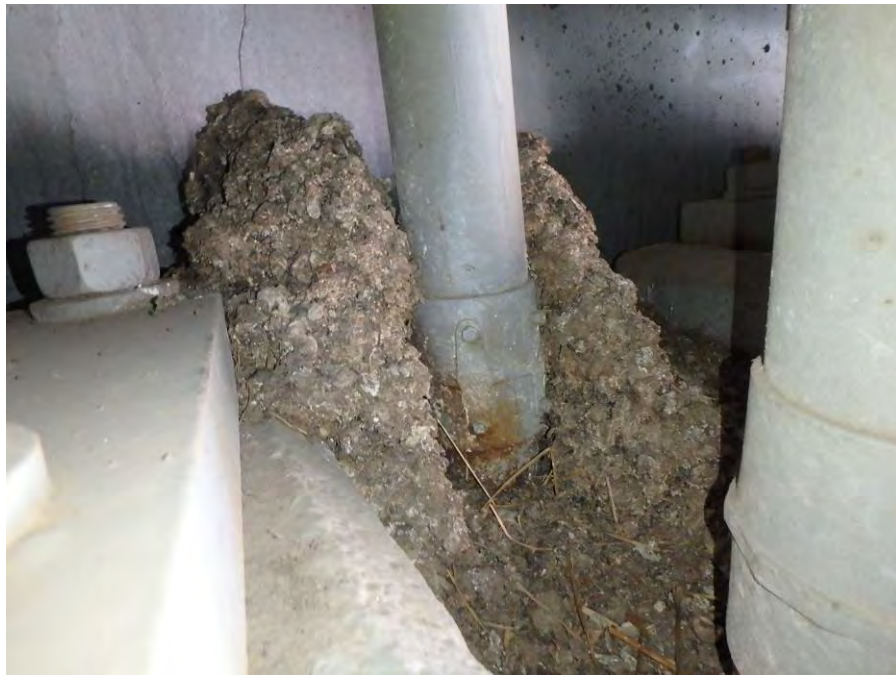
Photograph No. 72 – Significant Debris Accumulation on the East Abutment Bridge Seat in Bay 8

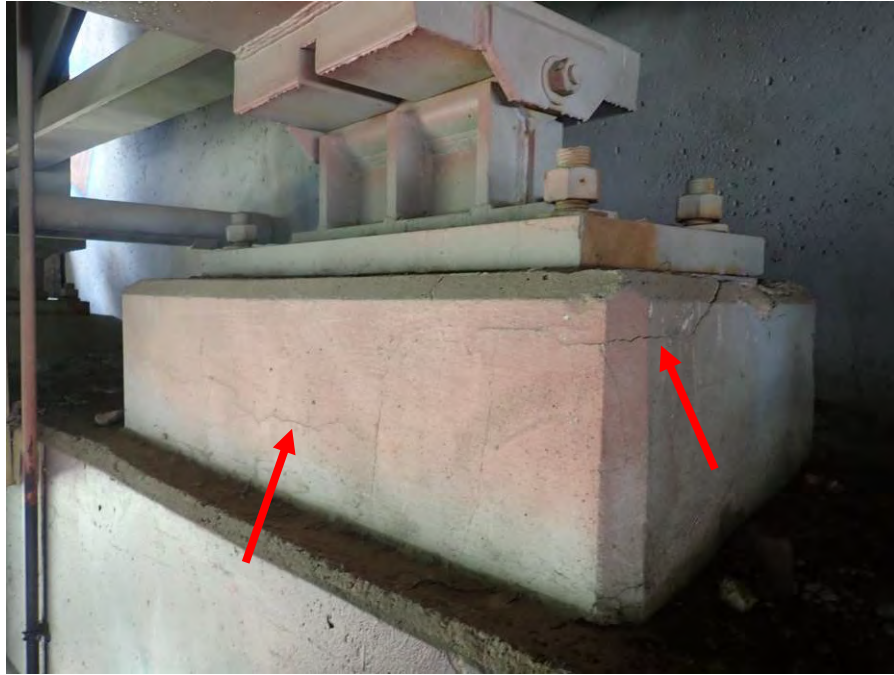
Photograph No. 73 – Typical Hairline Cracks in Concrete Repairs to East Abutment Pedestals (Arrows) – West Side of Girder 2 Shown

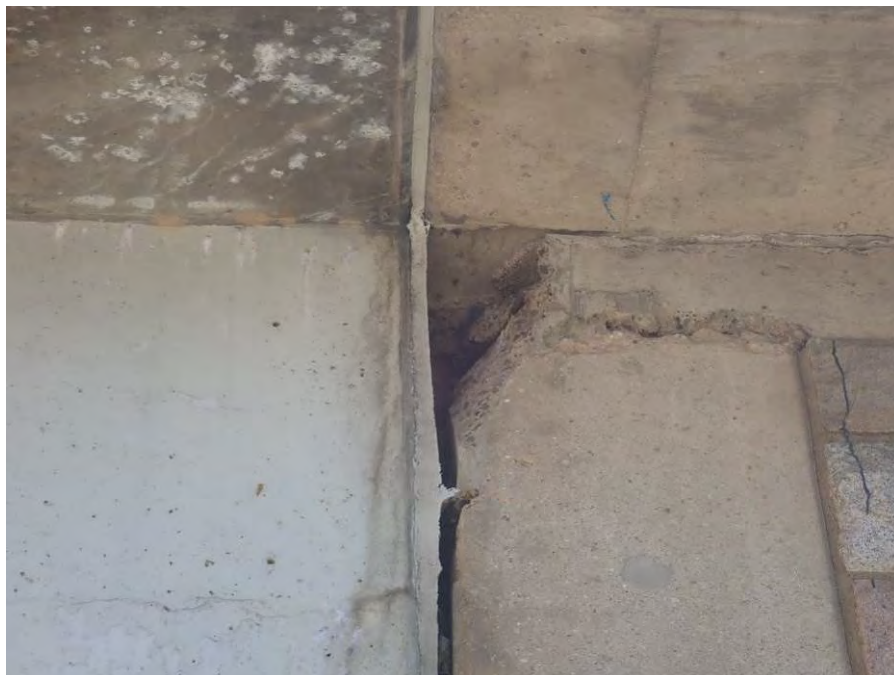
Photograph No. 74 – 18” High x 9” Wide x Up to 10” Deep Spall at the Top of the Southeast Wingwall

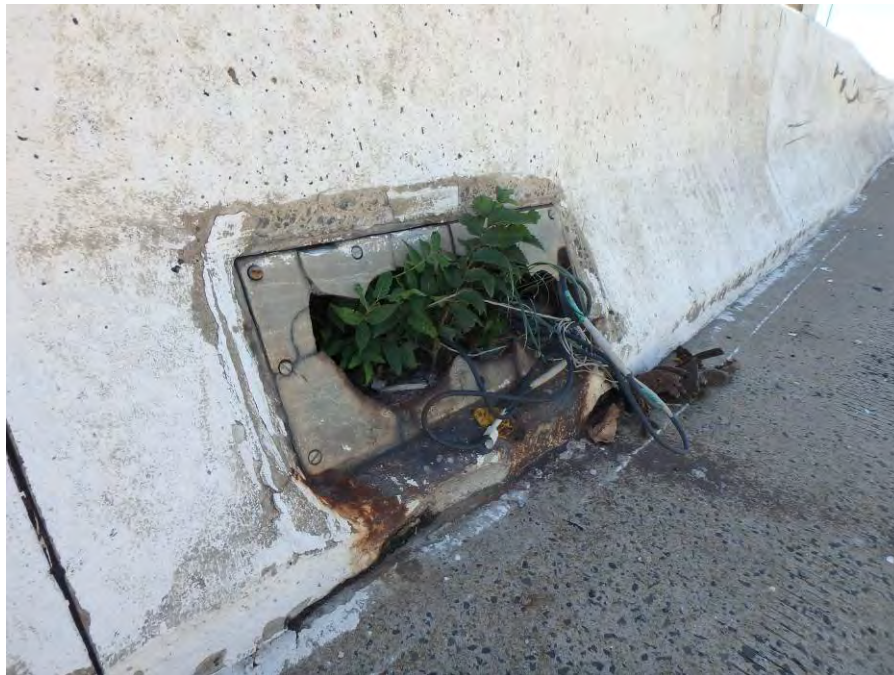
Photograph No. 78 – Span 10, Broken Electrical Access Panel Cover in the North Face of the Median Beneath the Eastbound Sign Structure

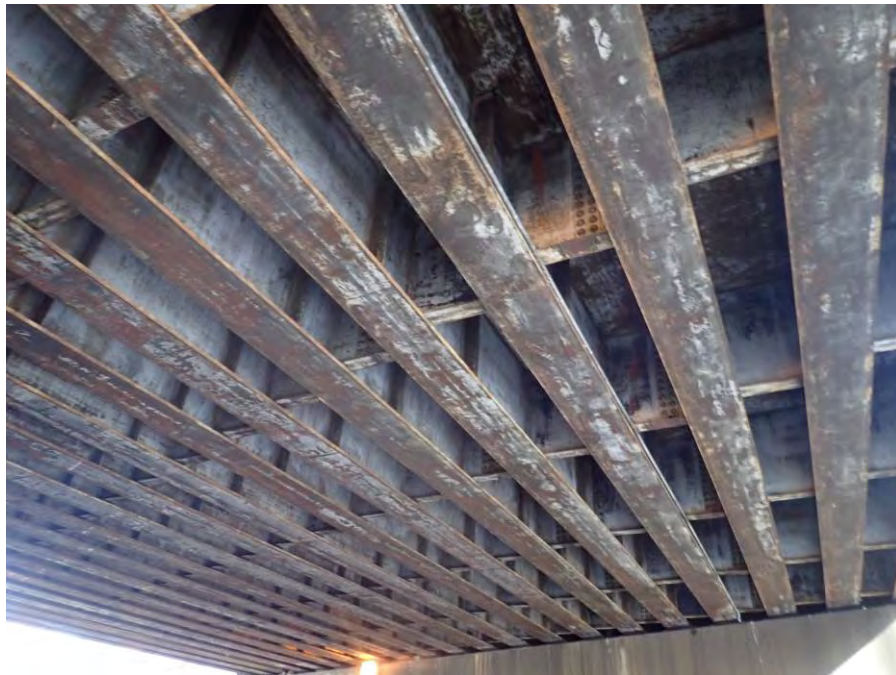
Photograph No. 6 – Typical Superstructure with Deteriorated Paint and Minor Corrosion

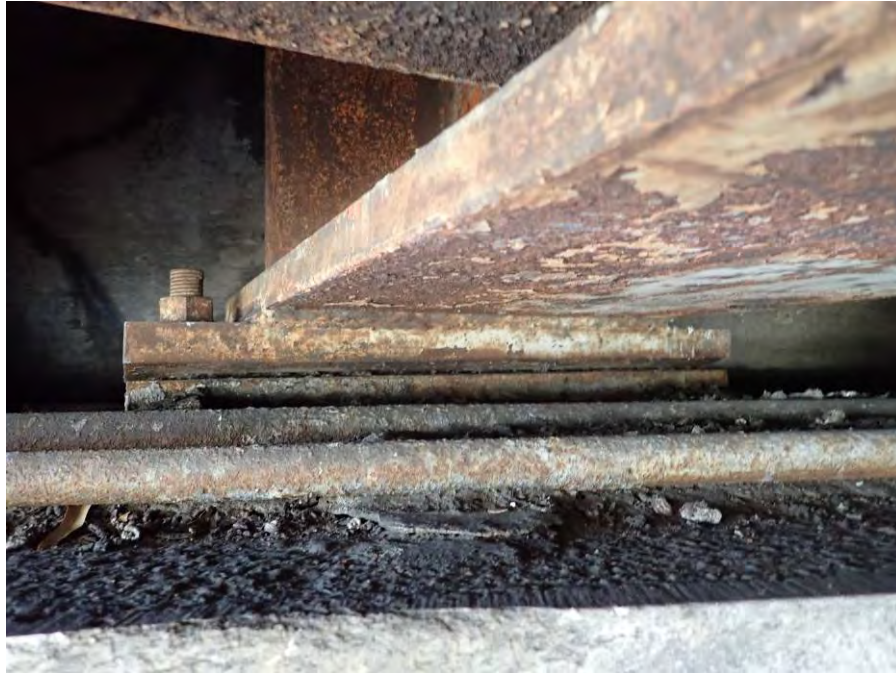
Photograph No. 9 – Typical East Abutment Bearing. Note Deteriorated Paint and Minor Corrosion. Bearing 2 Shown

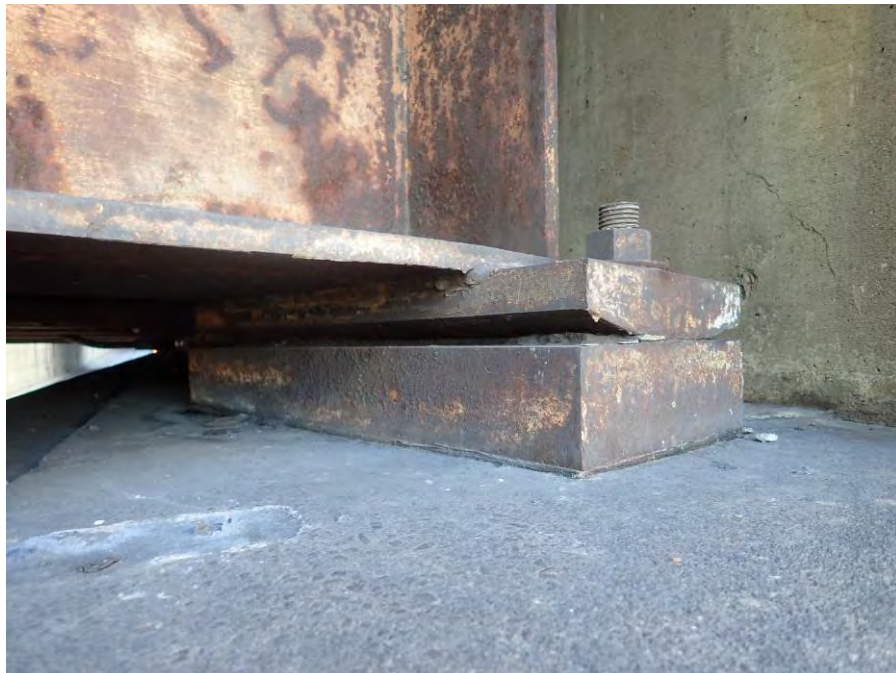
Photograph No. 10 – Typical West Abutment Bearing. Note Deteriorated Paint and Minor Corrosion. Bearing 1 Shown

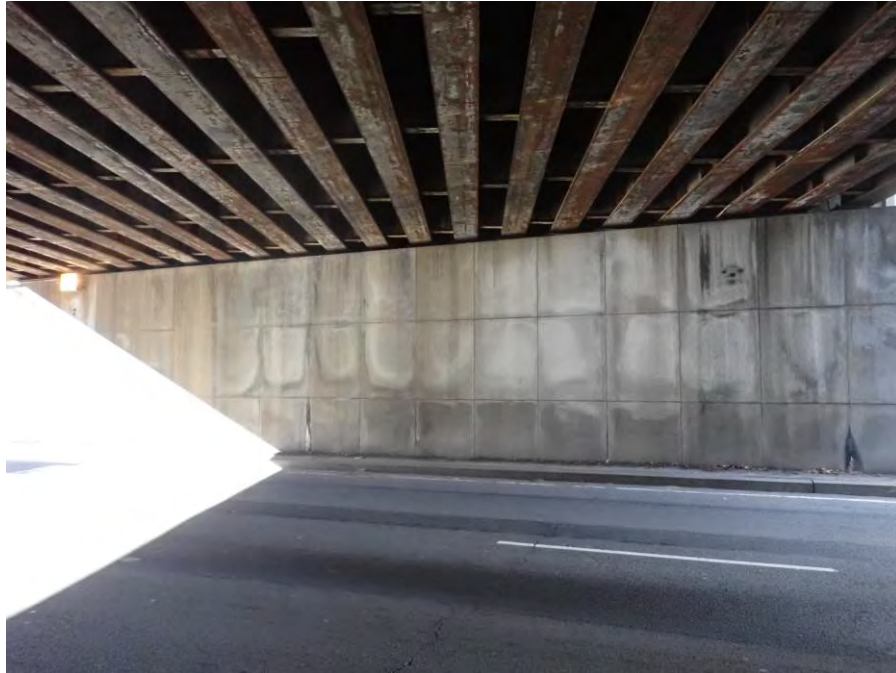
Photograph No. 11 – General View of the West Abutment. Note Typical Staining

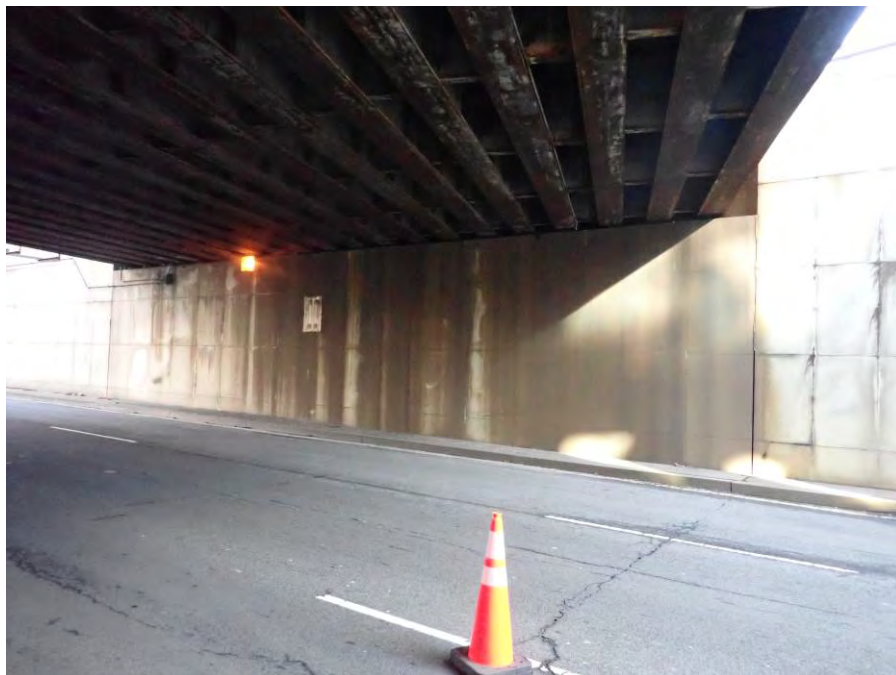
Photograph No. 12 – General View of the East Abutment. Note Typical Staining

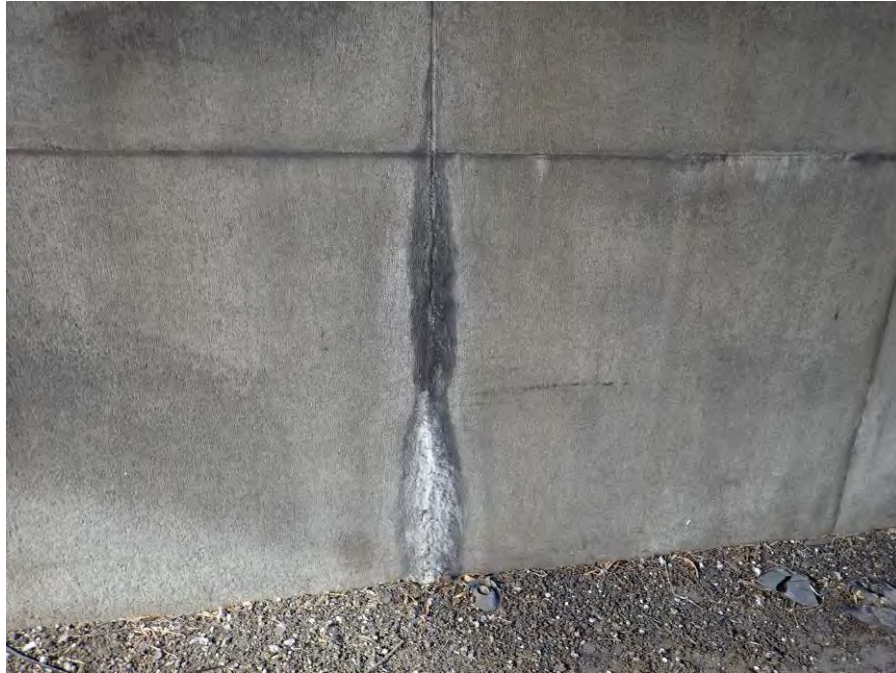
Photograph No. 17 – Cracked Mortar with Efflorescence in the West Abutment Stem

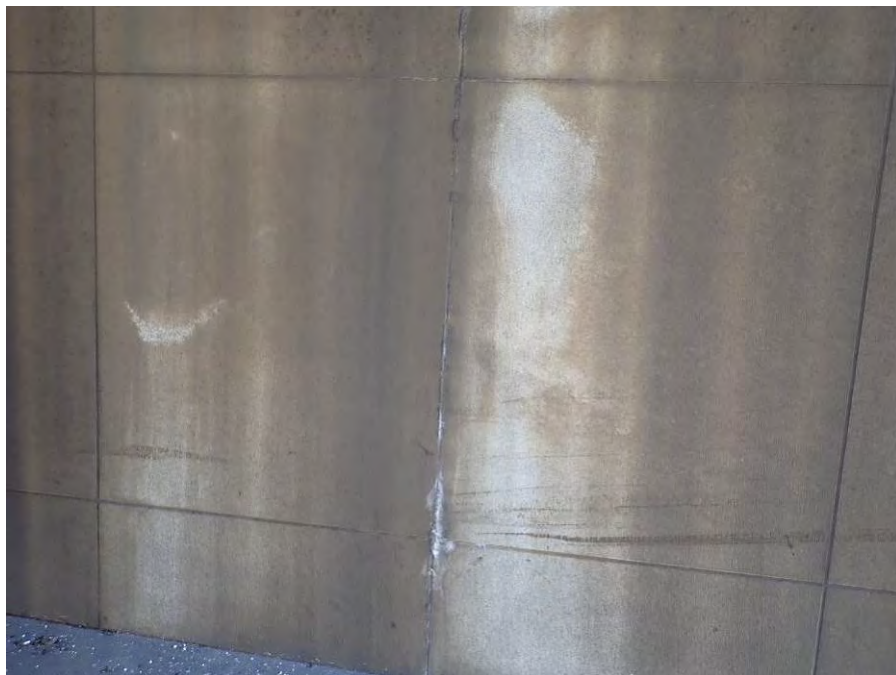
Photograph No. 18 – Cracked Mortar with Efflorescence in the East Abutment Stem

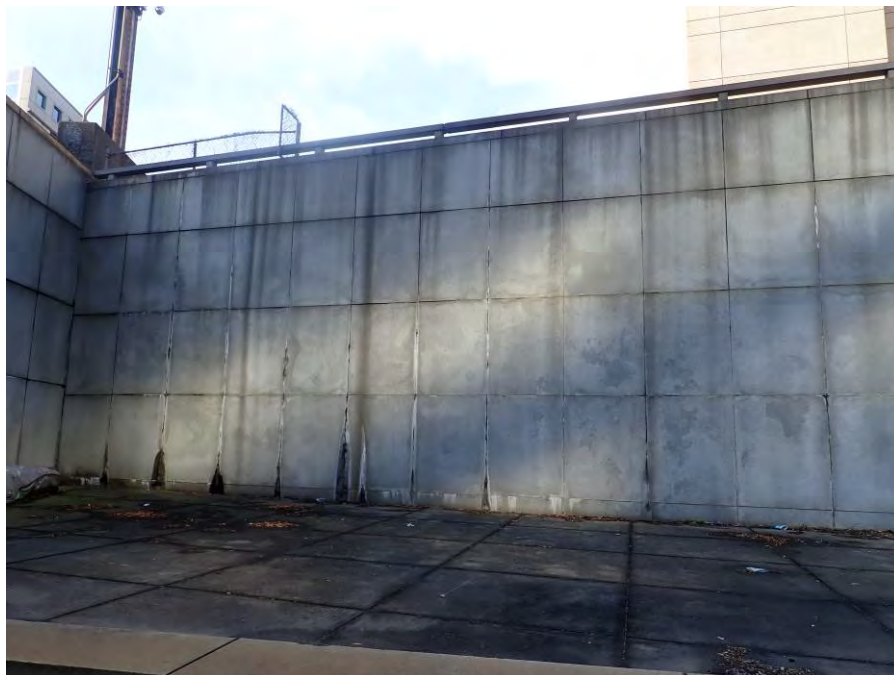
Photograph No. 20 – Northwest Wingwall.
Note Mortar Cracking with Efflorescence

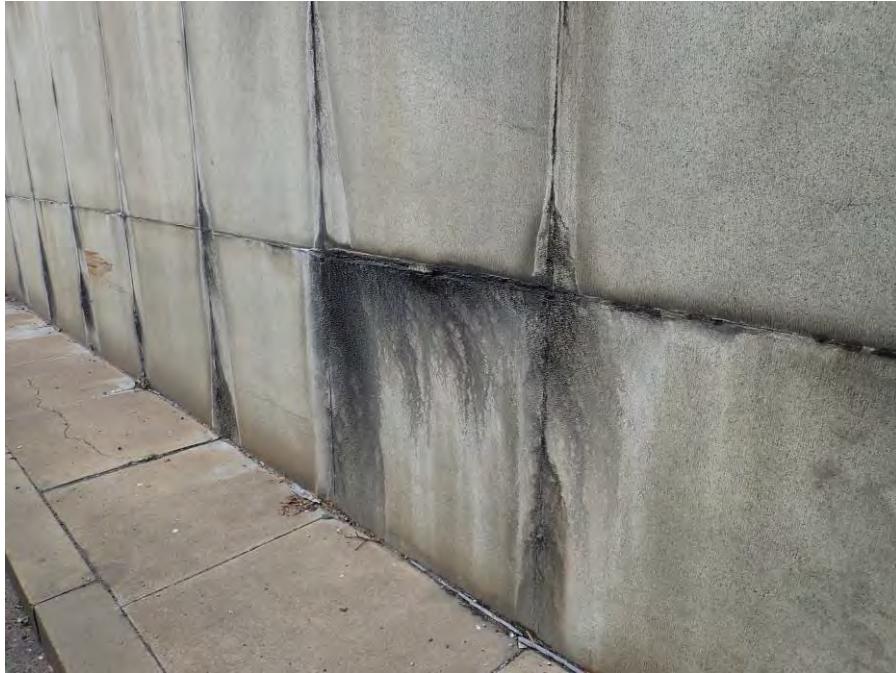
**Photograph No. 21 – Southwest Wingwall.
Note Mortar Cracking with Efflorescence**

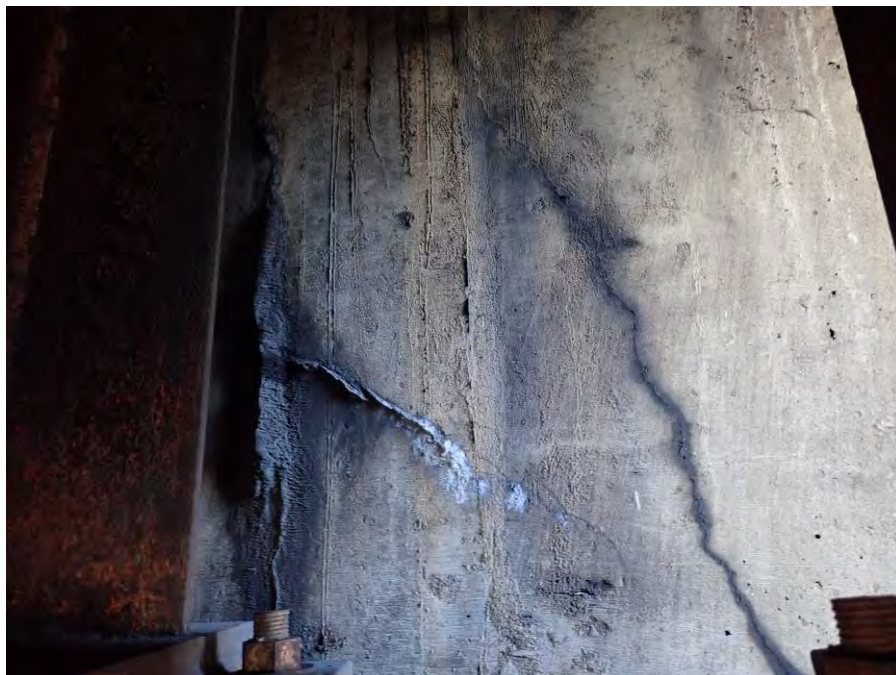
**Photograph No. 22 – Typical Hairline Cracks in the
West Abutment Backwall. Bay 1 Shown**

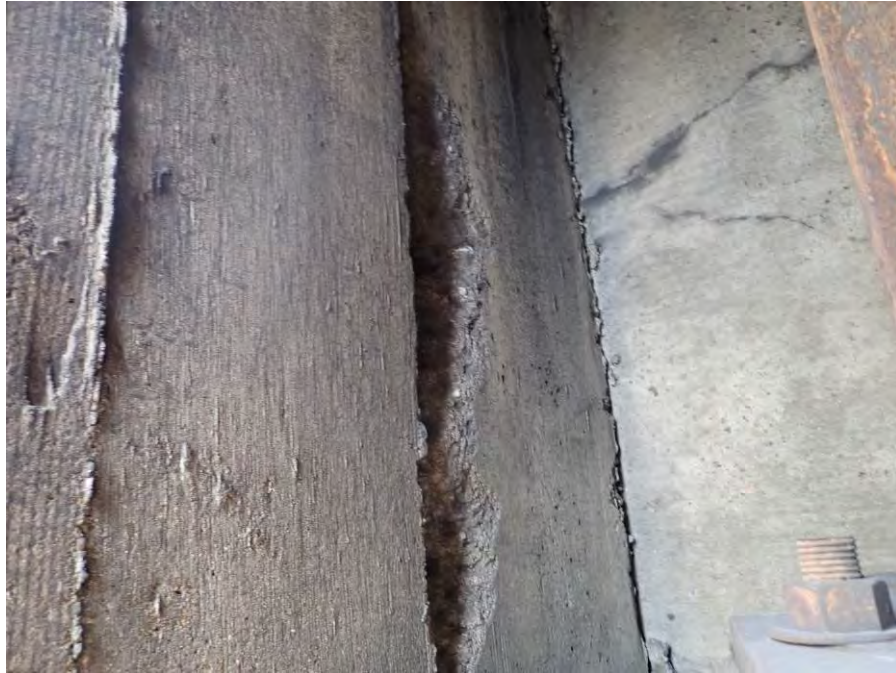
Photograph No. 25 – 2'-4" High x 6" Wide x Up to 3 3/4" Deep Spall in the South Face of the Northeast Wingwall

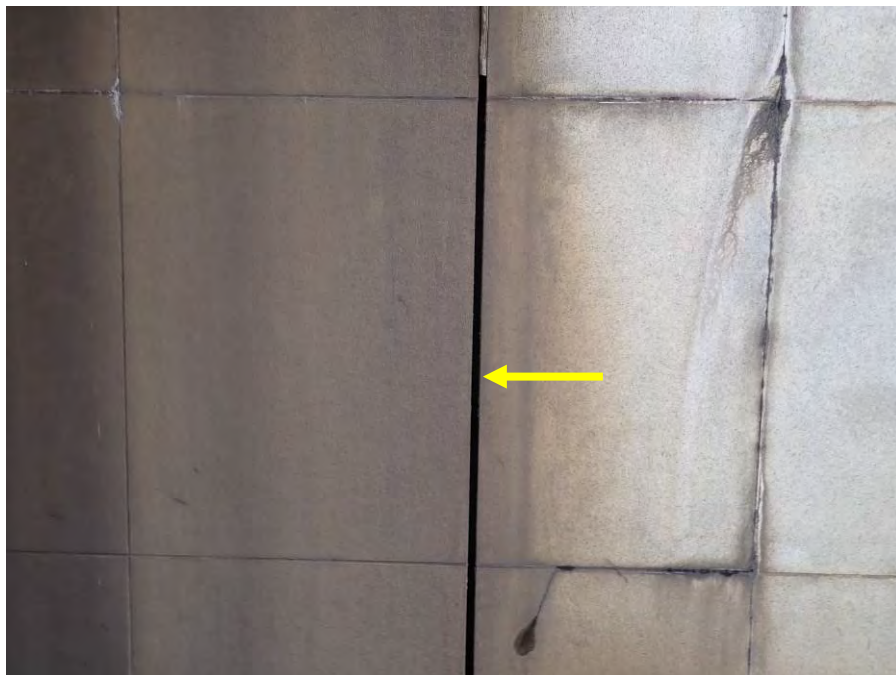
Photograph No. 26 – Typical Missing/Deteriorated Abutment to Wingwall Joint Material. Southeast Wingwall Shown

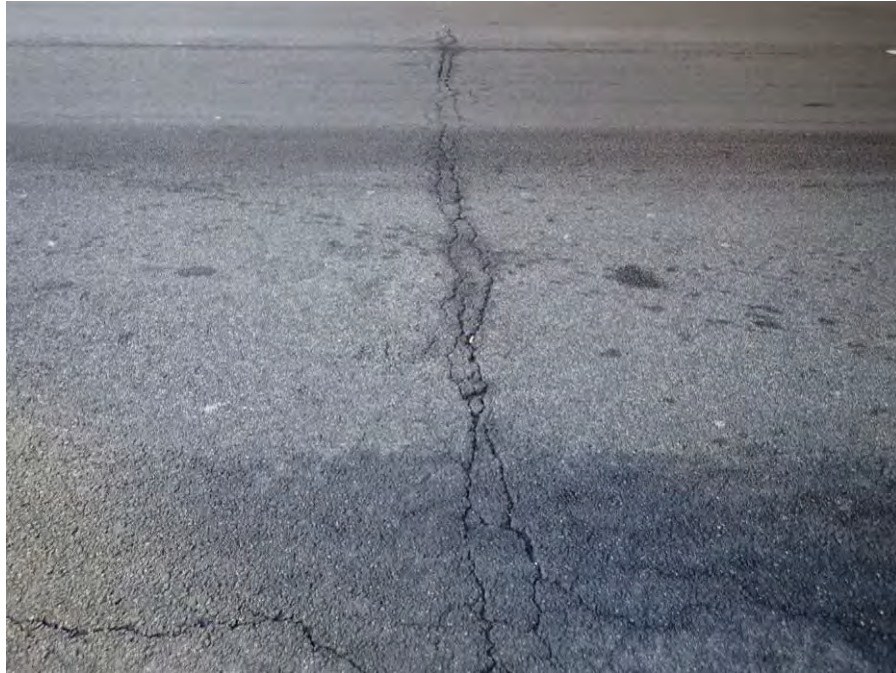
Photograph No. 29 – Up to 1/4" Wide Transverse Crack Spanning the Full-Width of the Roadway at the North End of the Bridge, Looking East

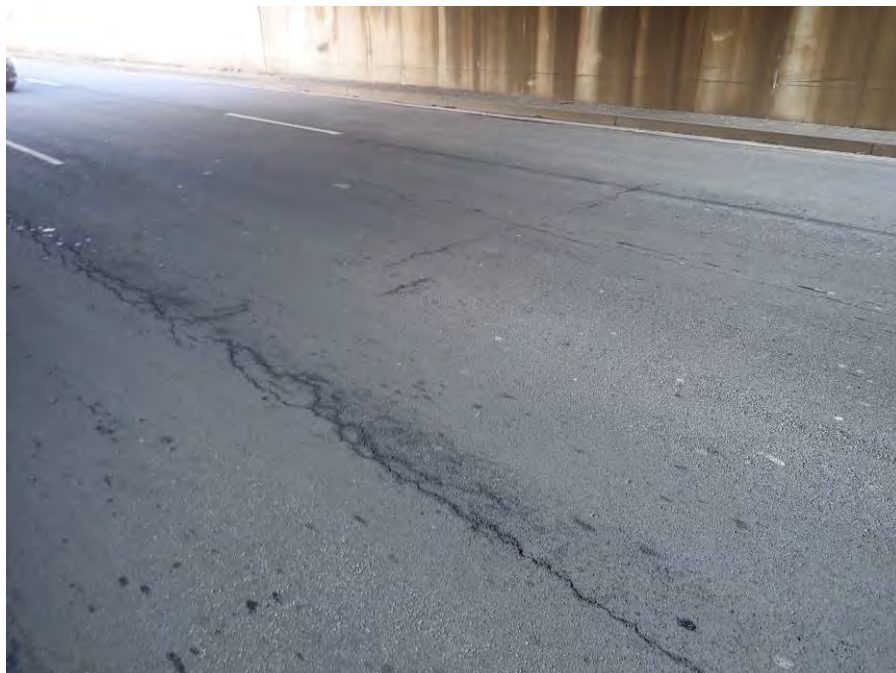
Photograph No. 30 – Up to 1/4" Wide Longitudinal Crack in the Right Lane of the Roadway below the Bridge

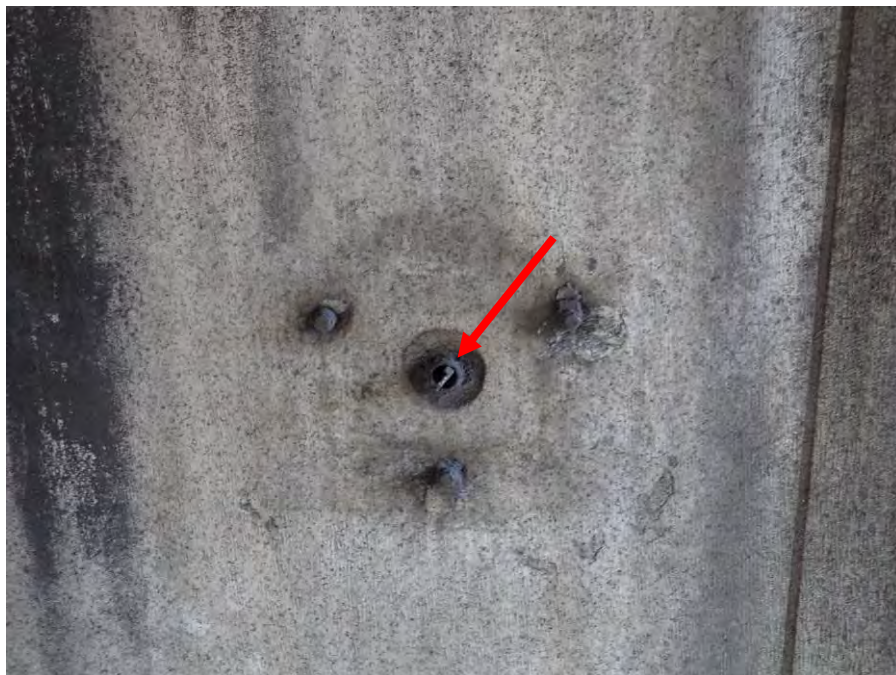
Photograph No. 34 – West Abutment Stem, Old Utility Conduit with Exposed Wiring
