2017 BRIDGE INVENTORY

BRIDGE NO.: 0076 **HIGHWAY:** New York Avenue, N.E.
OVER: Anacostia River

INSPECTION START DATE: 12/11/2017 **INSPECTION END DATE:** 01/11/2018
INSPECTION CYCLE: 24 mo. **INSPECTION TYPE:** Routine

2017 District of Columbia Bridge Inspections Summary Report

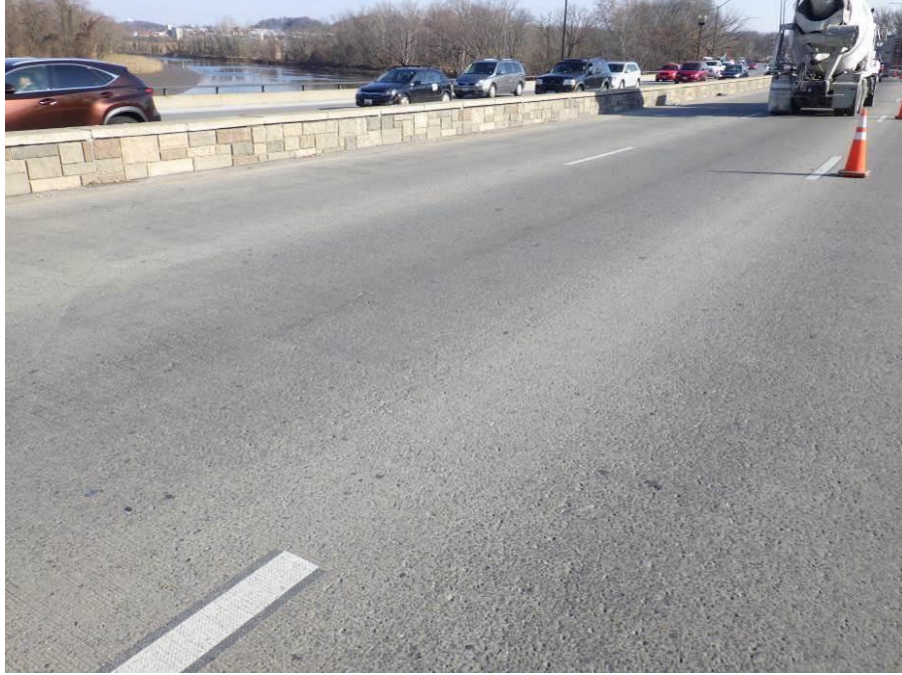
<p>12 300 302 330 331 520</p>	<p>Deck:</p> <p>The concrete wearing surface is in good condition (see Photograph No. 13). There is light scaling in the traffic lane wheel paths and a 3'-4" long x 4'-2" wide area of minor shallow spalling in the South shoulder of Span 2 in the Eastbound lanes. The Westbound lanes exhibit a 4'-6" x 4'-6" area of shallow spalling in the right shoulder over the West Abutment Span and a 12'-0" long x 6'-0" wide area of shallow spalling in the right lane of Span 2 (see Photograph No. 14). There is a 10" long x 7" wide x 1 1/2" deep pothole in the left Eastbound lane of the West Abutment Span and an 18" wide x 6" long x up to 1/2" deep spall in the wearing surface in the right Westbound lane adjacent to the West Abutment joint. The left Eastbound lane of the East Abutment Span exhibits a 12" x 12" repair. There are longitudinal hairline cracks in the wearing surface over the two cellular abutments (see Photograph No. 15). These cracks should be monitored as they may allow for possible leakage on and between the concrete box beams in the abutments. There is water ponding on the North shoulder of Span 1. The roadway markings are in satisfactory condition with missing sections in the Eastbound lanes of Span 1. Seventeen (17) roadway reflectors are broken or missing in the Eastbound lanes and fourteen (14) are broken or missing in the Westbound lanes (see Photograph No. 16).</p>

Photograph No. 13 – Typical Wearing Surface, Eastbound Lanes in Spans 2 and 3 Shown, Looking Northeast

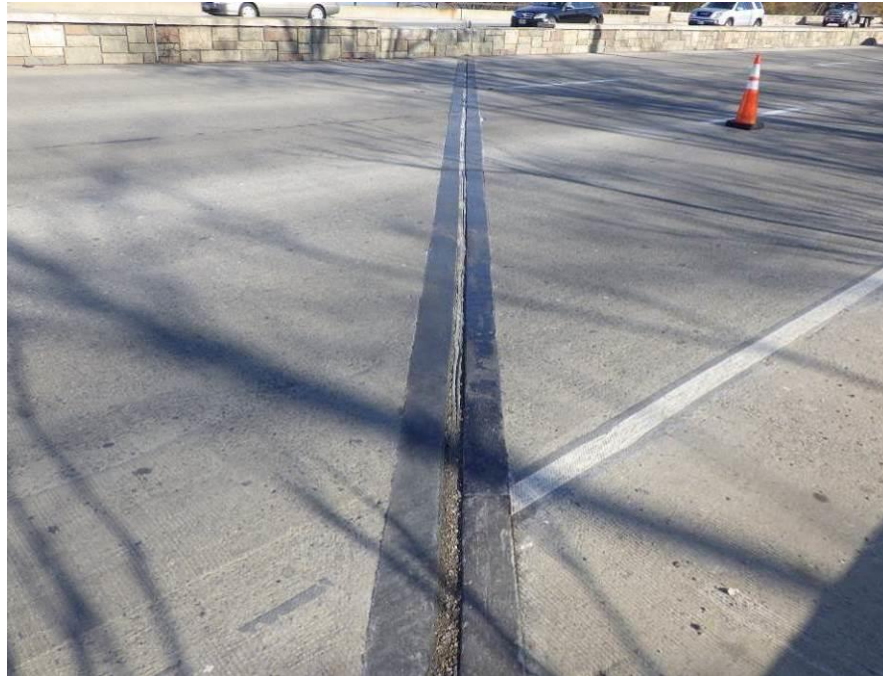
Photograph No. 25 – Compression Joint over Southern Portion of East Abutment, Looking North

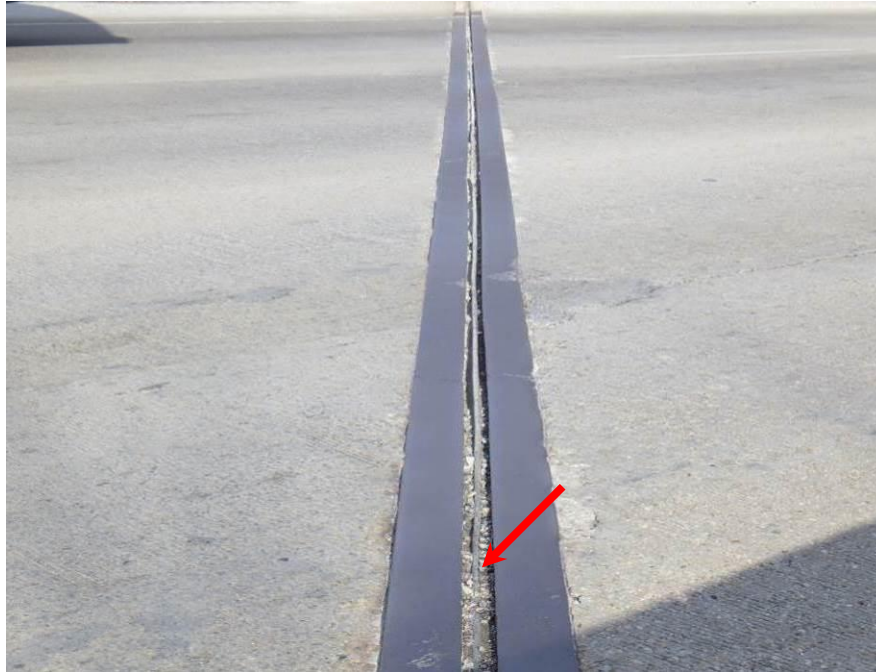
ELEMENT NO.	COMMENTS
12 300 302 330 331 520	<p>Deck (Continued):</p> <p>The two strip seals located at the far end of the abutment spans are in satisfactory condition with moderate debris accumulations in the Eastbound lanes, minor debris in the Westbound lanes and moderate debris in the Westbound shoulders (see Photograph No. 27). There are several shallow spalls in the deck on each side of the joints. The North and South shoulders of the West Approach in the Westbound and Eastbound lanes have a vertical misalignment of up to 3/4" and the joint material is bulging considerably in the shoulder area (see Photograph No. 28); the approach side of the joint is higher than the bridge side of the joint.</p> <p>There are four drains along the South side of the median and four drains along the North parapet. The deck drains and downspouts are in satisfactory condition. Two of the four drains along the median (in Spans 1 and 4) are completely clogged with debris and the other two have minor amounts of the debris in the grates (see Photograph No. 29). One of the four drains along the North parapet is completely clogged with debris and the other three are clear of debris. All of the downspouts exhibit moderate paint deterioration and minor to moderate surface corrosion with minor section loss at the bottom end.</p>

Photograph No. 27 – Typical Strip Seal Joint at the Far End of the Abutment Spans, North Portion of East Joint Shown. Note Moderate Debris at Shoulder (Arrow)

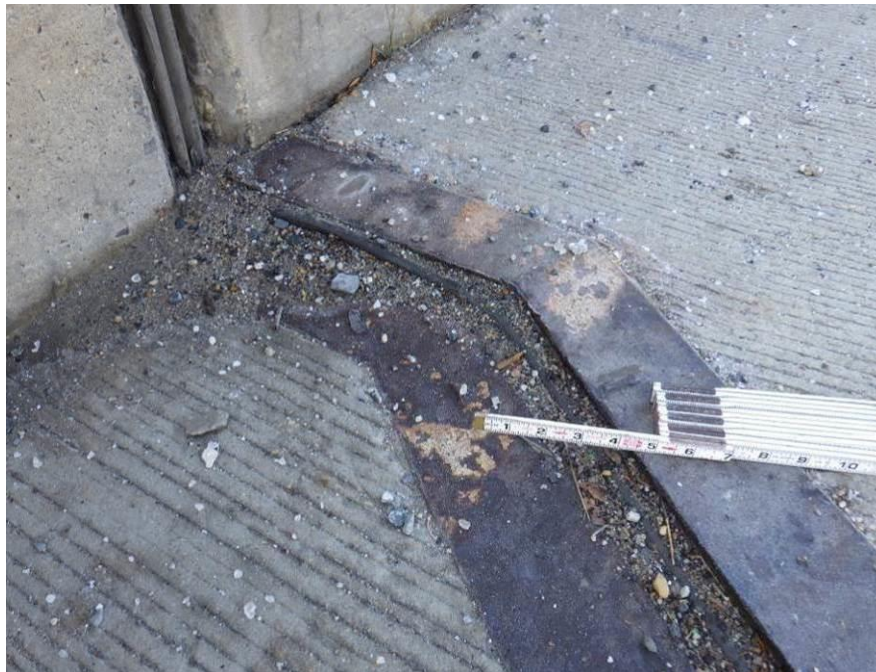
Photograph No. 28 – 3/4" Vertical Differential of the Joint Armor and Bulging Joint Material in South Shoulder at the Far End of the West Abutment Span in the Eastbound Lanes, Looking Southwest

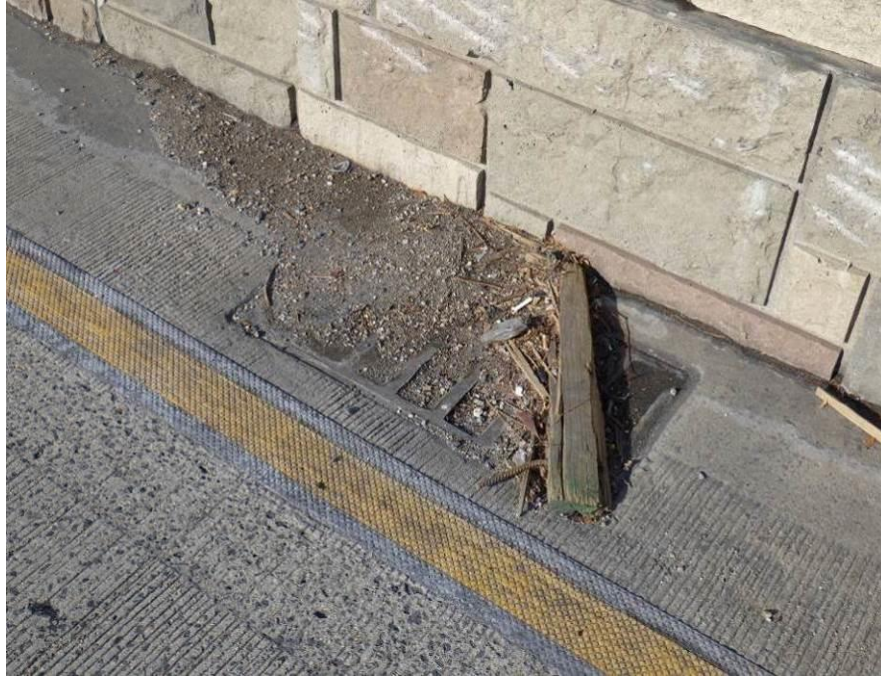
Photograph No. 29 – 100% Clogged Scupper, Span 1
Scupper at Median Shown

BRIDGE ELEMENT	RECOMMENDED ACTION	PC
Drainage Devices	Remove debris from partially or completely clogged drainage grates (5 EA).

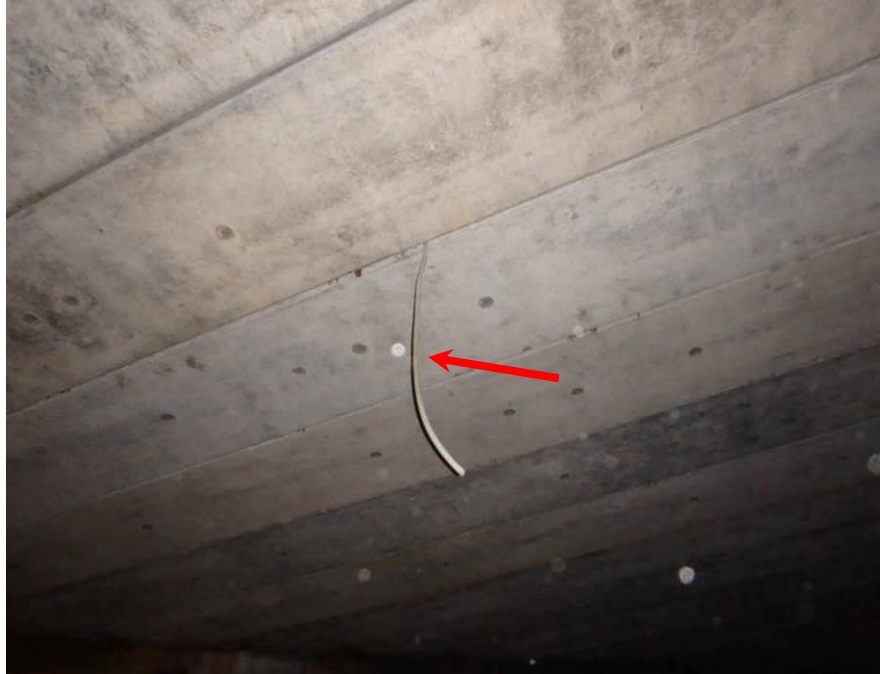
Photograph No. 31 – Joint Material Hanging from between Box Girders in East Abutment Span (Arrow)

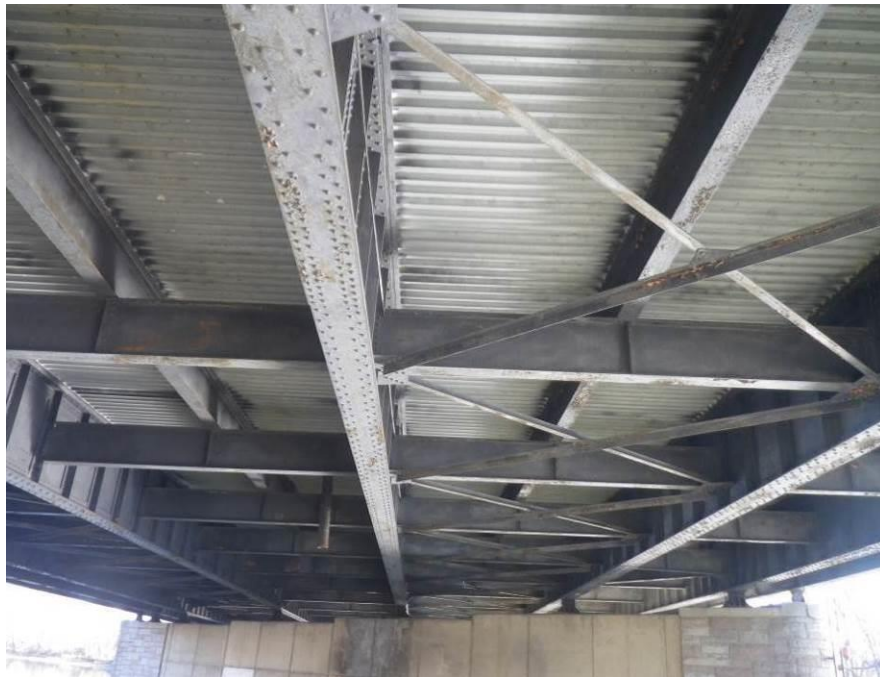
ELEMENT NO.	COMMENTS
<p>104 107 109 113 152 310 311 313 515</p>	<p>Superstructure (Continued):</p> <p>The painted diaphragms and lateral bracing are in good condition with minor paint deterioration (refer to Photograph No. 32).</p> <p>The elastomeric bearings for the concrete box beams and prestressed concrete beams at the East and West Abutment spans are in good condition with no defects noted (see Photograph No. 36).</p> <p>The steel rocker bearings of the steel girder spans are in satisfactory condition (see Photograph No. 37). The bearings for Girders 3, 4, 6, 7 and 8 at the East Abutment, the bearings for Girders 1, 2, 4, 5, 6, 7 and 8 at the West Abutment, the bearings for Girders 1, 2, 3, 4, 5 and 7 at Pier 1 and the bearings at Pier 3 exhibit paint failure and minor surface corrosion. Several of the rocker bearings at Piers 1 and 3 exhibit delaminated corrosion on the masonry plate and crevice corrosion between the masonry plate and the rocker (see Photograph No. 38). All of the bearing pins lack lubrication. The concrete bearing pedestal for Girder 7 at the West Abutment is spalled, and there is loss of bearing at the Southeast corner for 1/2" beneath the masonry plate. There is greater than 50% section loss of the Northeast and Southwest anchor bolt nuts of Bearing 3 at the West Abutment.</p> <p>The fixed bearings at Pier 2 are in good condition with minor corrosion (see Photograph No. 39).</p> <p>Nearly all of the masonry plate concrete encasements of the pedestals for the bearings are spalled at the piers and at both abutments (see Photograph No. 40). Some of the unsound and loose areas of concrete encasements at the East Abutment and all of the areas of unsound and loose concrete encasements at the other substructure units were removed during the inspection.</p>

Photograph No. 32 – Girder Span Superstructure, Span 2 Shown, Looking East

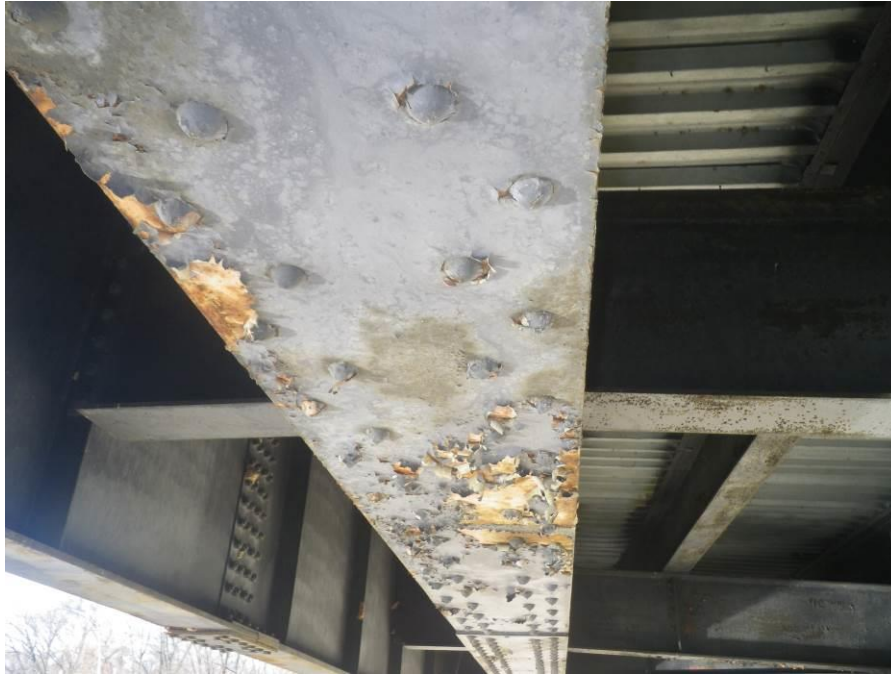
Photograph No. 33 – Typical Peeling Paint on Girder Bottom Flanges, Girder 7 in Span 2 near Pier 1 Shown, Looking Southwest

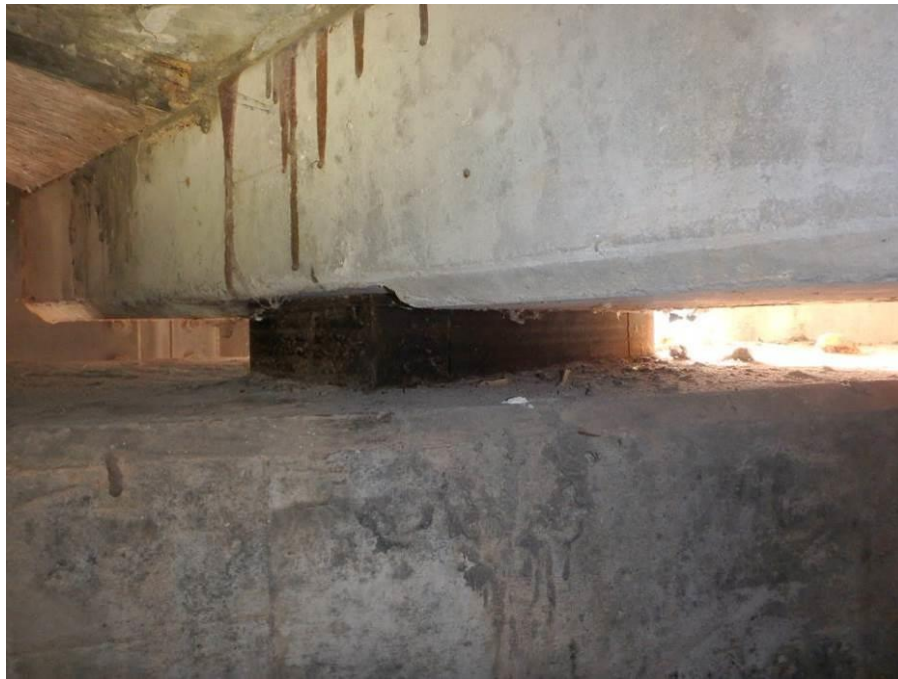
Photograph No. 36 – Typical Elastomeric Bearing Pad for Concrete Box Girders, Beam 20 at the West Abutment Shown, Looking Southeast

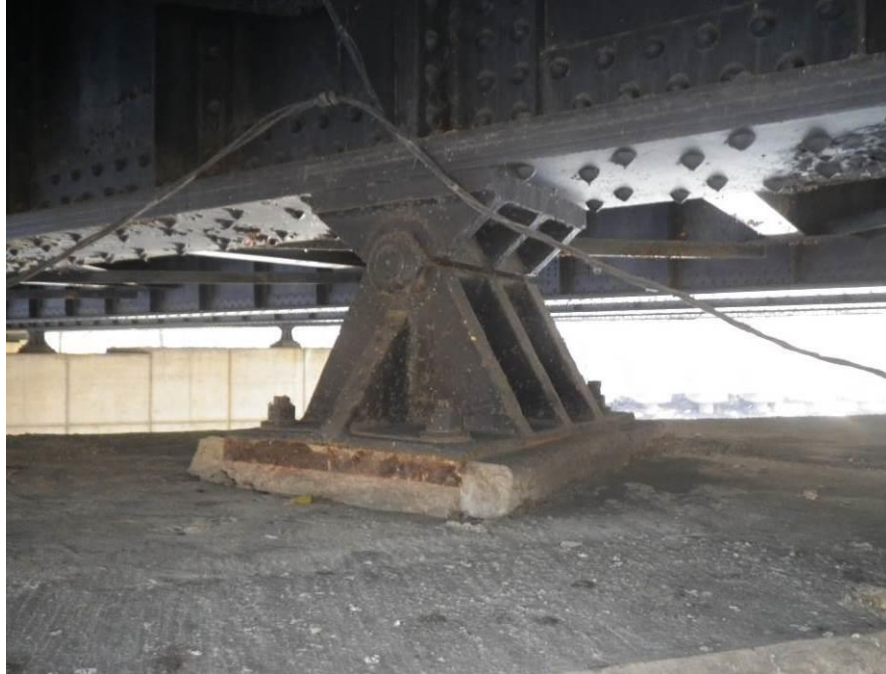
Photograph No. 39 – Typical Fixed Bearing at Pier 2, Bearing 3 Shown, Looking Southeast

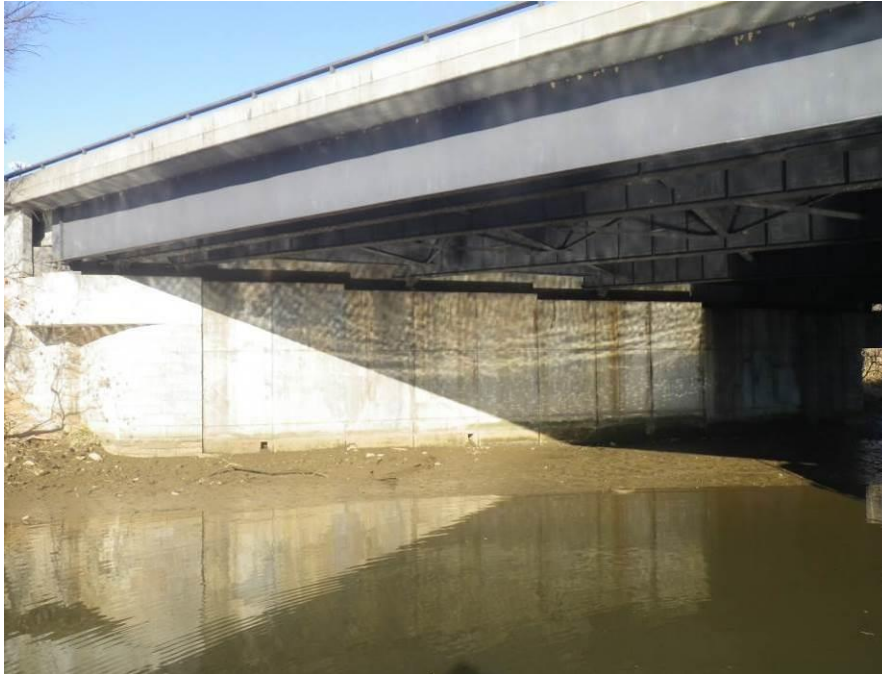
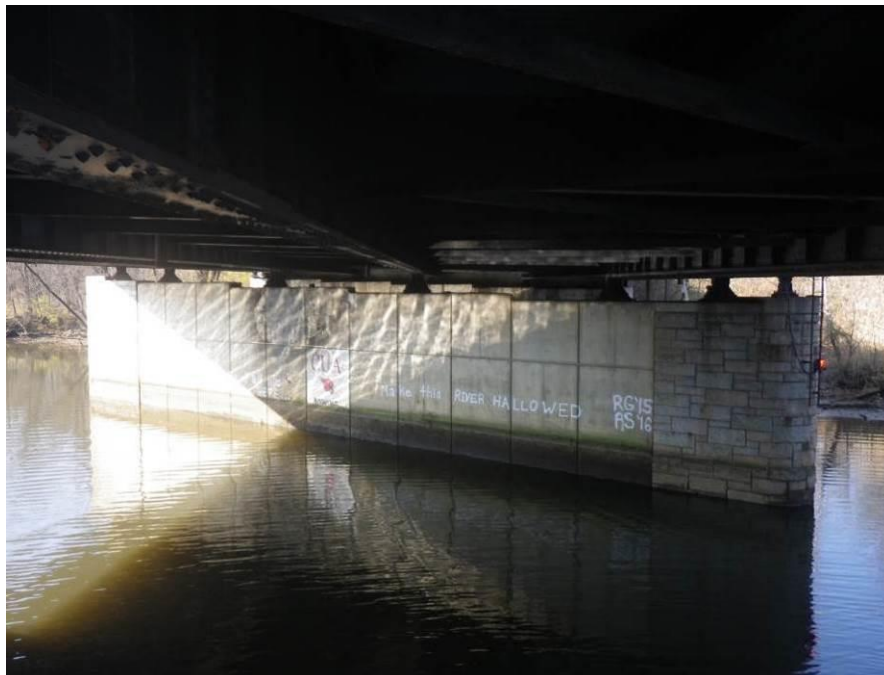
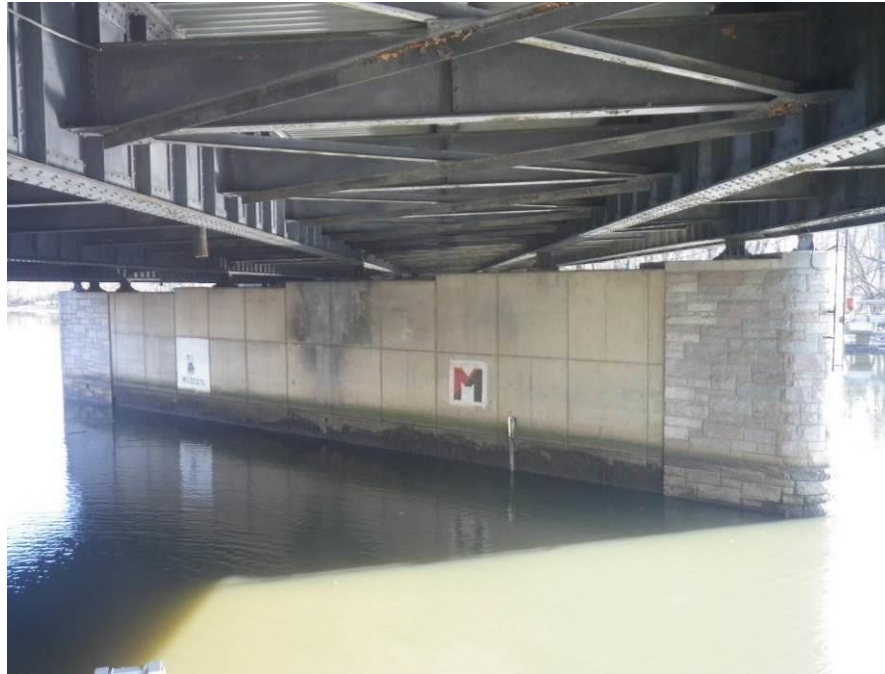
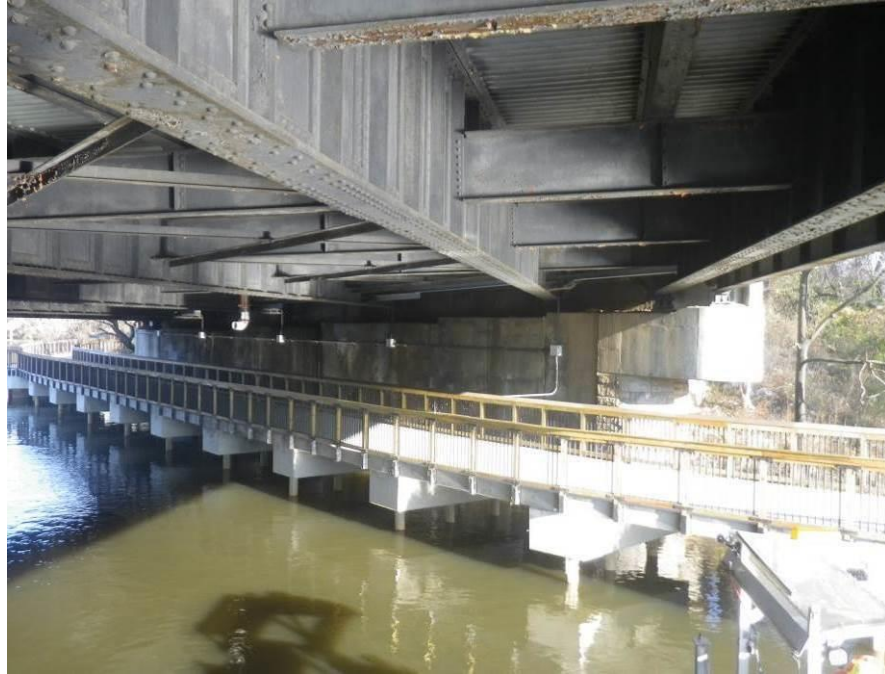
<p>210 215</p>	<p>Substructure:</p> <p>The substructure units are in satisfactory condition overall (see Photograph Nos. 41 through 45). The substructure units located in the stream channel (West Abutment, East Abutment, Piers 1, 2 and 3) typically exhibit severe scaling of the reinforced concrete stem below the waterline leaving up to 6" deep voids with exposed reinforcing steel in the East Abutment and in the West faces of Piers 1 and 2 (see Photograph Nos. 46 and 47).</p> <p>The West Abutment grade beam is in good condition. There are 12 vertical hairline cracks with efflorescence and a 22" x 17" x up to 2 1/8" deep spall with up to 75% section loss to the exposed corroded reinforcing steel between Box Beams 5 and 6 (see Photograph No. 48). Efflorescence, corrosion staining and moisture staining were present at random locations throughout the entire length of the grade beam. The fill material inside of the West Abutment Span has typically settled along the base of the grade beam and extends up to 3' back below the grade beam (see Photograph No. 49). A portion of the grade beam that is outside of the West Abutment Span curtain wall at the South end exhibits some hairline cracking with efflorescence and corrosion stains (see Photograph No. 50).</p>

Photograph No. 41 – General View of the West Abutment, Looking Northwest

Photograph No. 42 – Pier 1, East Face

Photograph No. 43 – Pier 2, West Face

Photograph No. 45 – General View of the East Abutment, Looking East

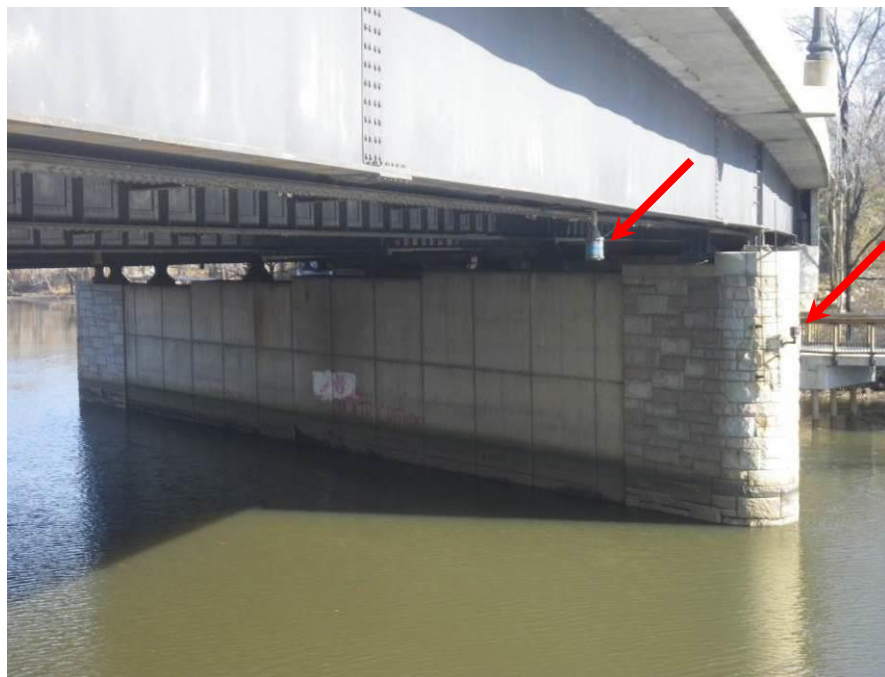
Photograph No. 44 – Pier 3, West Face. Note Non-Functioning Navigation Lights on South Side of Bridge (Arrows)

4
Lighting	Repair non-functioning navigational lights (5 EA). Cover or remove the severed electrical wire at the North end of Pier 3 (1 EA).

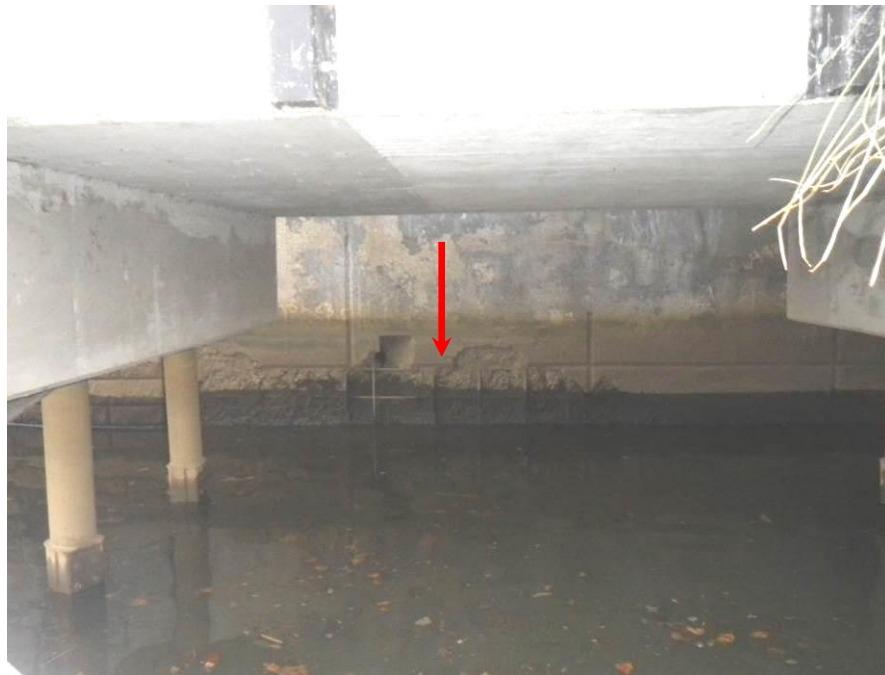
NBI Item No.	Name	Rating	Descriptions
58	Deck	7	
59	Superstructure	7	
60	Substructure	6	Severe scaling below waterline, and moderate spalls and delaminations in abutment stems
61	Channel	7	
62	Culverts	N

Photograph No. 46 – Typical Severe Scaling with Exposed Reinforcing Steel below Waterline at East Abutment, Visible Due to Low Tide (Arrow)

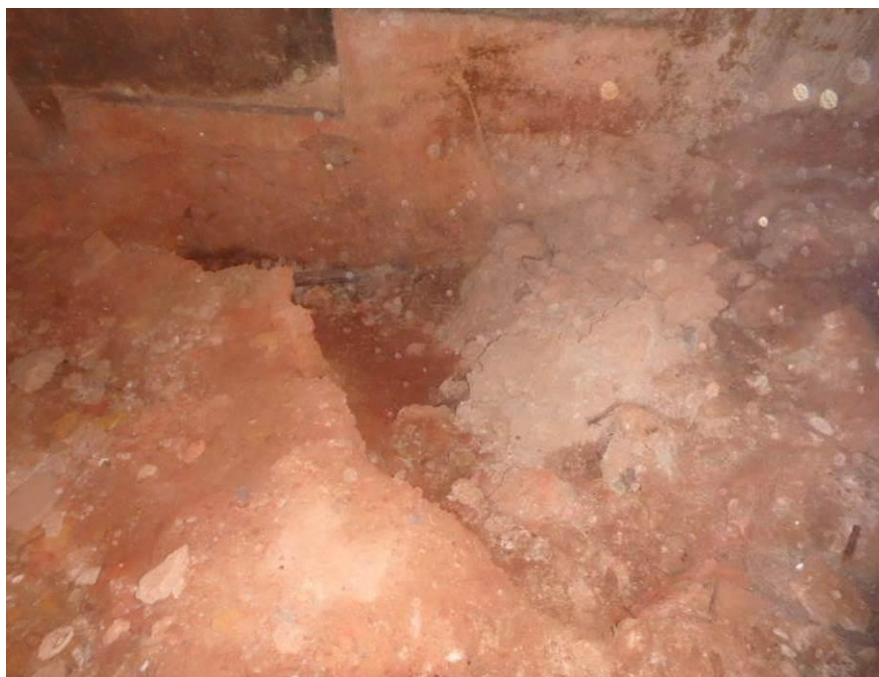
Photograph No. 62 – 11'-0" Long x 8'-6" Wide x Up to 4'-0" Deep Erosion Hole in the East Abutment Span, Looking North

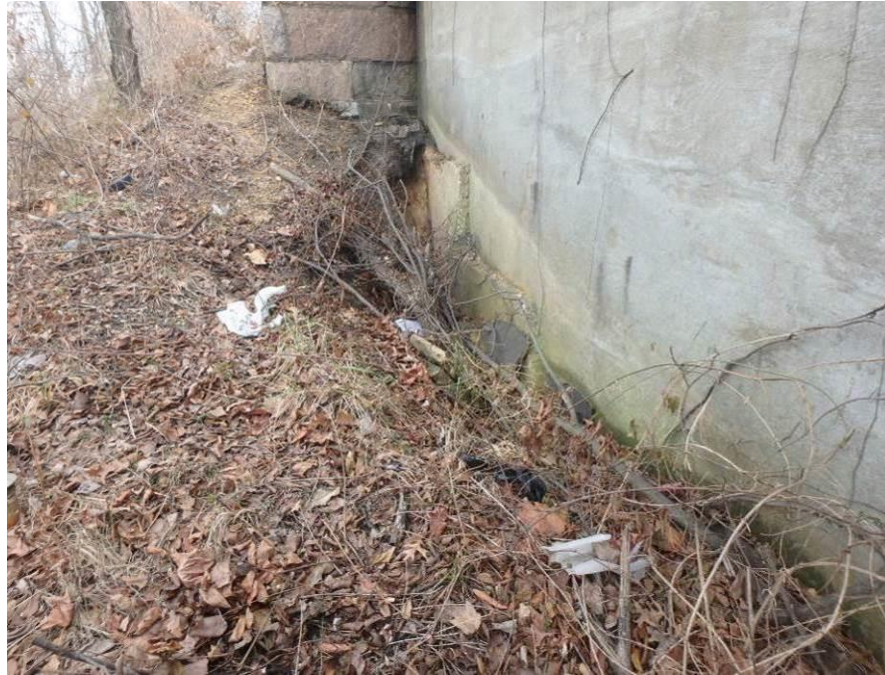
Photograph No. 63 – 12'-0" Long x 4'-0" Wide x Up to 5'-0" Deep Erosion Hole adjacent to the Northeast Wingwall

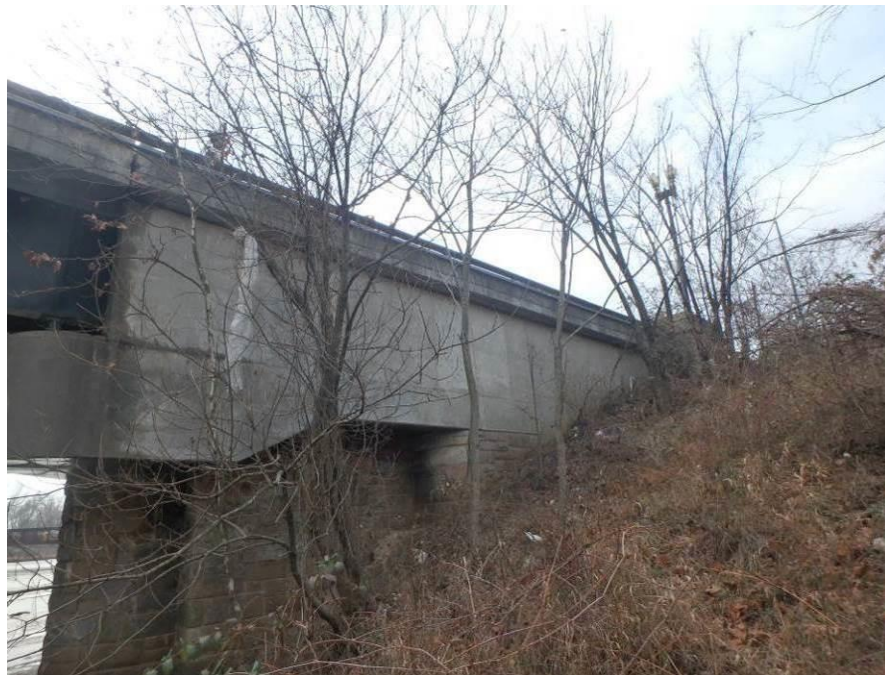
Photograph No. 66 – Northwest Curtain Wall. Note Minor Vegetation Growth adjacent to Exterior of Curtain Wall

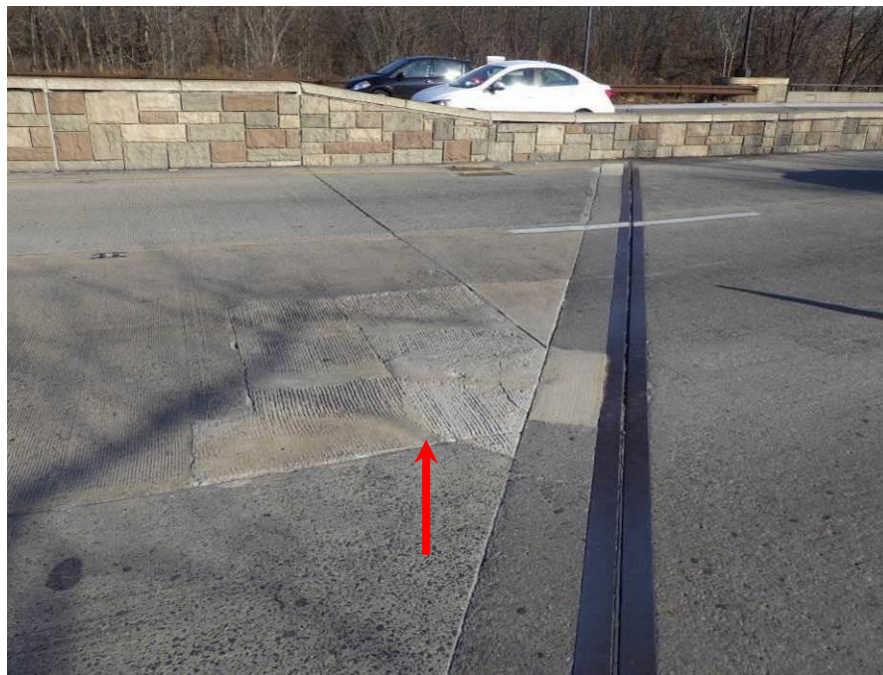
Photograph No. 70 – New Concrete Patch in the Center Eastbound Lane of the West Approach Roadway (Arrow)

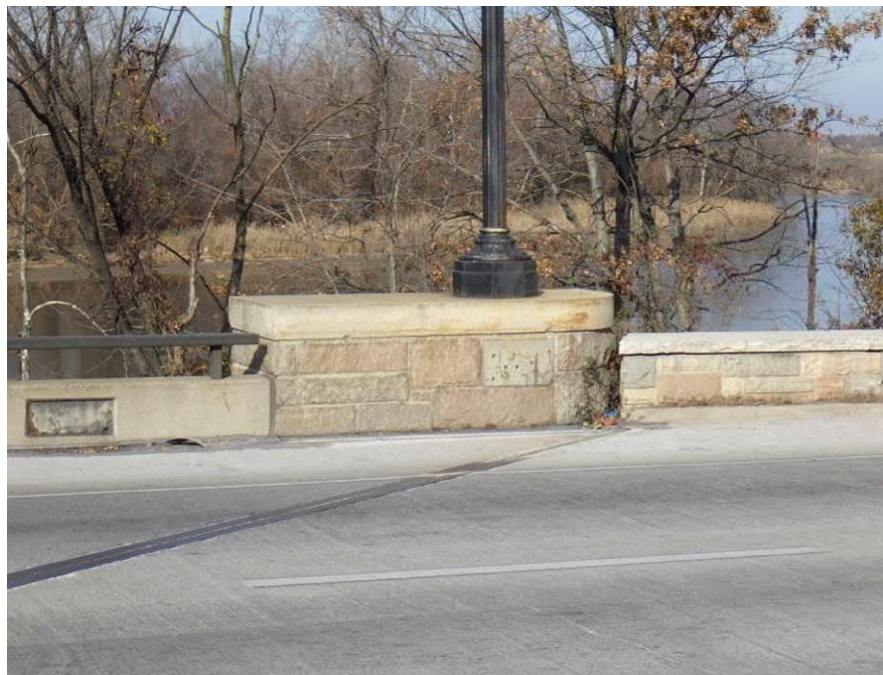
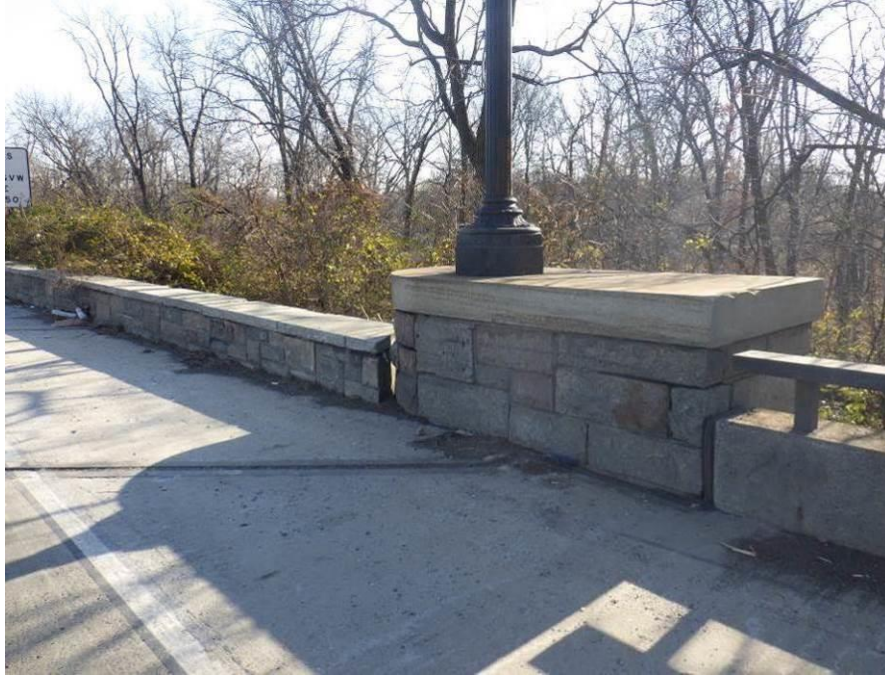
ELEMENT NO.	COMMENTS
321	<p>Approaches (Continued):</p> <p>The approach railings are in satisfactory condition. At the Northeast and Southeast Approaches, the bridge parapets transition into a masonry railing (see Photograph Nos. 74 and 75). Approximately 50' East of the East Approach slab, there is a 10' long section of the median capstone that is displaced up to 9" to the South (see Photograph No. 76). Pointing is missing between the median barrier fascia stones in random areas. This defect is typical to the masonry retaining walls at the Northeast and Southeast Approaches. There is evidence of uneven settlement in the North parapet at the East Approach with up to a 1 1/2" vertical difference. A section of the East Approach South parapet is displaced to the South and there is a minor spall in the adjacent curb. Metal guide rails located at the Northwest and Southwest corners of the bridge are in satisfactory condition with an established patina. The attachment of the Northwest guide rail to the bridge railing is not standard and exhibits moderate impact damage (see Photograph No. 77). The Southwest guide rail is not gradually stiffened at the bridge (see Photograph No. 78).</p>

Photograph No. 74 – Northeast Transition to Masonry Railing on East Approach, Looking North

Photograph No. 75 – Southeast Transition to Masonry Railing on East Approach, Looking Southeast

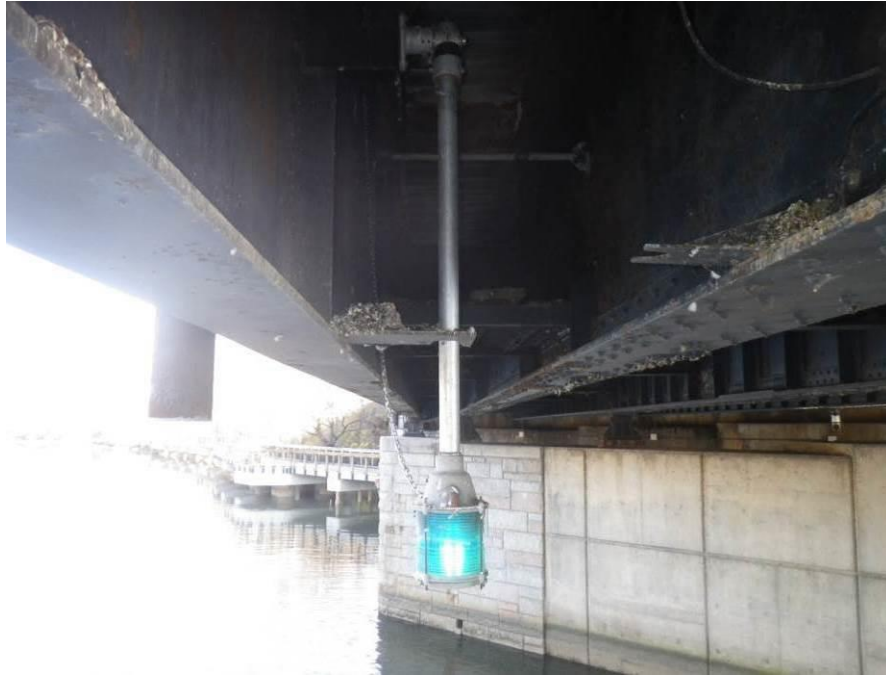
Photograph No. 79 – Replaced Green Navigation Light for the North Side of Span 3

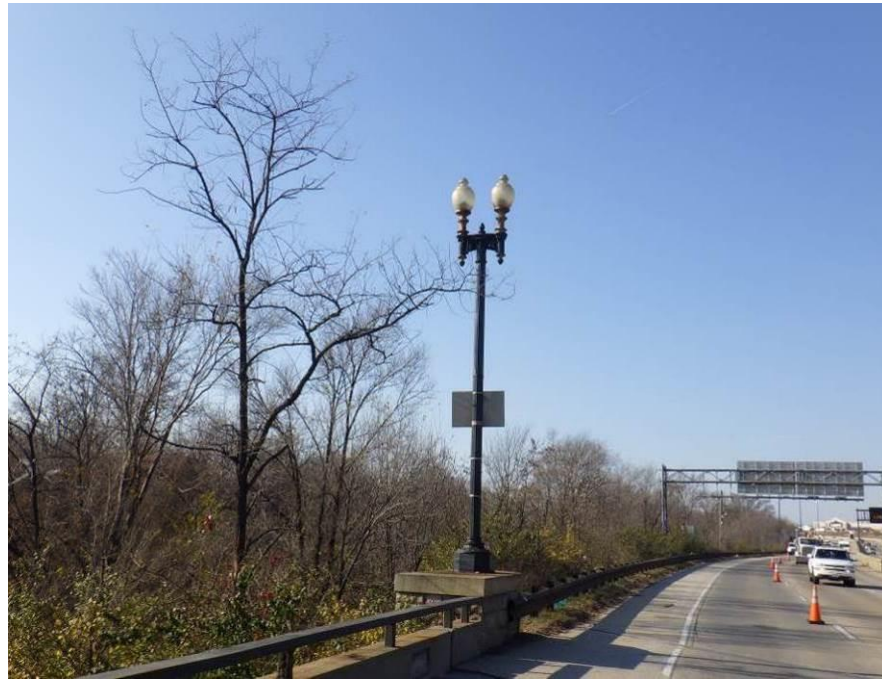
Photograph No. 81 – Typical Double Luminaire Light Standard, Southwest Corner of the Bridge Shown

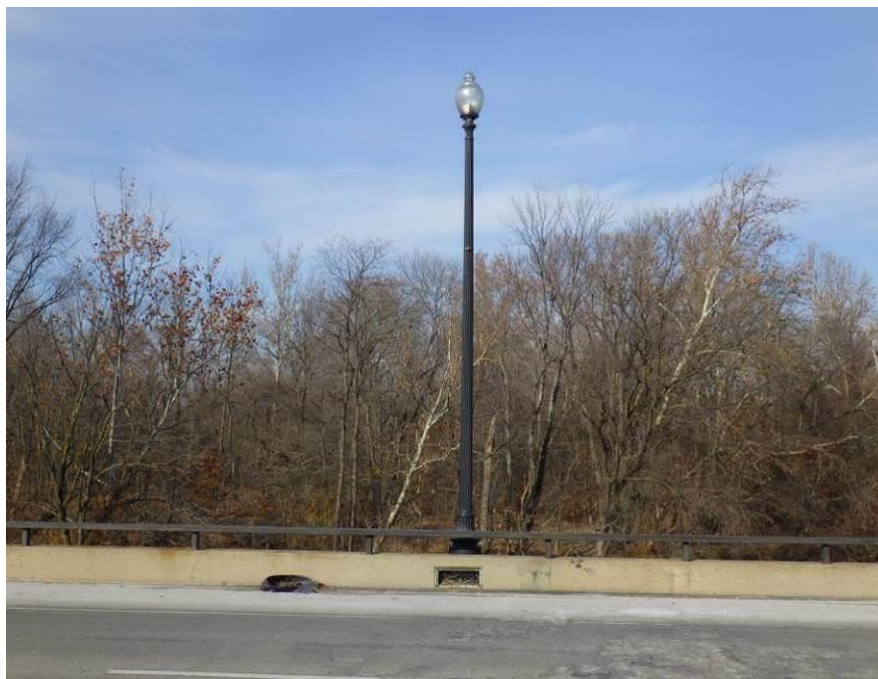
Photograph No. 82 – Typical Single Luminaire Light Standard. Replaced Light Standard on the North Side of Span 2 Shown
