DISTRICT DEPARTMENT OF TRANSPORTION

BRIDGE INSPECTION MANUAL

August 2021

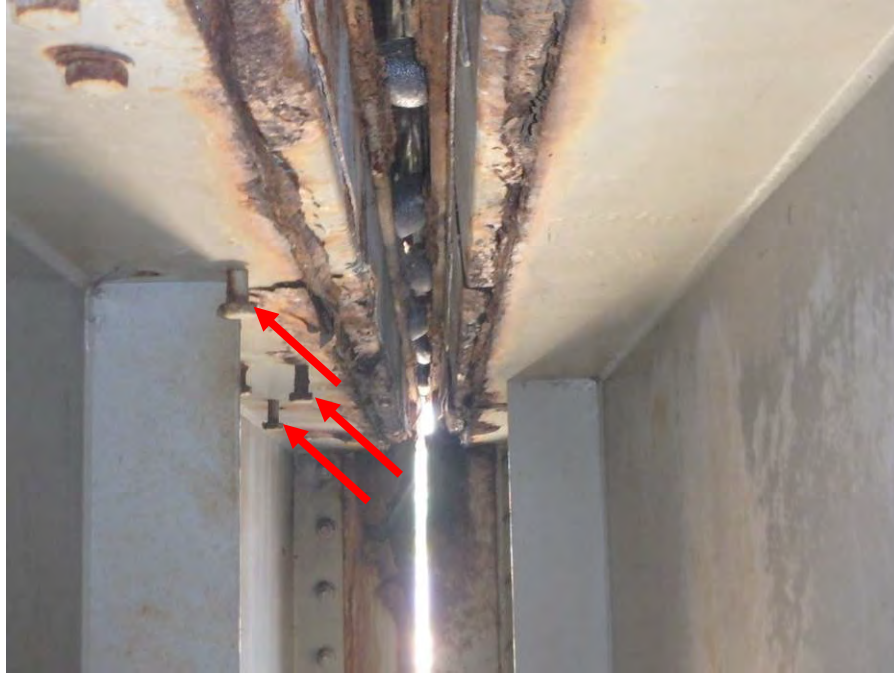
Photograph No. 17 – Typical Area of Moderate Corrosion and Evidence of Moisture Leakage – Bent 2 Joint Shown. Note Abandoned Joint Attachment Fasteners (Arrows)

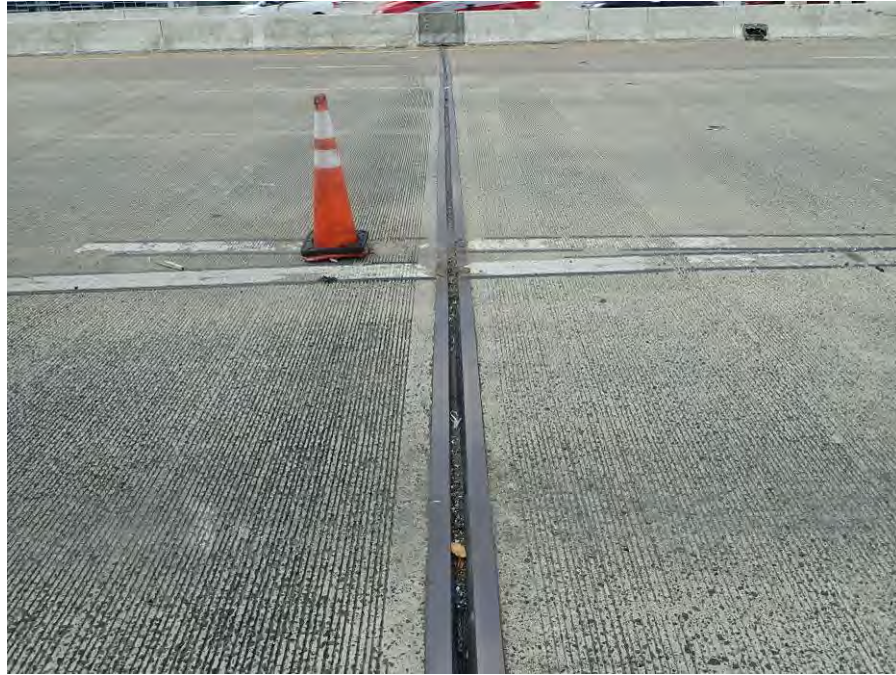
Photograph No. 19 – Typical Deck Joint with Minor to Moderate Debris Accumulation in Seal, Westbound Lanes at Bent 7 Shown, Looking South

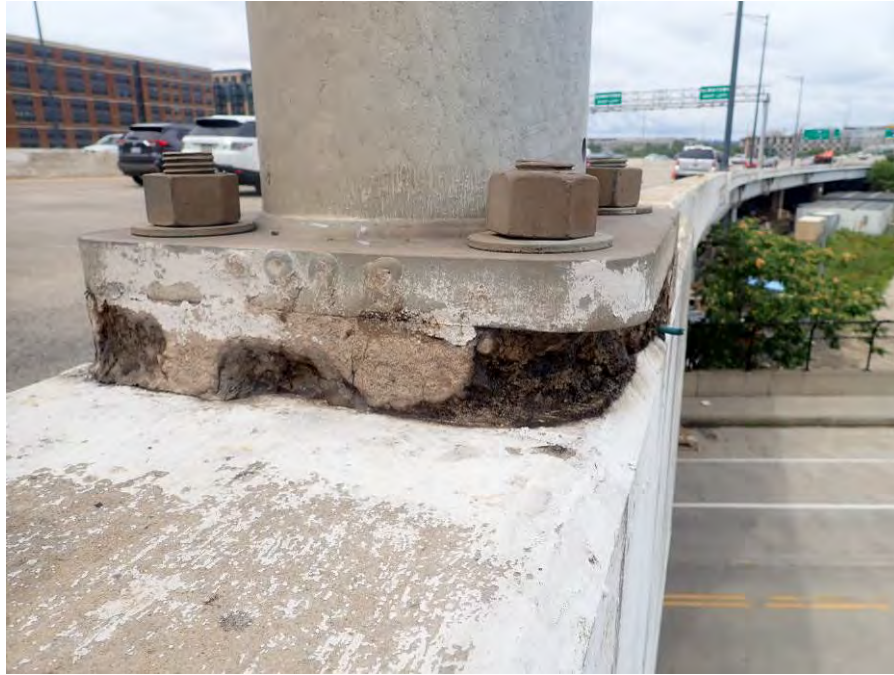
Photograph No. 23 – Up to 1” Deep Moderate Scaling in the Sign Structure Column Base Mortar on the Westbound North Parapet in Span 7

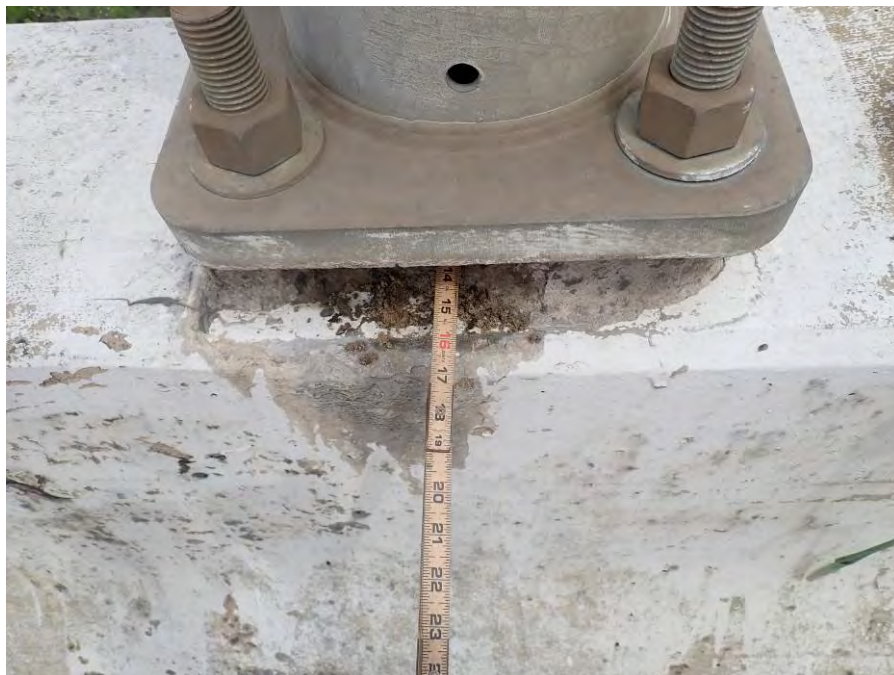
Photograph No. 24 – Hole in Base Mortar Up to 15” Deep in Span 5 at the Support for the Sign Structure at the North Parapet

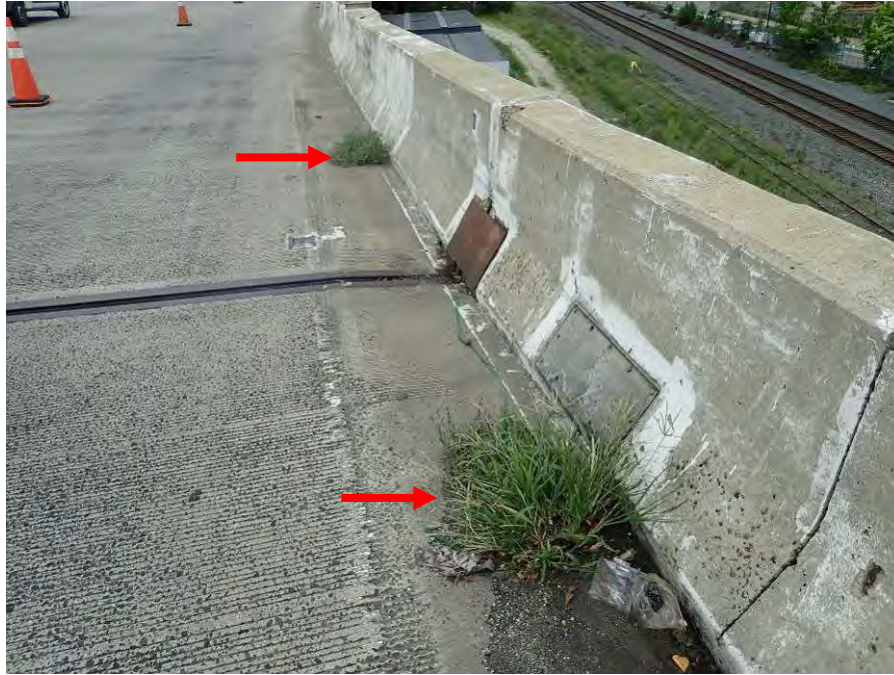
Photograph No. 27 – Typical Clogged Scuppers – Spans 5 and 6 in the Westbound Lanes Shown, Looking West

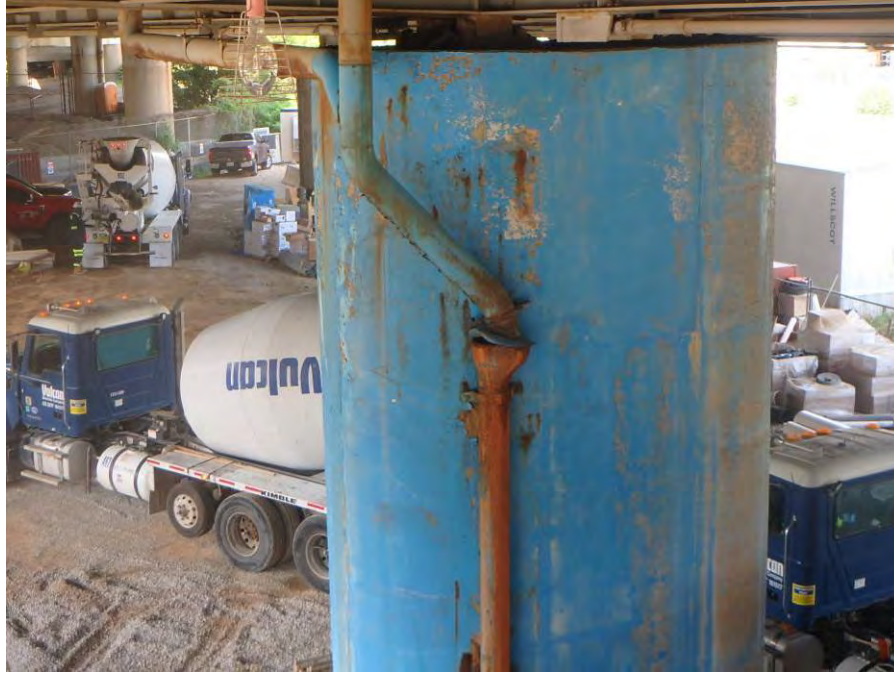
Photograph No. 29 – Typical Downspout Exhibiting Corrosion Staining with Corrosion Visible where Paint has Failed

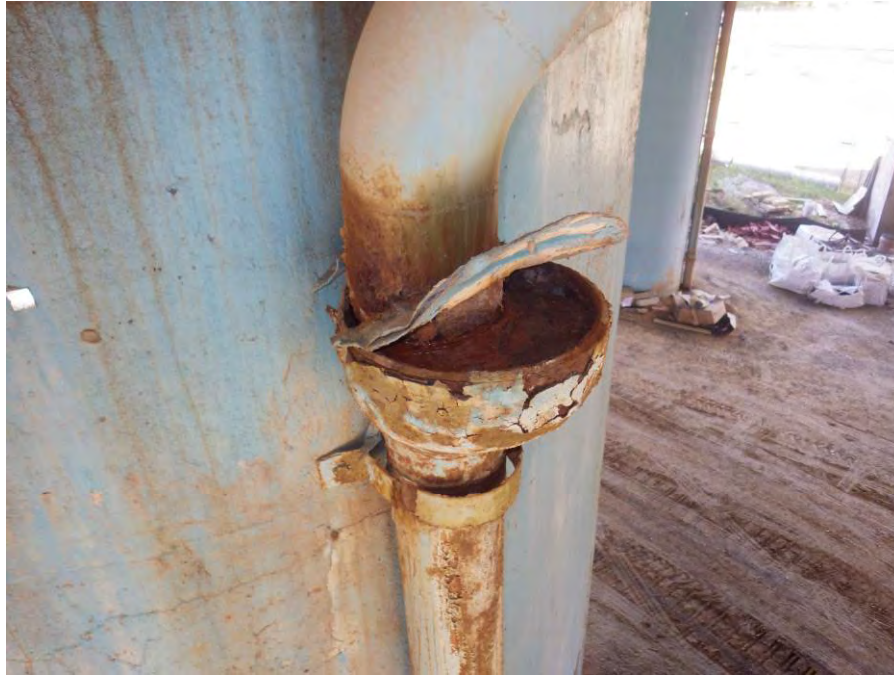
Photograph No. 31 – Downspout at Bent 5, Column 2 Completely Clogged with Debris

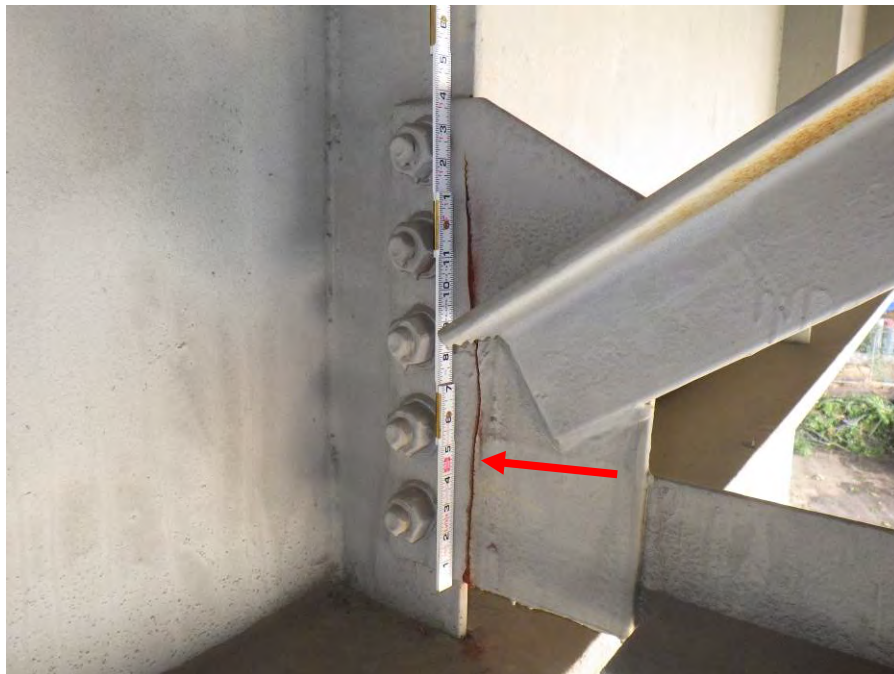
Photograph No. 34 – 14" Long Vertical Crack in Connection Plate to
Girder 13 at Third Cross-Frame East of Bent 1 in Bay 15 of Span 2

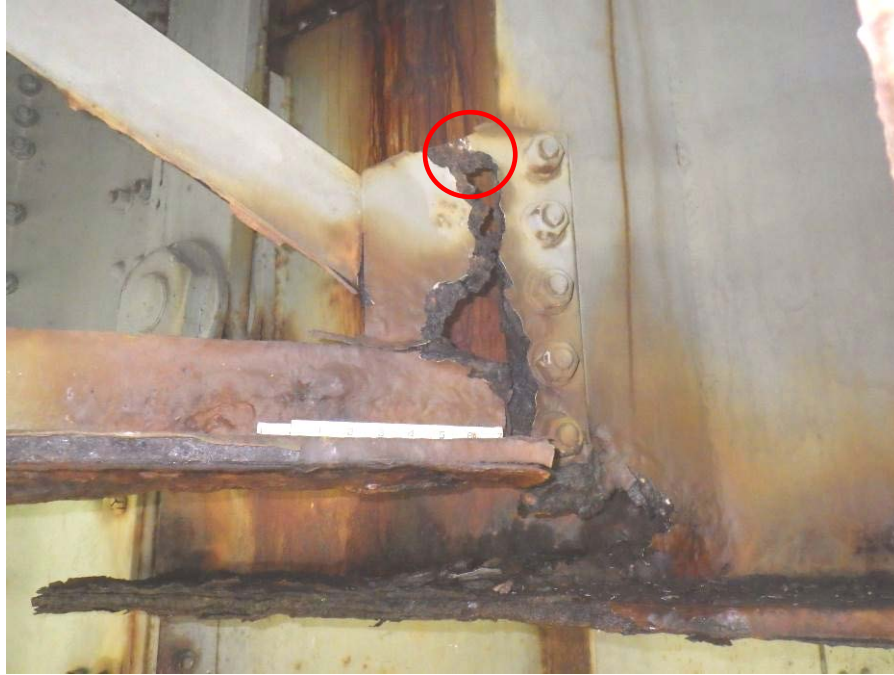
Photograph No. 35 – Cross-Frame Connection to the North Side of Girder 4 at Bent 9A – Significant Section Loss with Only 7/8” of Connection Remaining (Encircled). Note 5” Wide x 2” High Hole at Bottom of Stiffener

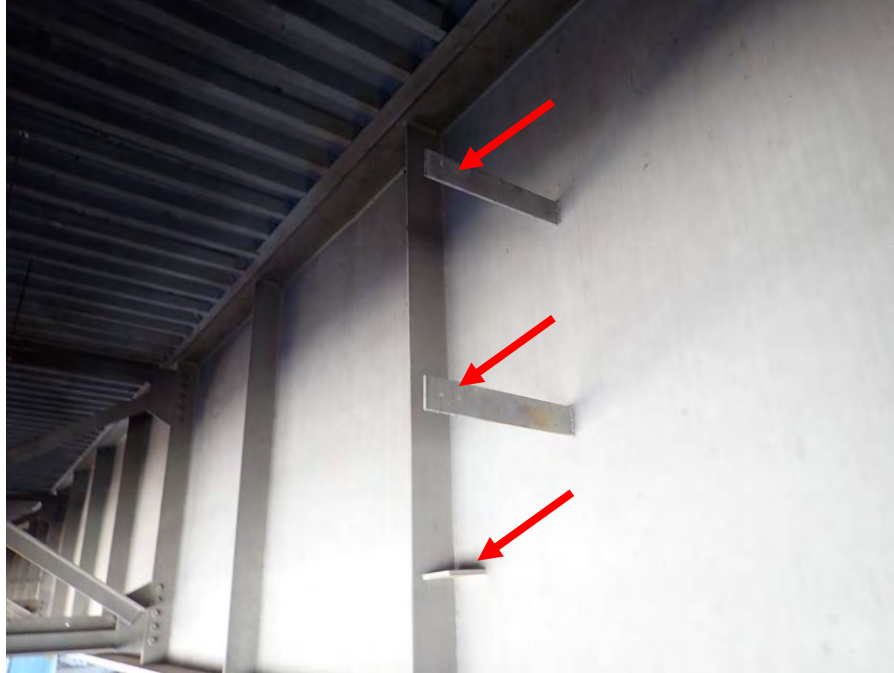
Photograph No. 39 – Abandoned Light Fixture Supports in Span 7 at Girder 2

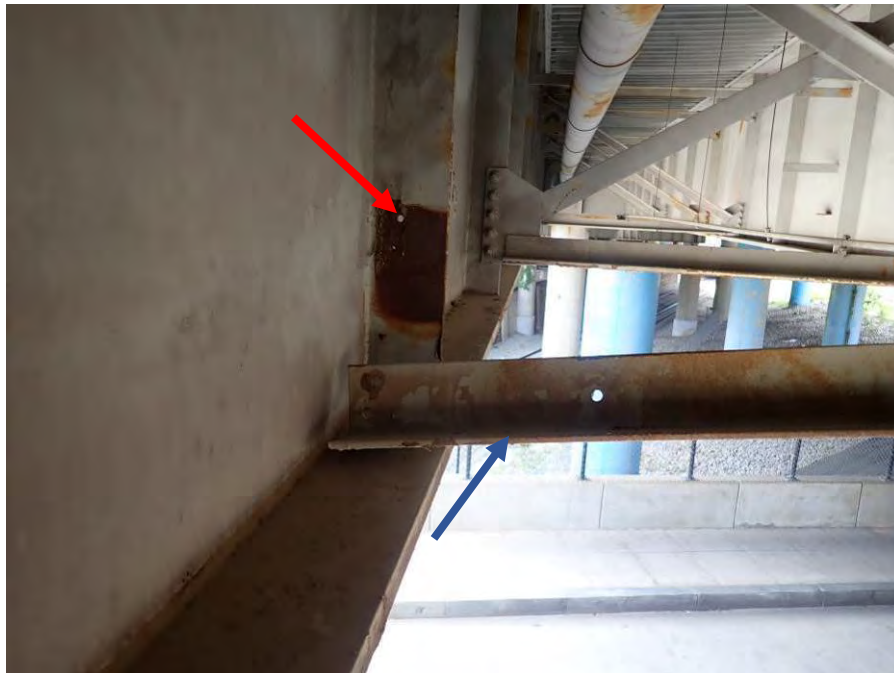
Photograph No. 40 – Location of Missing Fasteners (Red Arrow) at Displaced Horizontal Light Fixture Support between Girders 1 and 2 in Span 7 above New Jersey Avenue

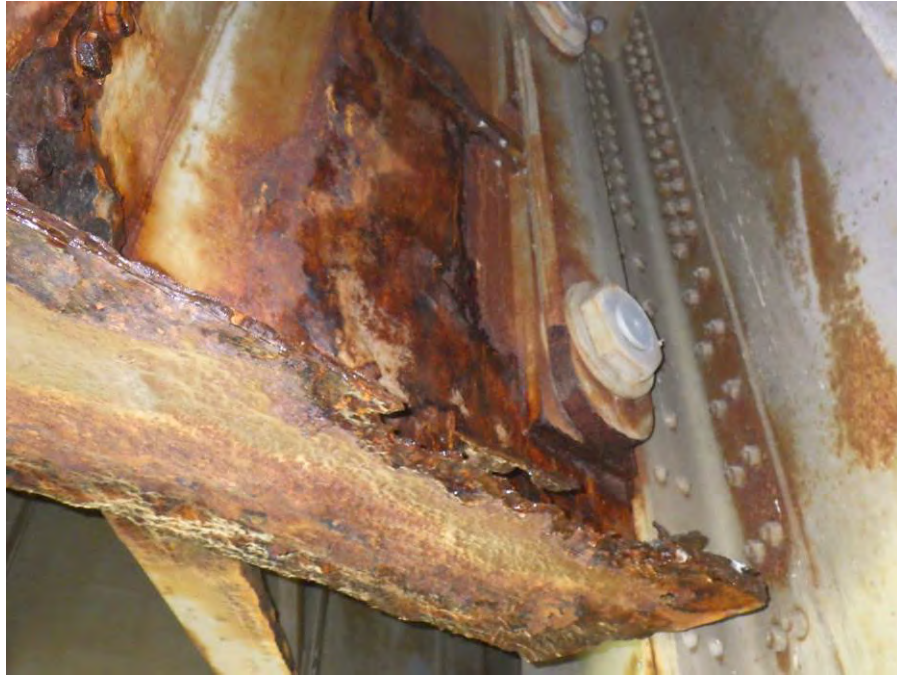
Photograph No. 41 – Bent 10A, South Side of Girder 4, Severe Section Loss for the Full-Width of the Girder Bottom Flange

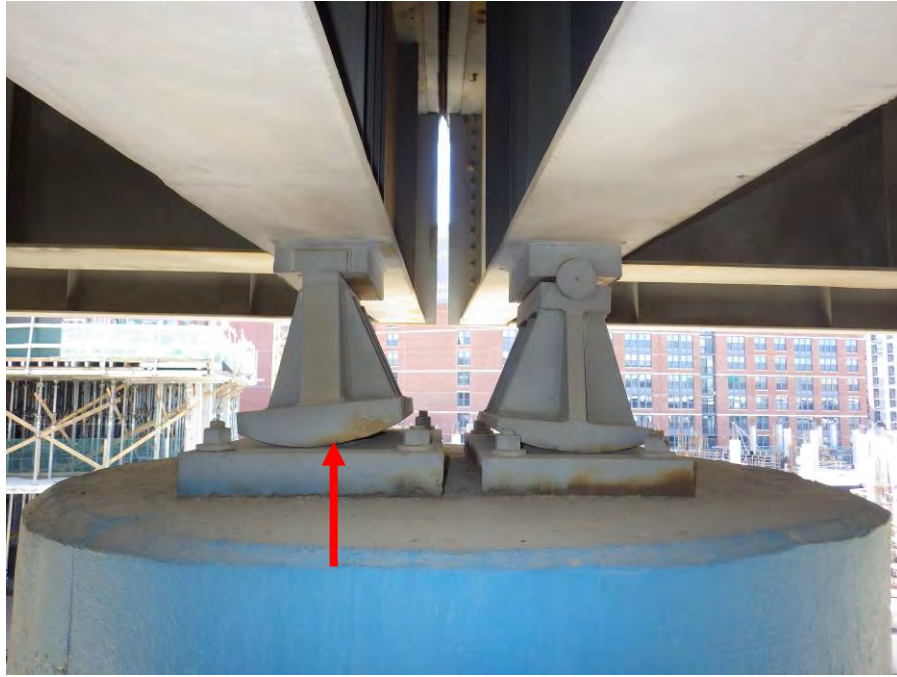
Photograph No. 45 – Rocker Bearing of Span 6 at Column 3 of Bent 5 – Slightly Greater than Normal Lean to the East, Looking South

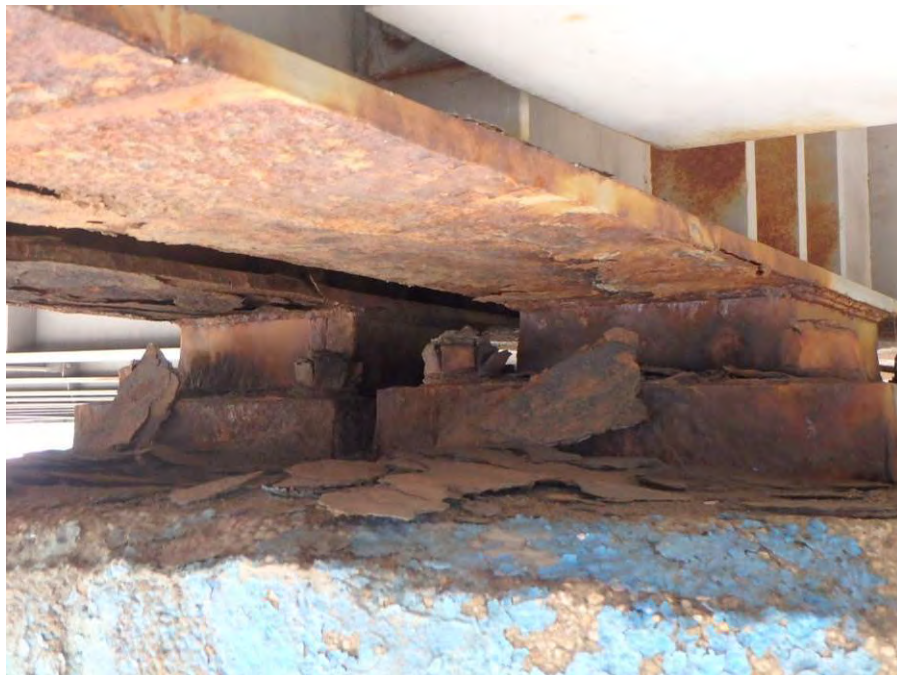
Photograph No. 46 – Moderate Section Loss in Bearing and Anchor Bolt Nuts of the Fixed Bearings at Column 4 of Bent 8, Looking Northwest

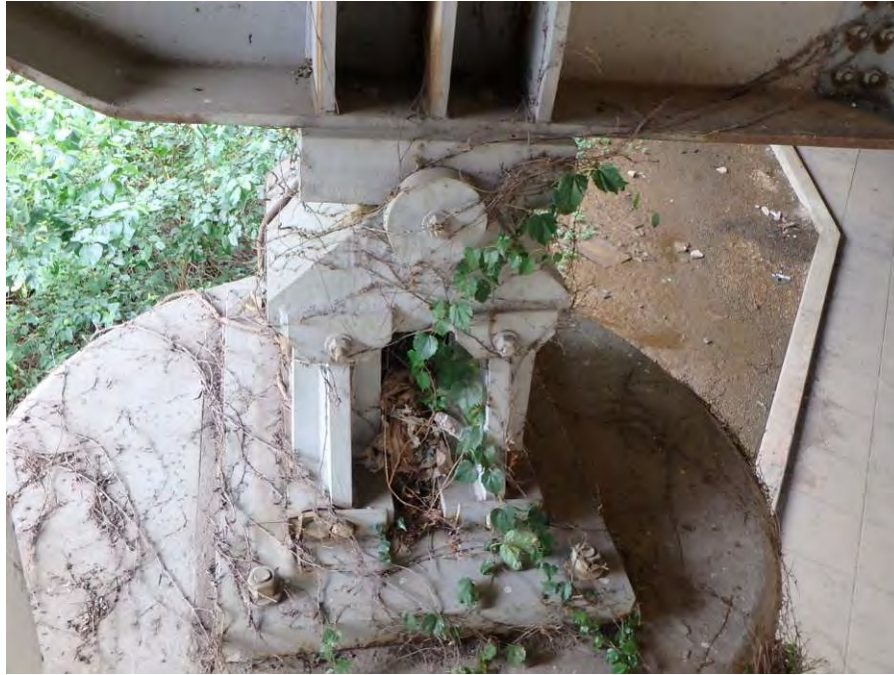
Photograph No. 47 – Overgrown Vegetation on Bearing 1 at Bent 9A

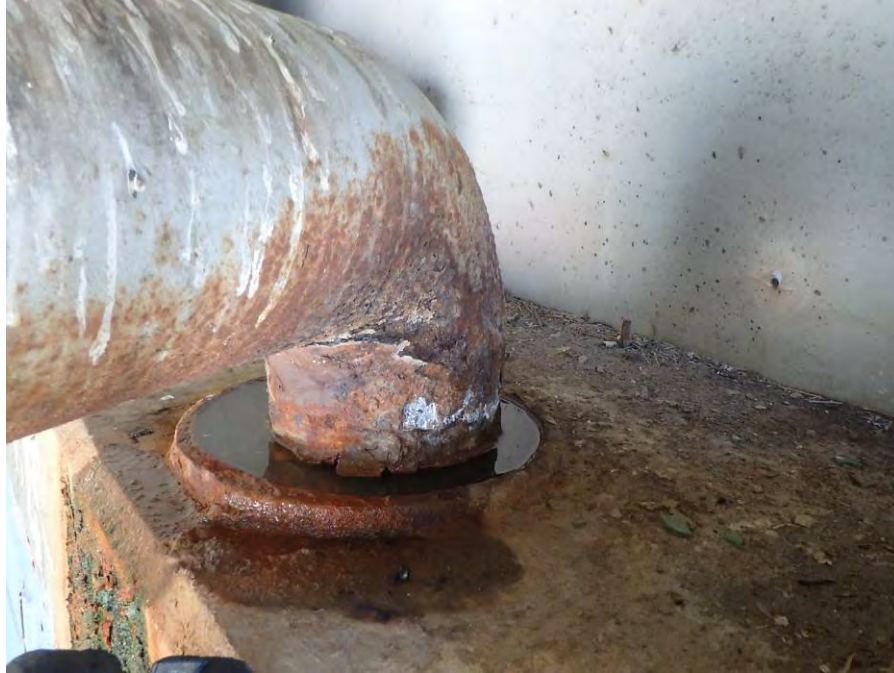
Photograph No. 75 – Clogged Drain Pipe at the South End of the East Abutment

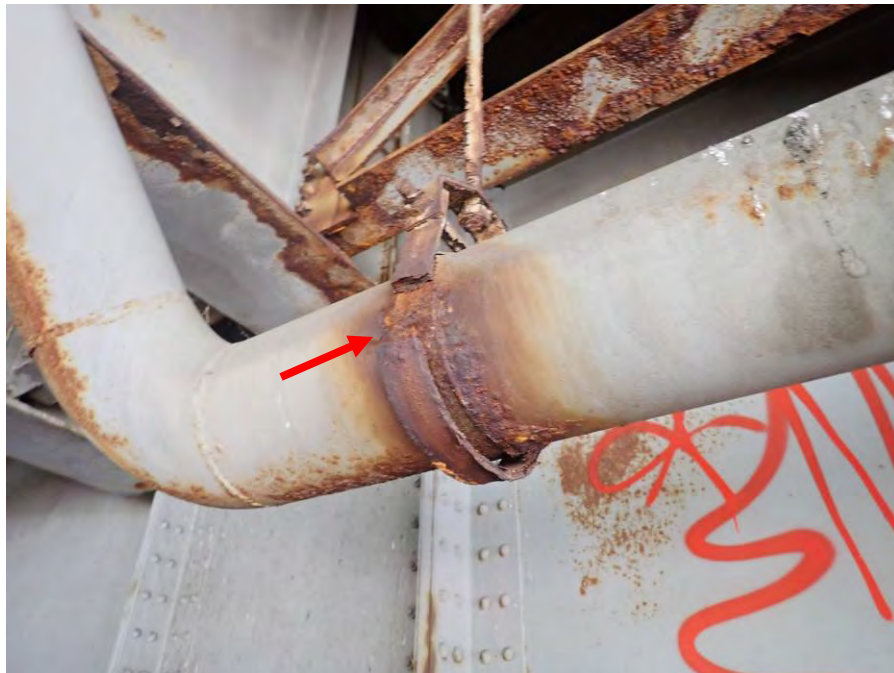
Photograph No. 76 – Broken Pipe Support in Bay 15 at Bent 11

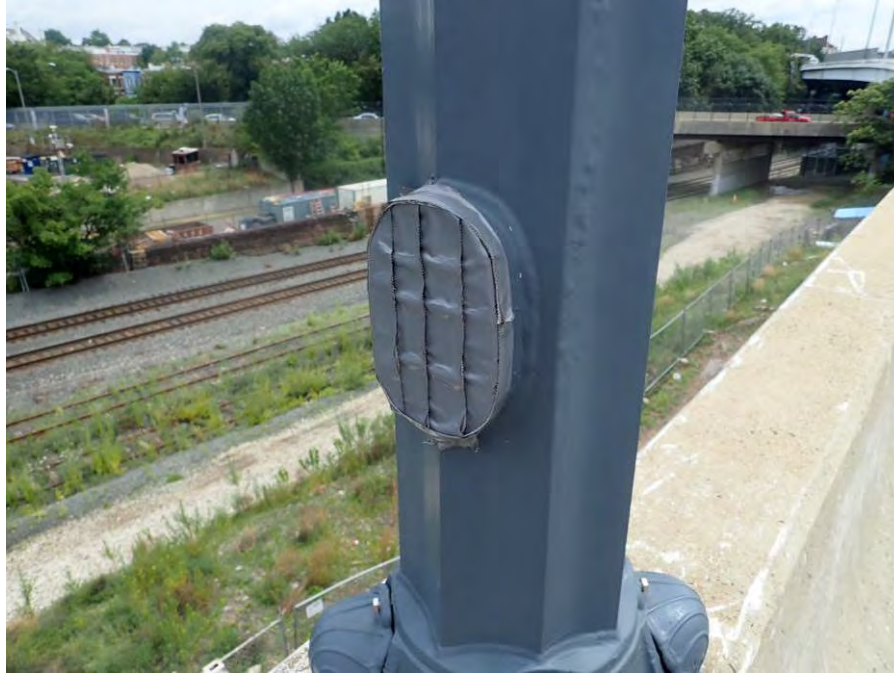
Photograph No. 79 – North Light Standard in Span 4 – Duct Tape Used to Cover Handhole Opening

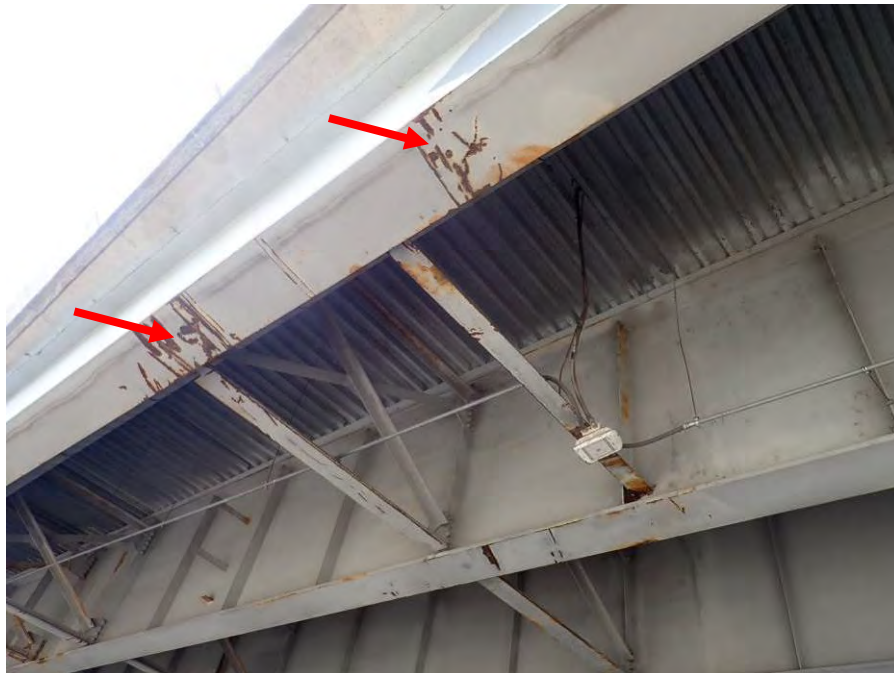
Photograph No. 80 – Typical LED Light Fixture in Span 7 above New Jersey Avenue.
Note Impact Marks to Underside of Longitudinal Girder (Arrows)

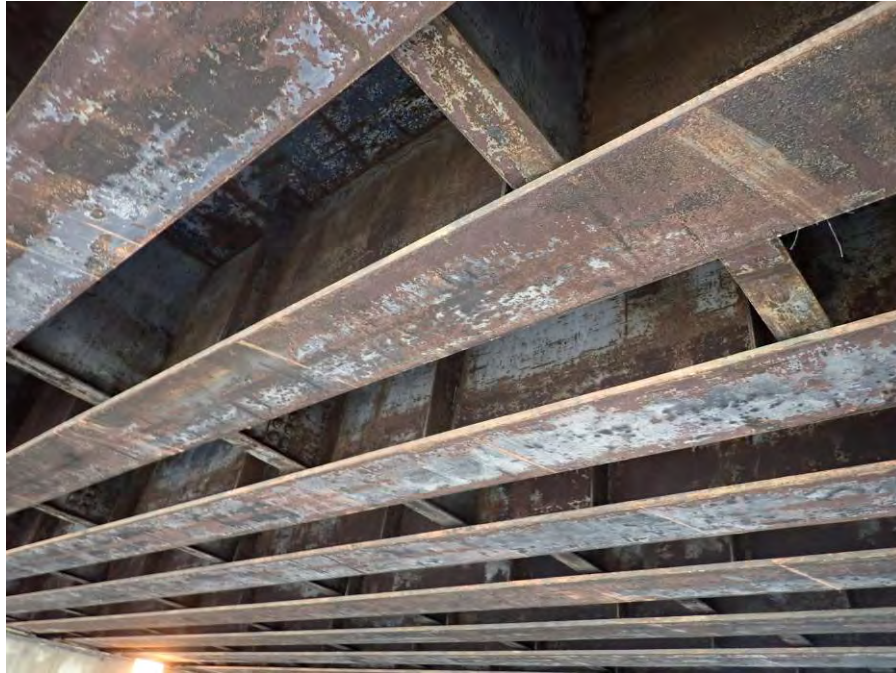
Photograph No. 7 – Typical Impact Scrapes on the Bottom Flanges of the Beams above the Center Lane, Looking Southeast

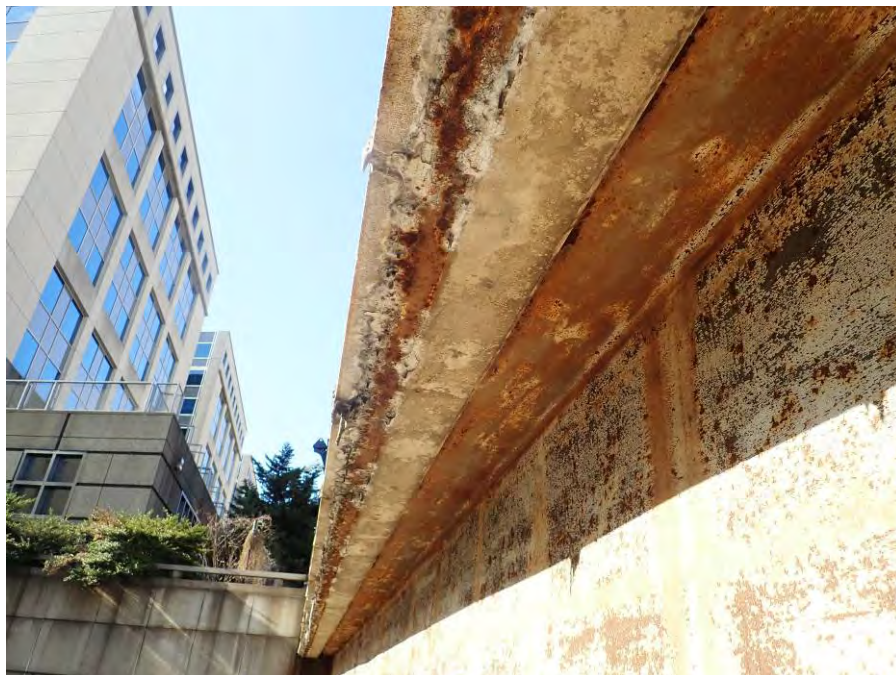
Photograph No. 8 – South Fascia. Note Efflorescence and Stalactites
